## **18.0 BUILDING 3171: KLUANE LAKE SCHOOL**

SMALL PUBLIC WATER SYSTEMS ASSESSMENT  
 WESTERN REGION

KLUANE LAKE SCHOOL  
 BUILDING # 3171  
 SITE LOCATION DIAGRAM  
 WELL ID: 3171

## SMALL PUBLIC WATER SYSTEM ASSESSMENT

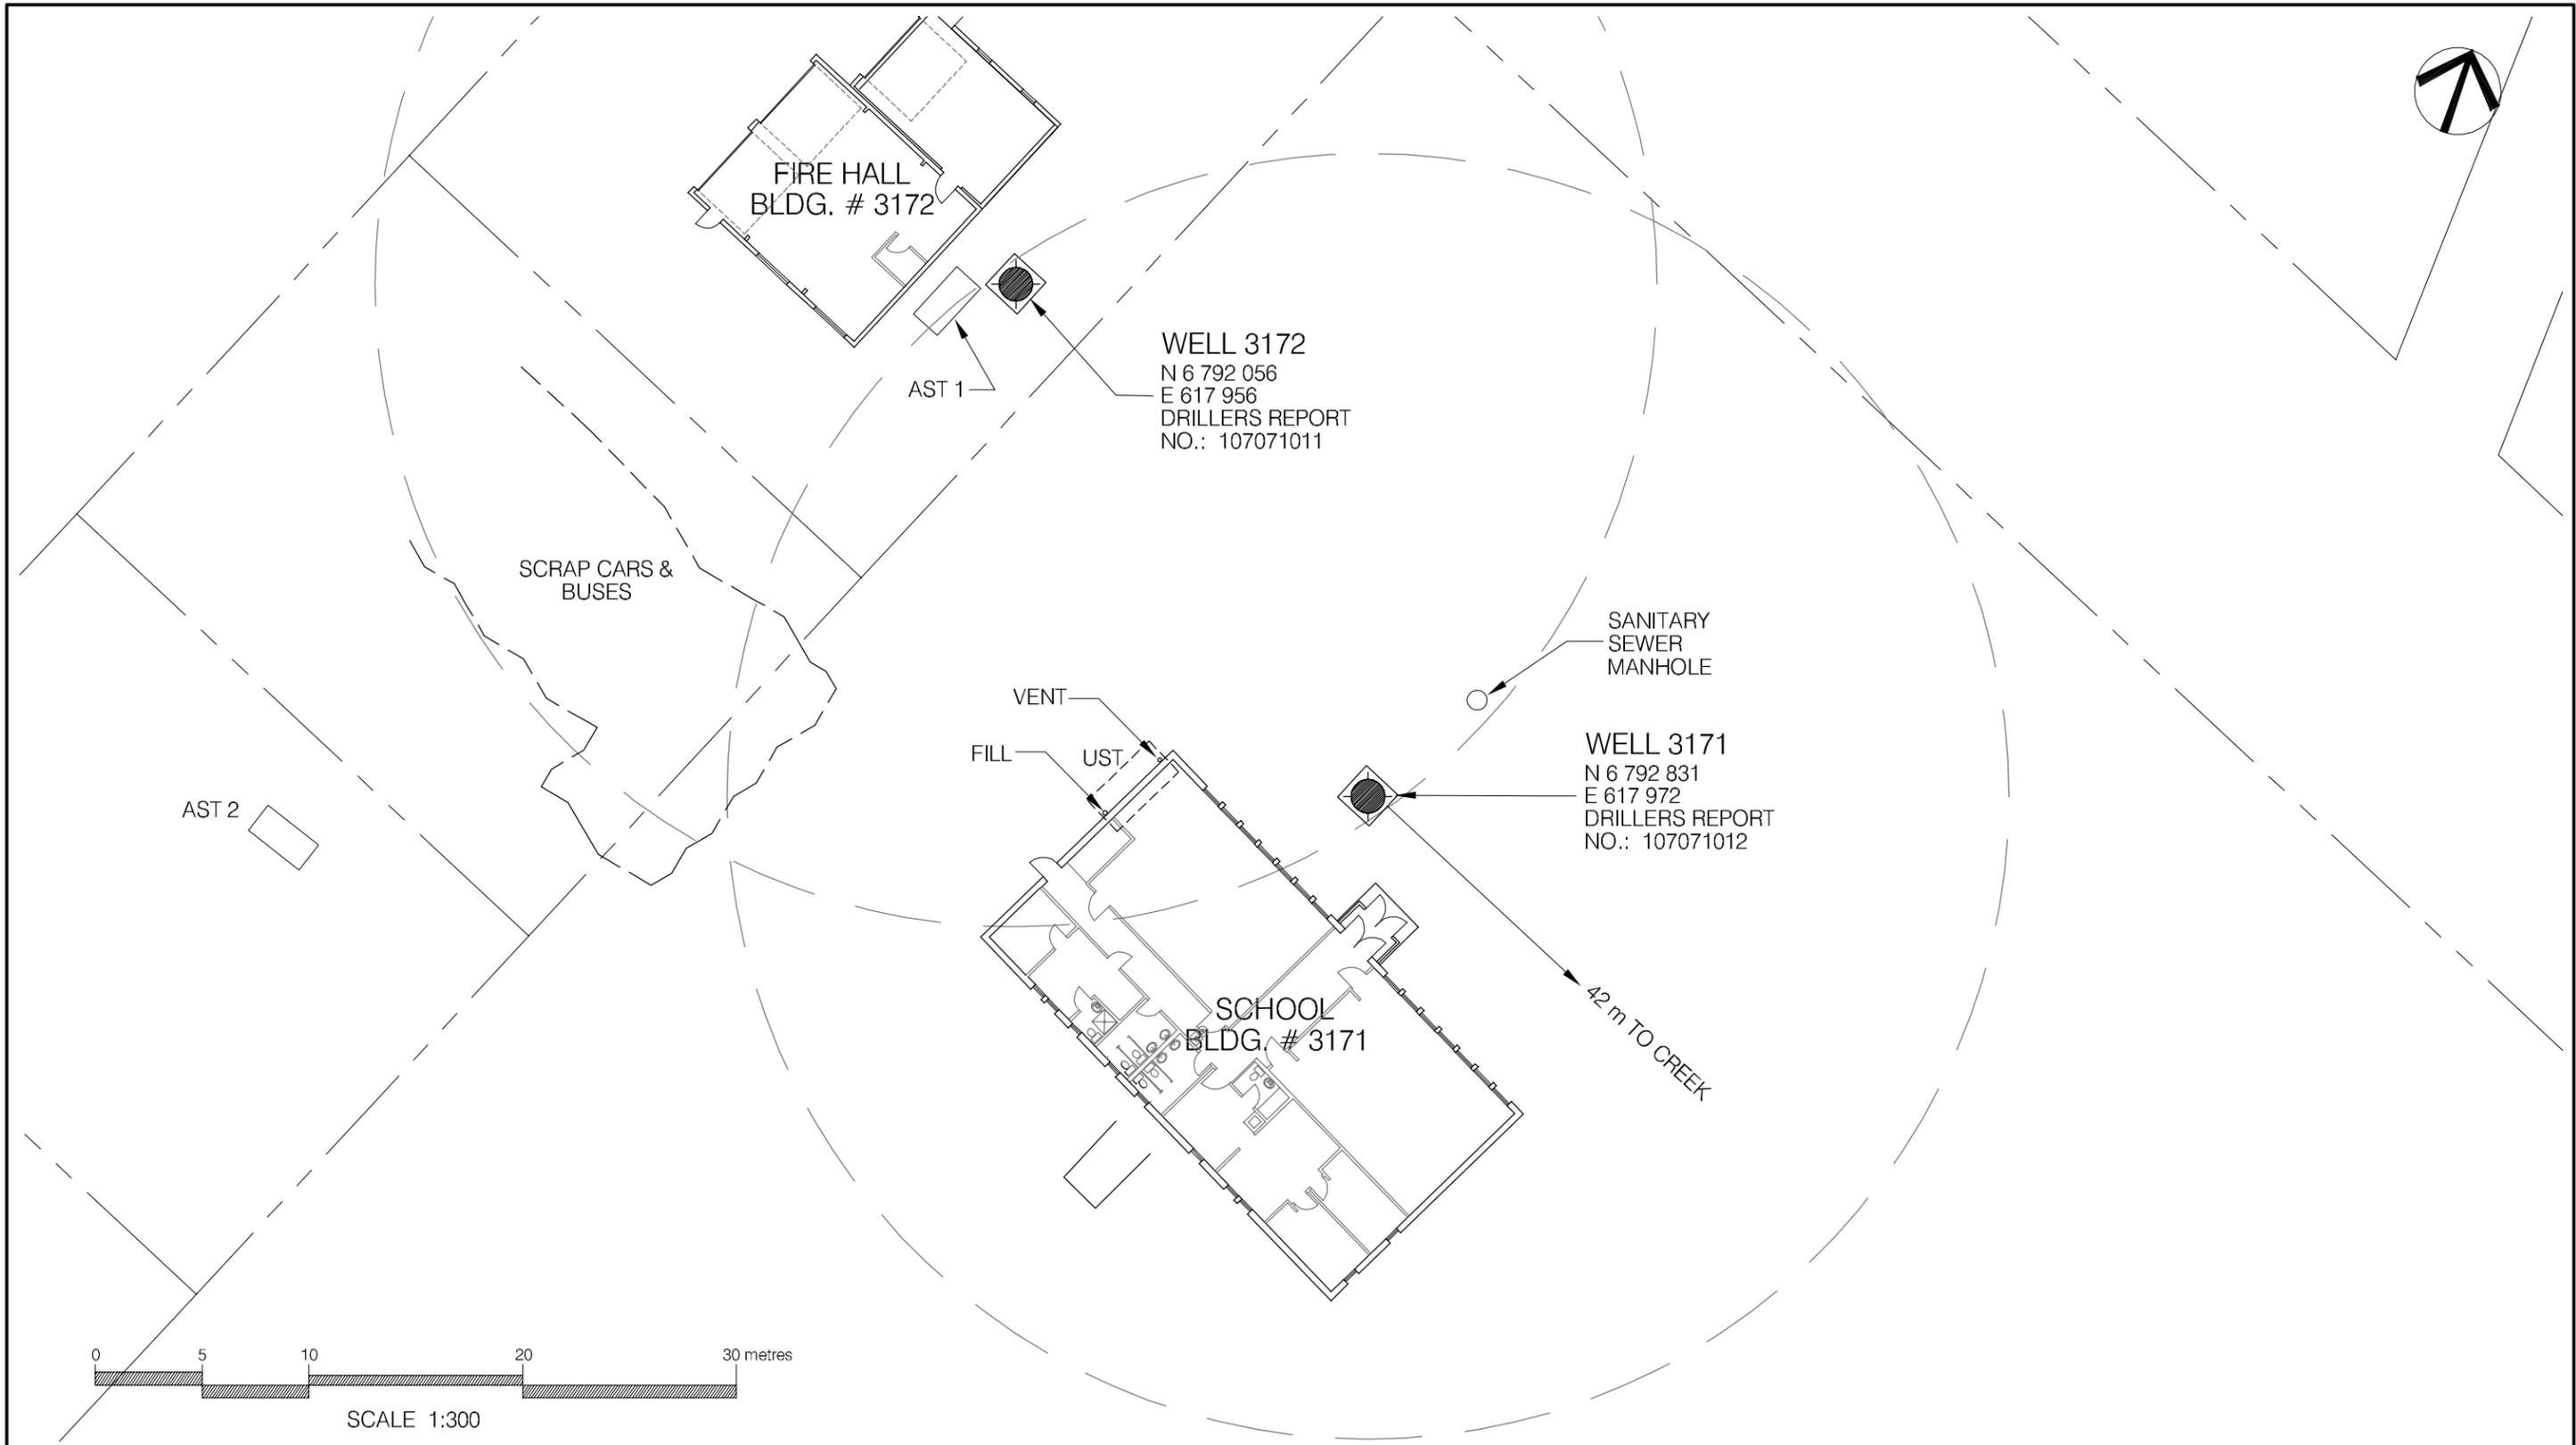
FIGURE No.  
 FIGURE 3171-A

30 m RADIUS FROM WATER WELL FOR CONSIDERATION OF PROXIMITY TO POTENTIAL CONTAMINANT SOURCES.  
 BUILDING STRUCTURES RELATIVE TO PROPERTY LINES ARE APPROXIMATE ONLY.

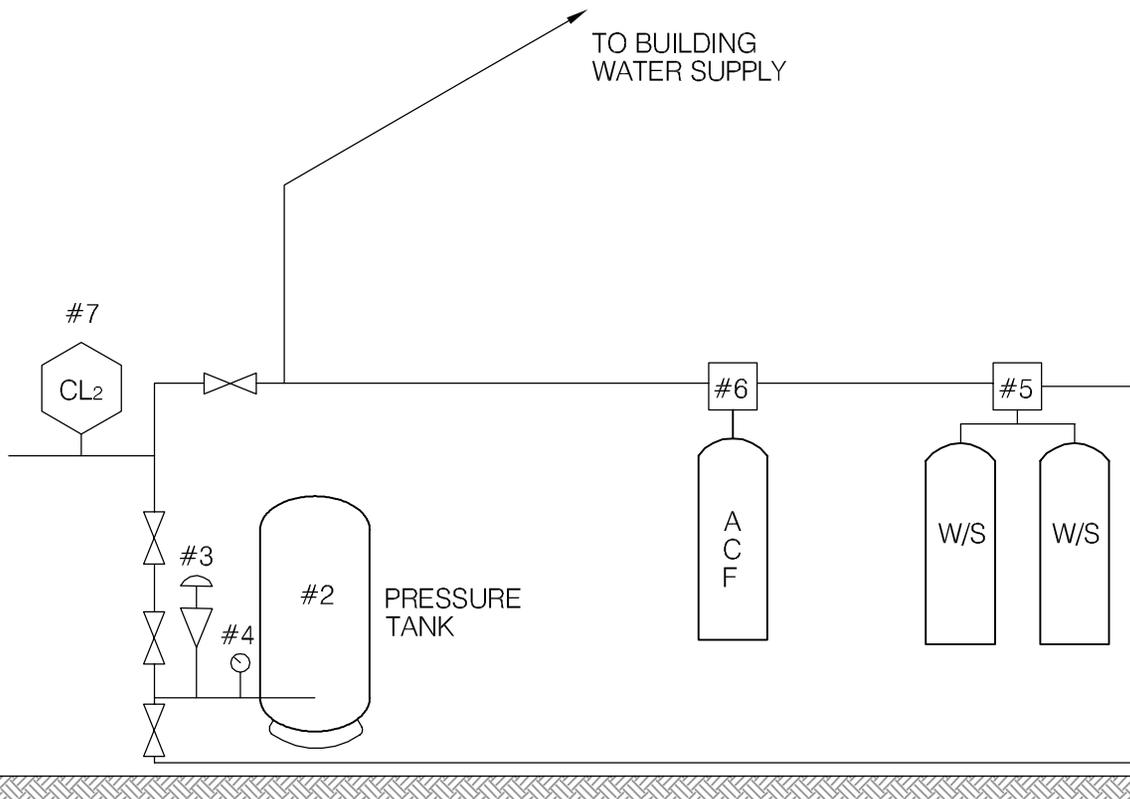
DWG.: FIGURE 3171-B

The water system is equipped with a duplex water softener and an activated carbon filter, and is also equipped with a pellet chlorination system that is installed on the wellhead. Field chemistry done at the time of the water system assessment reported a residual chlorine concentration of 0.00 mg/L for both raw and treated water, indicating that the either the chlorination system is likely not functioning properly, or that all chlorine is removed by the activated carbon vessel. A schematic detailing the well supply system is provided as Figure 3171-B in Appendix A18.

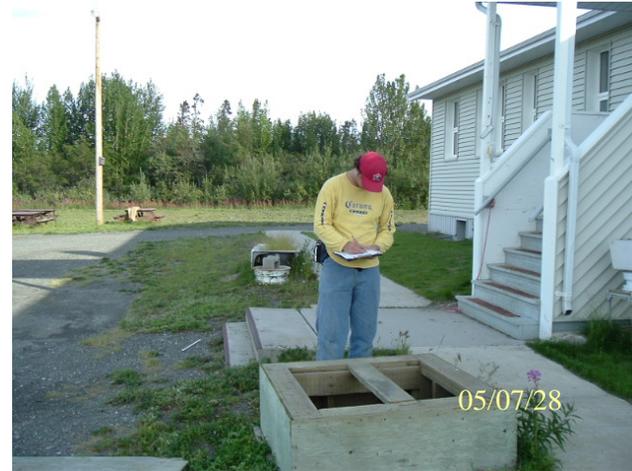
- Poor surface completion of the wellhead (located in a pit below grade);
- There is no surface sanitary seal (grout or bentonite seal as required by the Canadian Groundwater Association's Guidelines for Water Well Construction);

**Photo 0617:** 3171 Wellhead enclosure

- Standard wellhead upgrades consisting of a pitless unit installation, extending the casing to at least 500 mm above grade, and retrofitting of a surface sanitary seal (grout or bentonite to at least 3 m in depth);
- Installation of a commercial sized stainless steel duplex water NSF 61 filtration system with 5 micron followed by 1 micron absolute; and,
- Replace AST with a doubled walled “EnviroTank” type UST and relocate to at least 30 m from well.

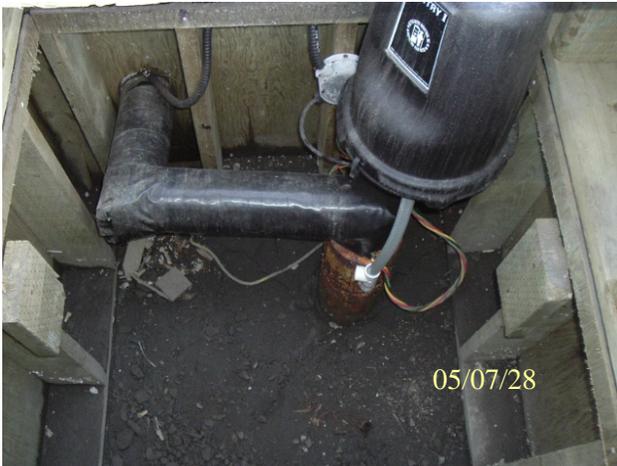
- Field chemistry indicated that the chlorination system was not functioning at the time of the water system assessment; and,
- The configuration of the water treatment system does not allow for a residual chlorine concentration at the point of use.

**Photo 0615:** 3171 Wellhead in pit, pellet chlorinator

- The casing should be extended to at least 500 mm above the base of the well pit, or as high as possible, and a temporary near surface sanitary seal should be installed around the well casing;
- The well and water system should be superchlorinated, and a chlorination tap installed at the wellhead to facilitate future superchlorination;
- Disinfection treatment consisting of a proportion feed chlorine injection system with appropriately sized retention tanks and appurtenances should be installed. The selection of this disinfection system is to ensure adequate residual chlorine within the distribution system. It has also been selected in consideration that the recommended upgrade option for the water supply serving the adjacent Fire hall would be to connect to this treated system; and,
- The activated carbon should be removed from the vessel and replaced with a multimedia bed.

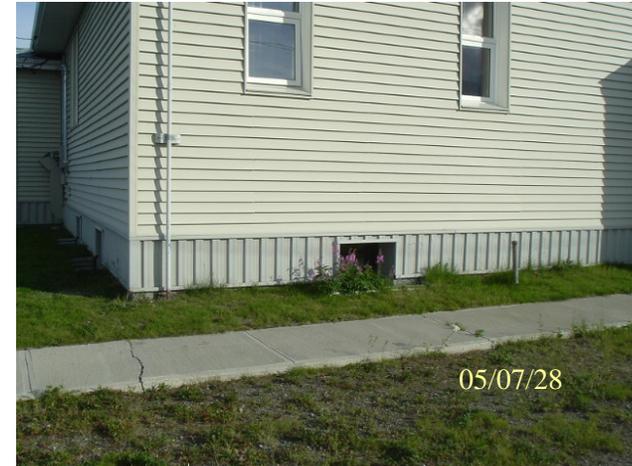
- The well is located within 30 m of potential sources of contamination, including an underground fuel storage tank at 9 m, an above ground fuel storage tank at 26 m, and scrap vehicles at approximately 30 m;

**Photo 0616:** 3171 Underground fuel storage tank

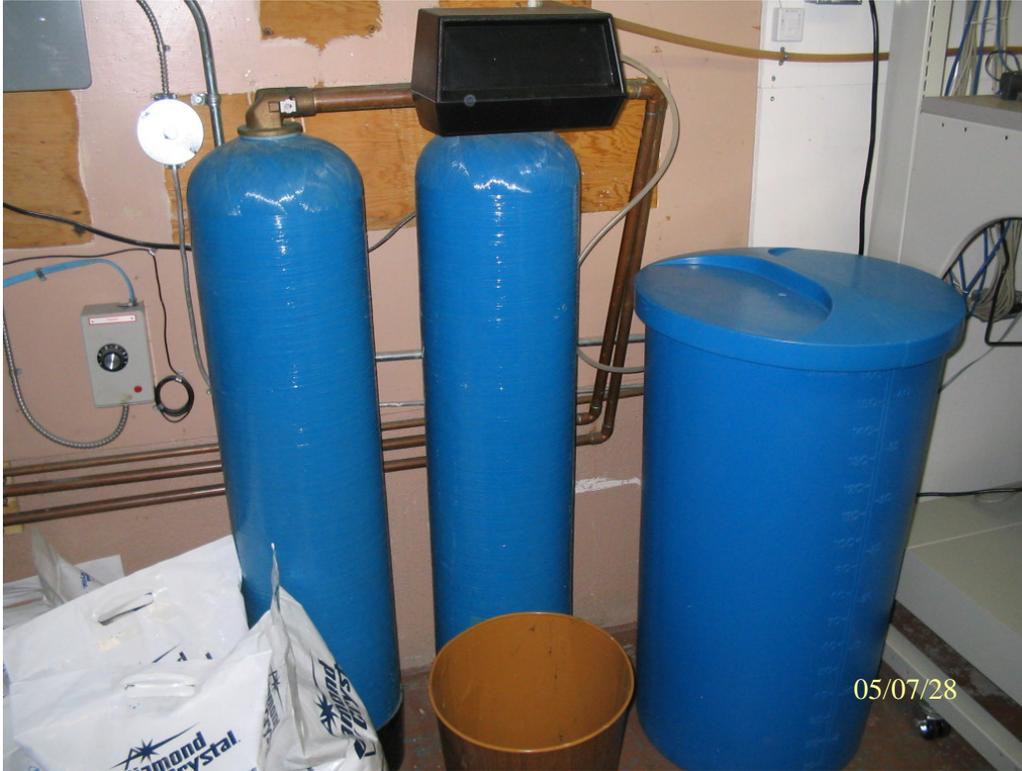
**Photo 0124:** 3171 Water softener and brine tank

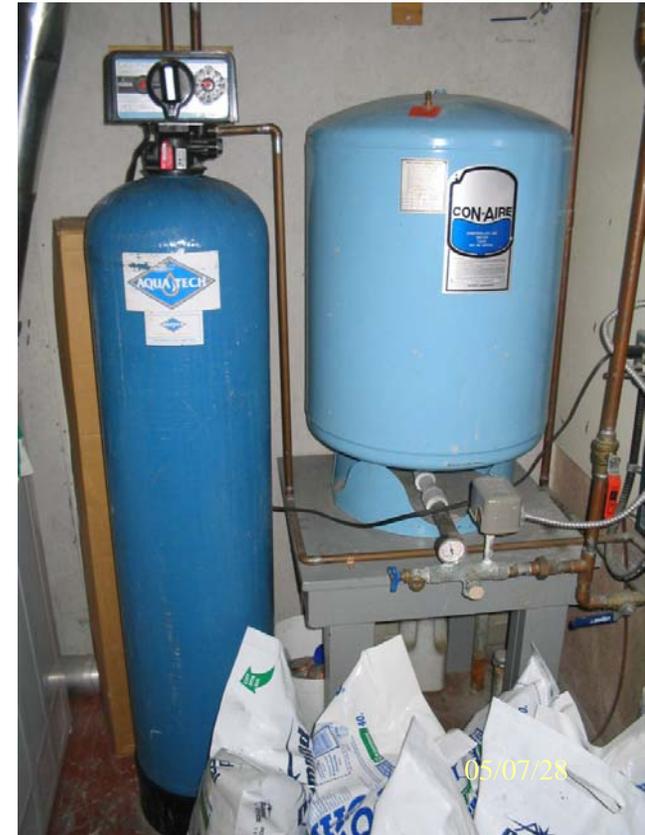
**Photo 0123:** 3171 Pressure tank (right), activated carbon filter (left)
