24.0 BUILDING 6542: CARMACKS FORESTRY DISTRICT OFFICE

SMALL PUBLIC WATER SYSTEMS ASSESSMENT
WHITEHORSE REGION

| CLIENT | | | TITLE WATER SYSTEM DISTRIBUTION/TREATMENT SCHEMATIC SYSTEM ID.: 6542 CARMACKS FORESTRY OFFICE | |

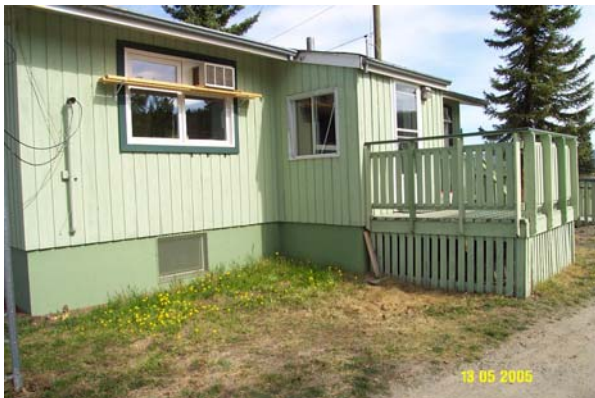
- The wellhead construction is susceptible to flooding because it is below ground in an attachment to the basement;
- The wellhead is located within 30 m of potential sources of contamination. There are two above ground fuel storage tanks within 30 m, one located 5 m from the wellhead inside the same basement of the office building and the other 24 m from the well outside near a neighboring building;

Photo 0155: 6542 Forestry District Office (wellhead located inside underneath)

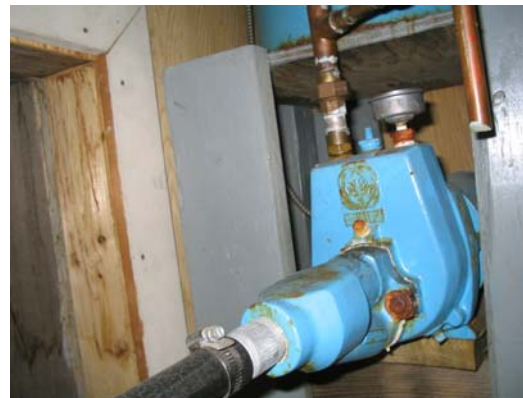
Photo 0023: 6542 Jet Pump

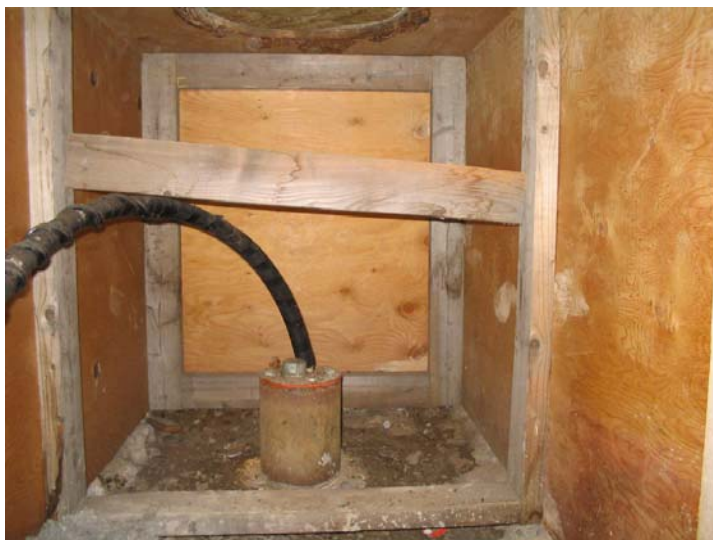
- Turbidity was in exceedence of CDWQG MAC for both samples collected.
- There is no surface sanitary seal (grout or bentonite seal as required by the Canadian Groundwater Association's Well Construction Guidelines);

Due to the location of the well in a small, enclosed attachment to the basement of the district office, and because it is incased in a PWF wooden enclosure that is covered by a layer of soil, it is very difficult to access the wellhead for maintenance purposes.

Photo 0020: 6542 Wellhead

- The existing well construction could be upgraded. The well casing should be extended above grade and a pitless adapter and near surface seal should be installed;
- A disinfection treatment system should be installed, and considering the water quality, a pretreatment system would need to be installed;
- Secondary containment should be installed on both above ground storage tanks identified at the site; and,
- Once the community system piped distribution system is installed, the treatment system would likely no longer be needed and could be reinstalled at another PMA maintained site.

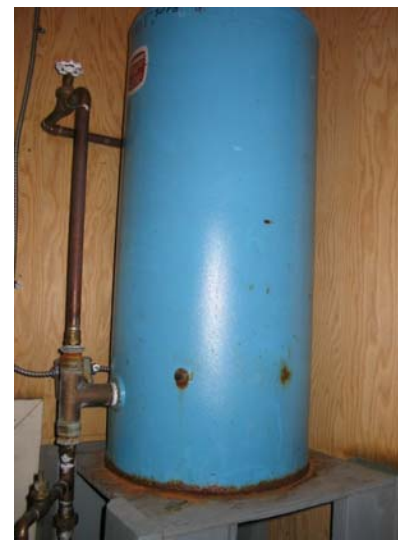
Photo 0022: 6542 Pressure Tank
