## **9.0 BUILDING 5987: PELLY CROSSING HEALTH CENTRE**

SMALL PUBLIC WATER SYSTEMS ASSESSMENT  
NORTHERN REGION

**Northern Region – Pelly Crossing Nursing Station  
Building # 5987**

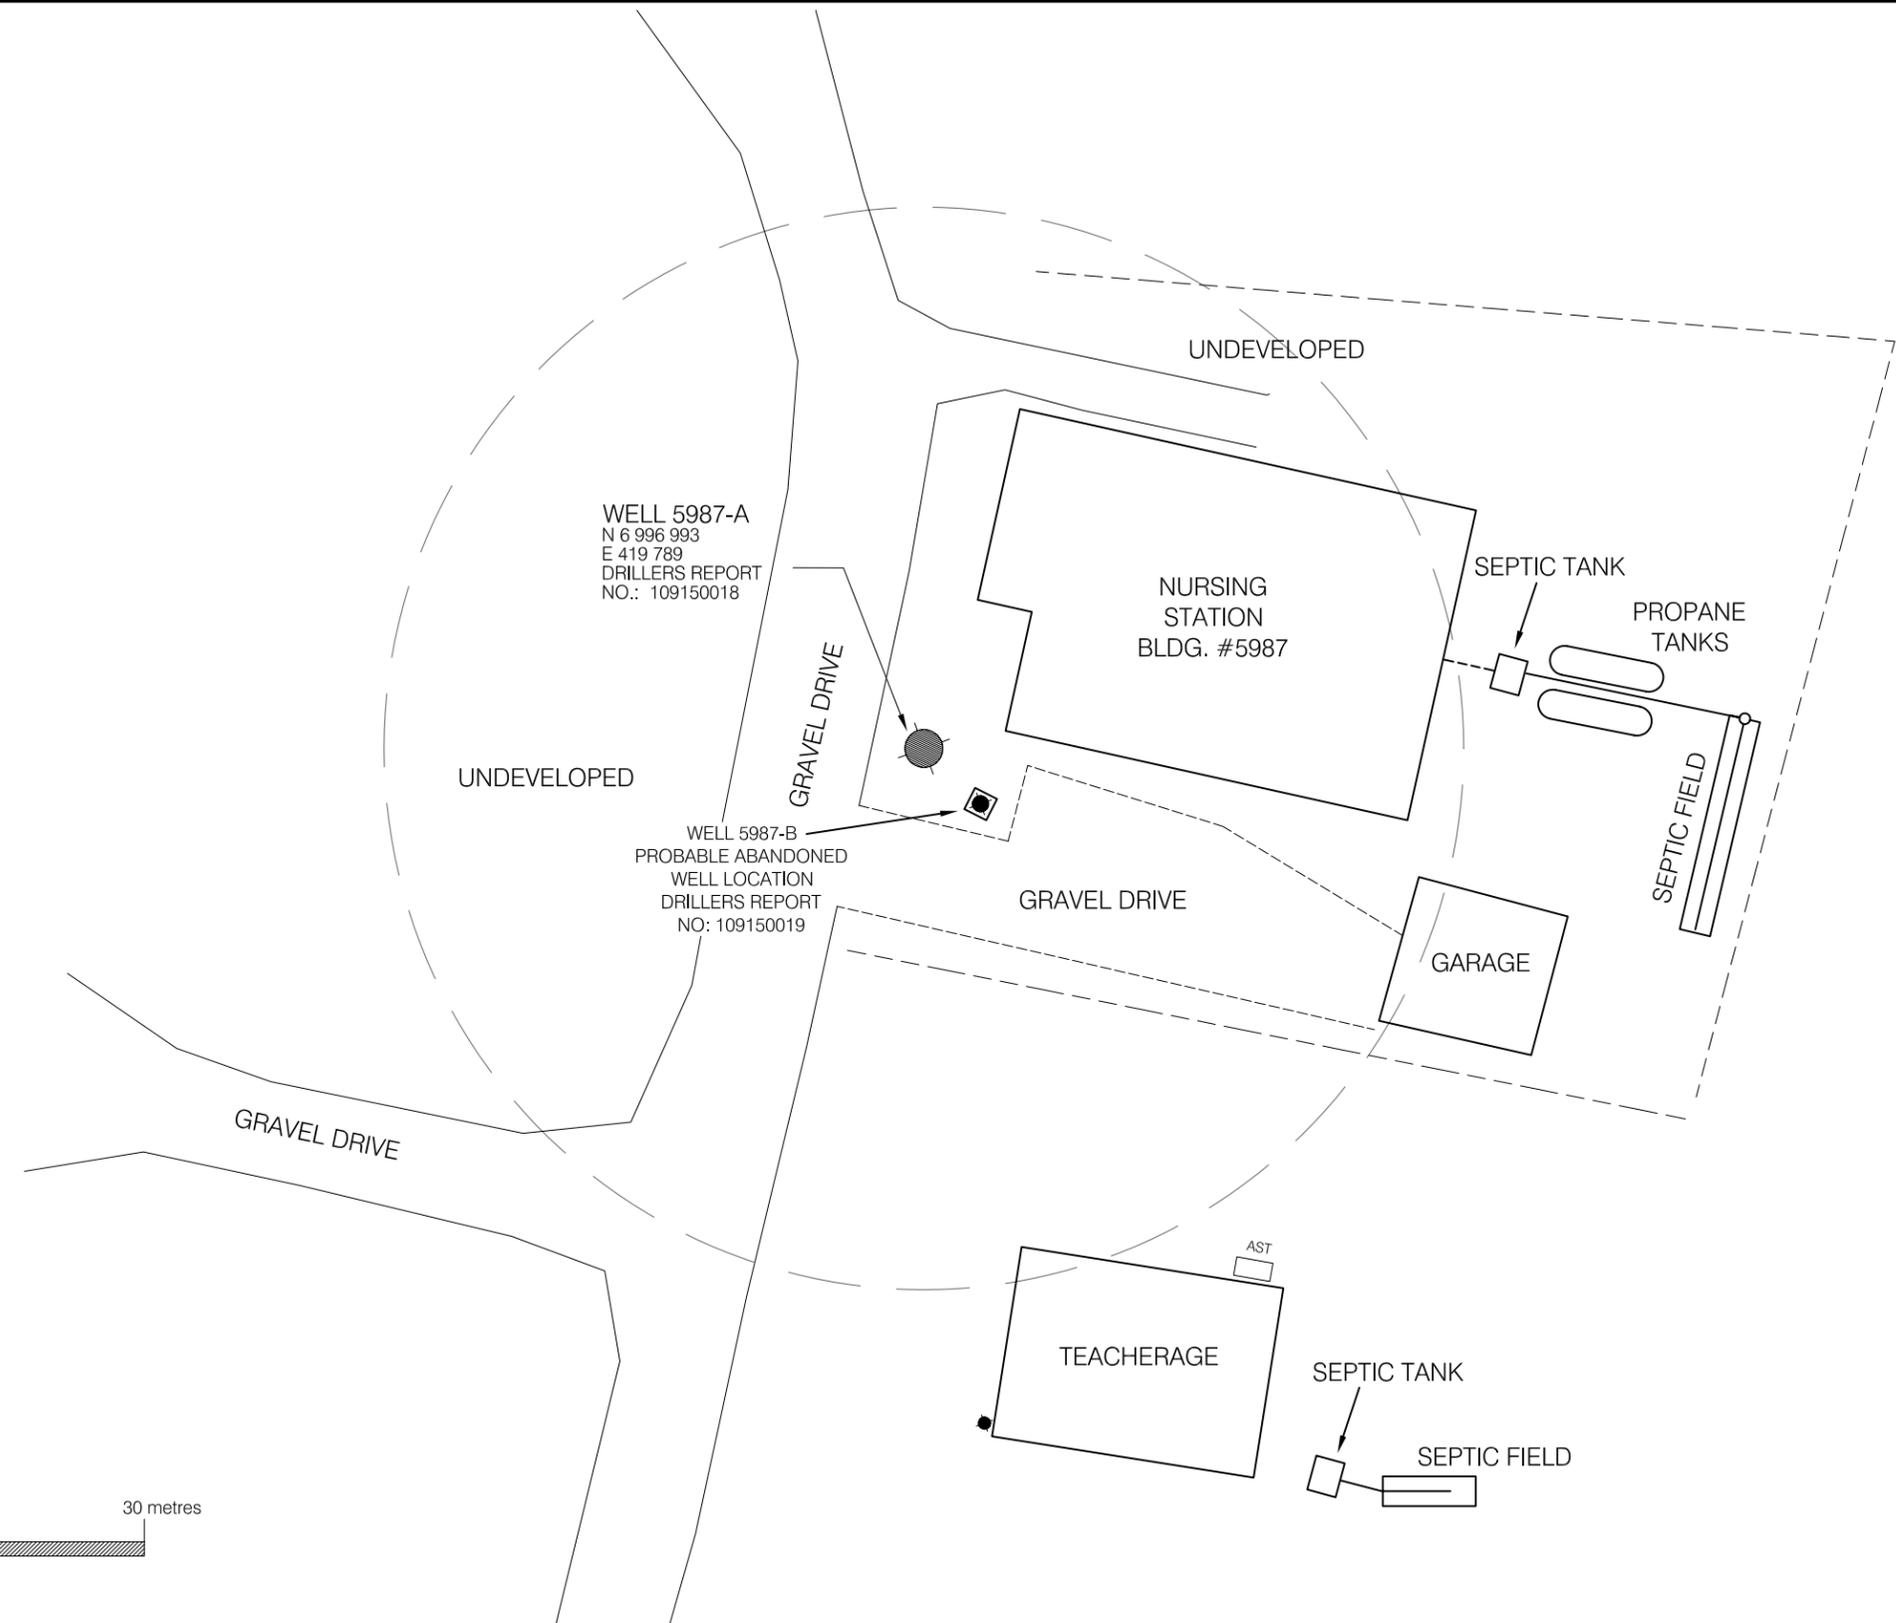
FIGURE No.  
FIGURE 5987-A

Wastewater from the health centre is discharged to an in-ground septic disposal system on the east side of the building and likely crossgradient from the well. The septic tank is located approximately 28 m from the well and the effluent discharge field is located approximately 40 m from the well. A site plan showing the septic system is given by Figure 5987-A in Appendix A9.

- An abandoned well at 2 m;
- A septic tank at 28 m; and
- An above ground fuel storage tank (AST) at 30 m.

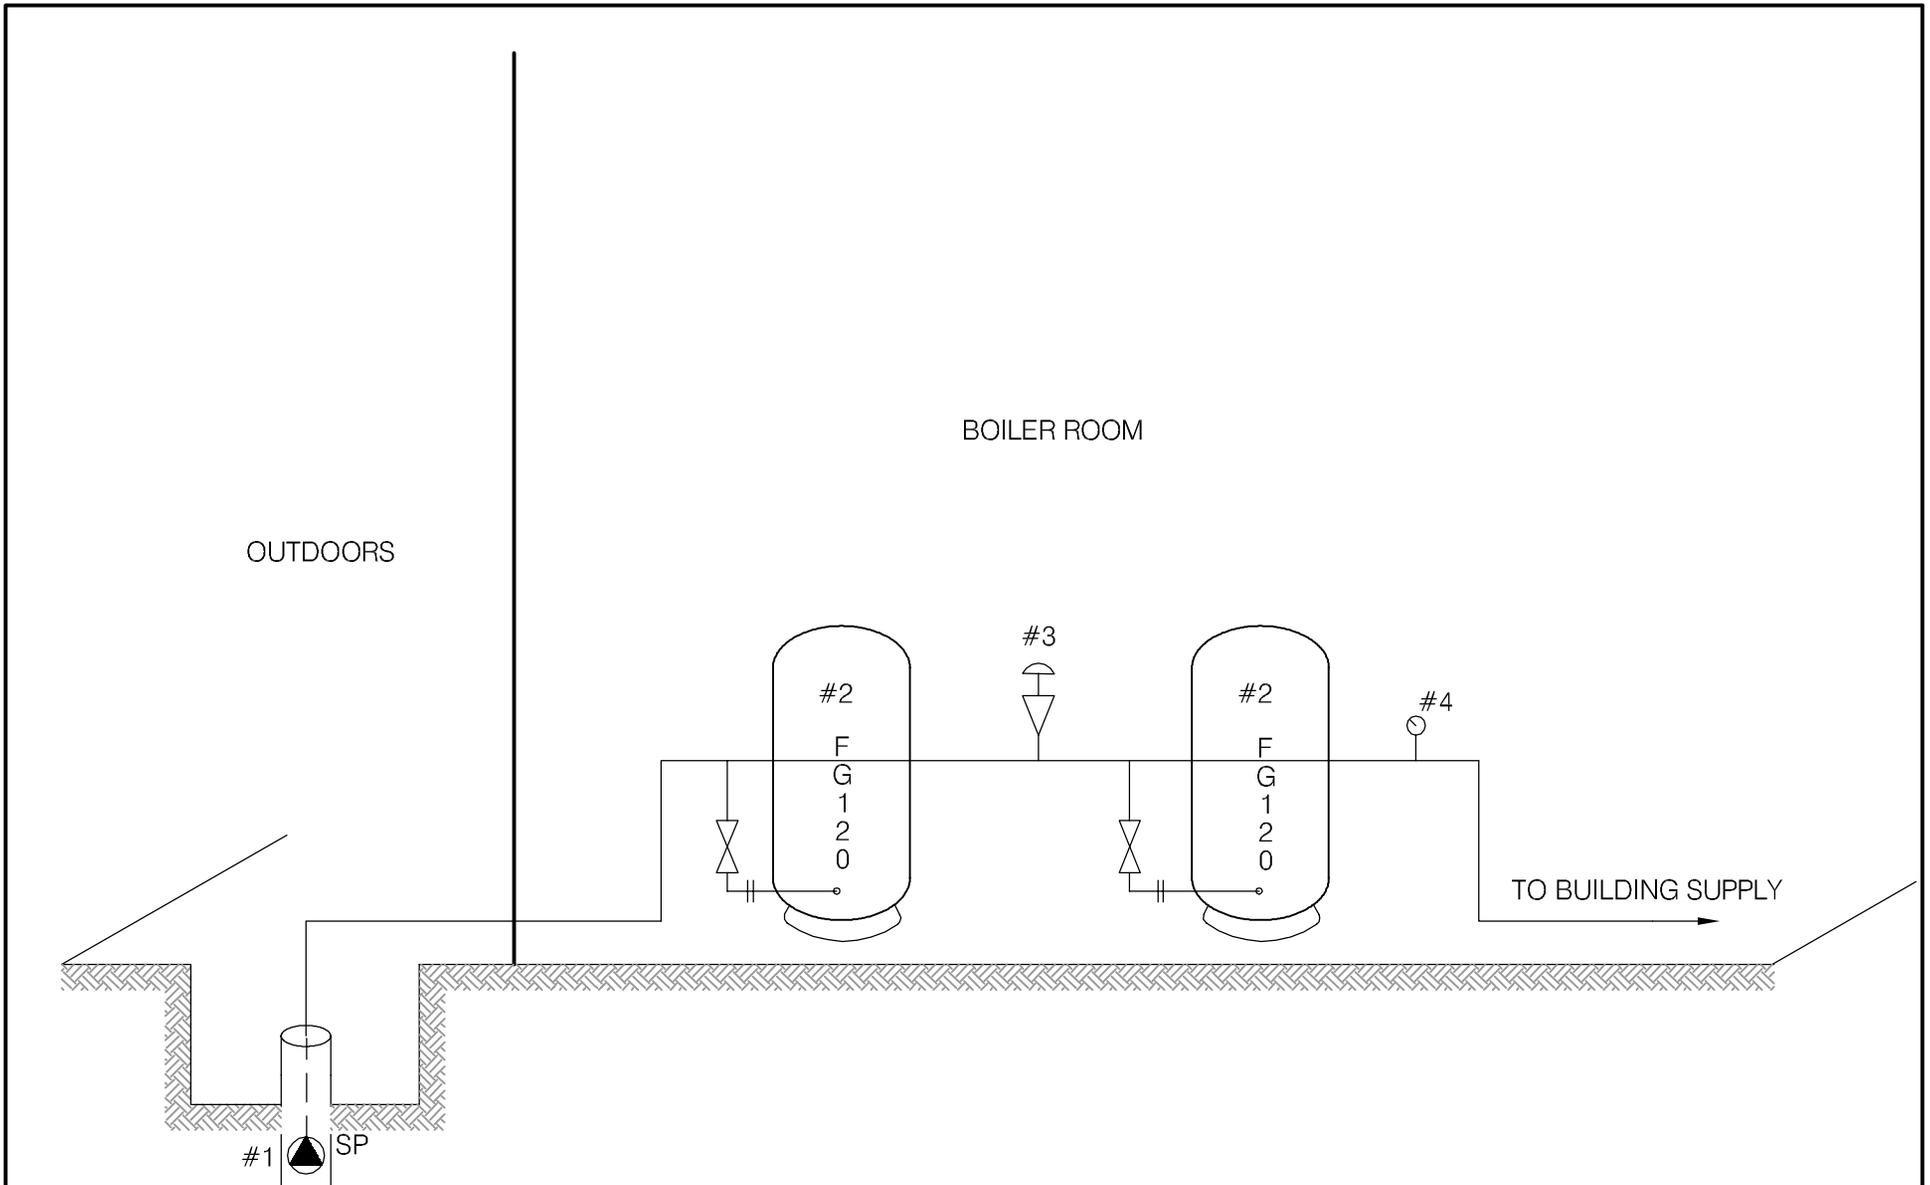
TITLE WATER SYSTEM DISTRIBUTION/TREATMENT SCHEMATIC SYSTEM ID.: 5987 NURSING STATION - PELLY CROSSING, YT.							
DATE	SEPT. 2005	DWN.	JSB	CHKD.	FMM	FILE NO.	1260002.004	DWG.:	FIGURE 5987-B

There is no treatment or disinfection for the water supplying this facility. A schematic detailing the water supply system is provided as Figure 5987-B in Appendix A9. Photos of the well and water system are also included at the back of this appendix.

- There is no treatment or disinfection system present.

- The well and water system should be super-chlorinated.
- Disinfection treatment consisting of filtration to 1 micron (absolute), and a UV system that is NSF/ANSI certified (or equivalent) should be installed to ensure disinfection of the water supplied to this building. These are conceptual design recommendations based on the information available for planning and budgeting purposes. Engineering input will be required for final system specifications.

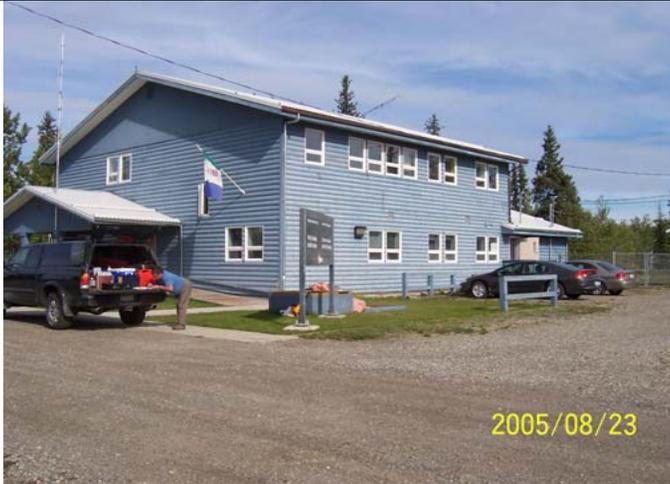
**Photo 393:** 5987 Pelly Crossing nursing station. (looking northeast)

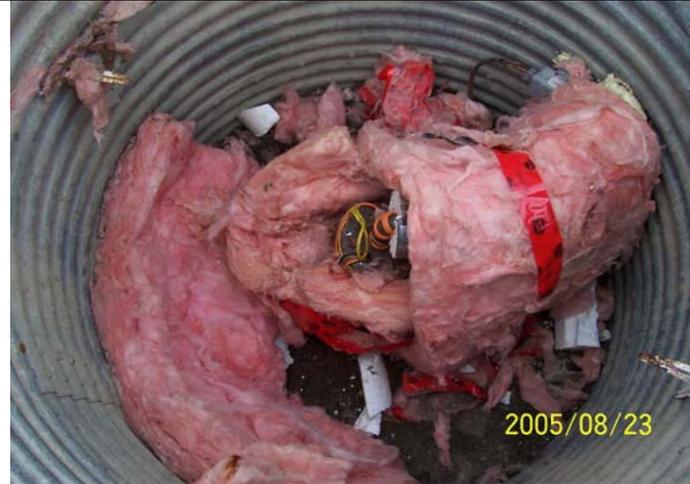
- Poor surface completion of the well (located in a pit below grade);
- There is no surface sanitary seal (grout or bentonite seal as required by the Canadian Groundwater Association's Guidelines for Water Well Construction);

- i. Is the well head below grade? describe in detail Yes (-0.66 m)
- ii. Are there signs of ponding on the enclosure(e.g. water stains, etc.)?  Yes  No
- iii. Is the wellhead enclosed by fiberglass insulations?  Yes  No
- iv. Any evidence of rodents? Specify No
- v. Does the well casing have a proper seal cap?  Yes  No

**Photo 394:** 5987 Well enclosure and wellhead in pit.

- Interim wellhead upgrades consisting of extending the casing to at least 500 mm above the base of the well pit, and installation of a localized near surface bentonite seal immediately around the wellhead should be completed.

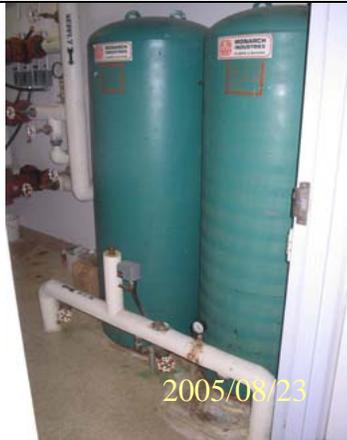
**Photo 202:** Water system. (pressure tanks & pump controls)

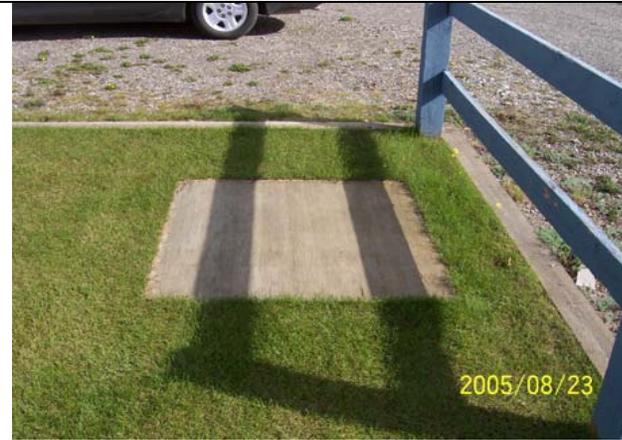
Potential Source 2: Abandoned well; Distance from well to Potential Source 2: 2m.

**Photo 396:** Potential location of abandoned well.

- Backflow prevention should be installed to ensure that potentially contaminated water can't flow from taps back to the water system.
- The abandoned well that is 2 m from the existing well in use should be properly decommissioned.
