10.0 BUILDING 3102: BEAVER CREEK FIRE HALL

SMALL PUBLIC WATER SYSTEMS ASSESSMENT
WESTERN REGION

GOVERNMENT OF YUKON
HIGHWAYS & PUBLIC WORKS
BEAVER CREEK FIRE HALL
BUILDING # 3102
SITE LOCATION DIAGRAM
WELL ID: 3102

SMALL PUBLIC WATER SYSTEM ASSESSMENT

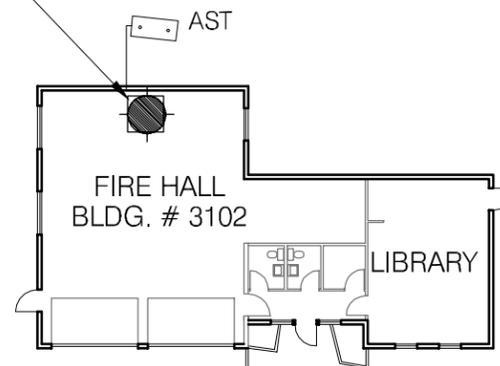
REVISION ISSUE
0
FIGURE No.
FIGURE 3102-A

There is a septic tank or a leach pit located to the west of the fire hall approximately 16 m from the well. It is unknown if there is an effluent discharge field present on the property. Conceptual hydrogeology (outlined in a following section) indicates that the septic system is likely upgradient from the well. A site plan showing the septic system is given by Figure 3102-A in Appendix A10.

○ SEPTIC TANK OR LEACH PIT
(NO FIELD LOCATED)

30 m RADIUS FROM WATER WELL FOR CONSIDERATION OF PROXIMITY TO POTENTIAL CONTAMINANT SOURCES.

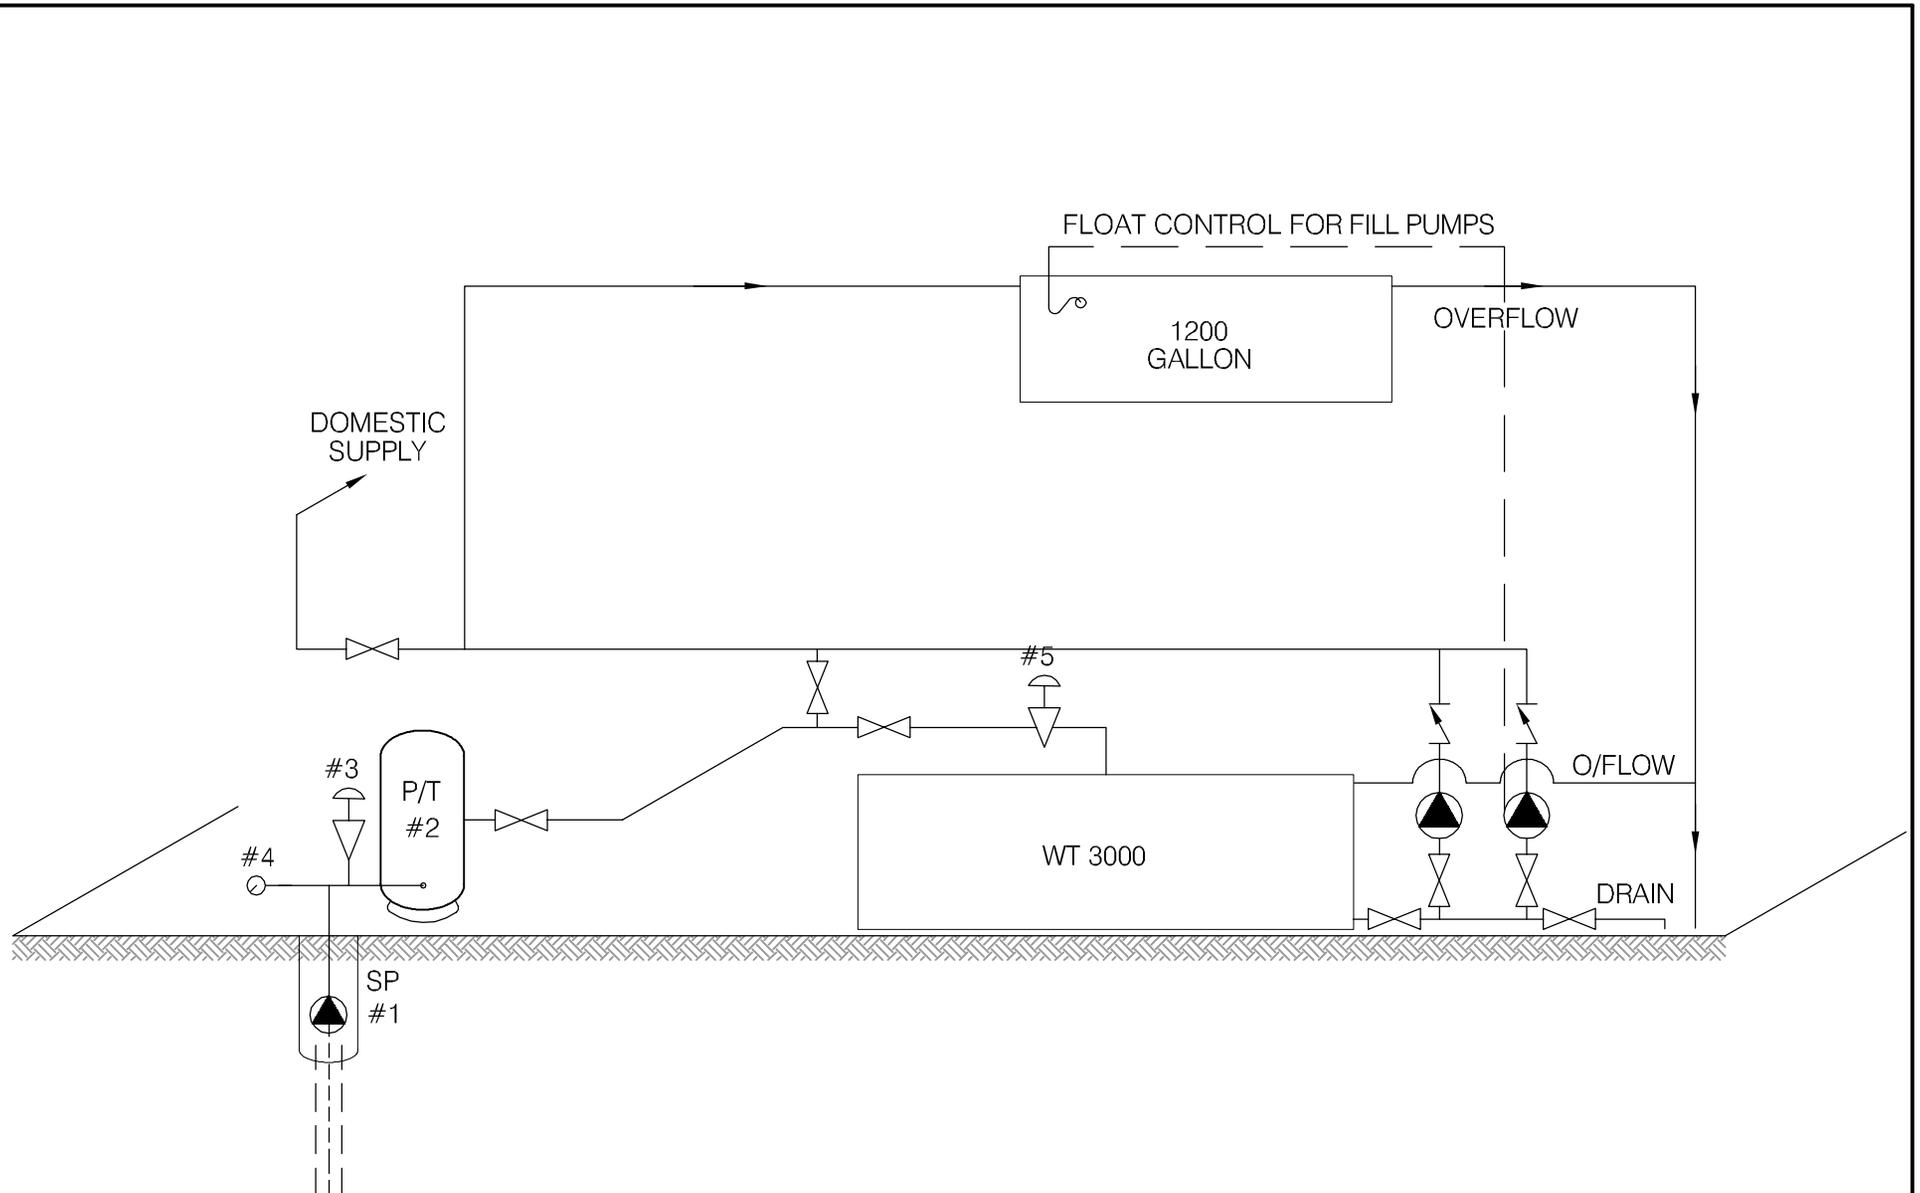
TITLE WATER SYSTEM DISTRIBUTION/TREATMENT SCHEMATIC SYSTEM ID.: 3102 BEAVER CREEK FIRE HALL			
DATE SEPT. 2005	DWN. JSB	CHKD. RMM	FILE NO. 1260002.003	DWG.: FIGURE 3102-B

There is no treatment or disinfection system for this system. Water is delivered to an approximately 12 000 L water storage tank which is at grade, and a 4800 L elevated water storage tank for fire protection. A schematic detailing the well supply system is provided as Figure 3102-B in Appendix A10.

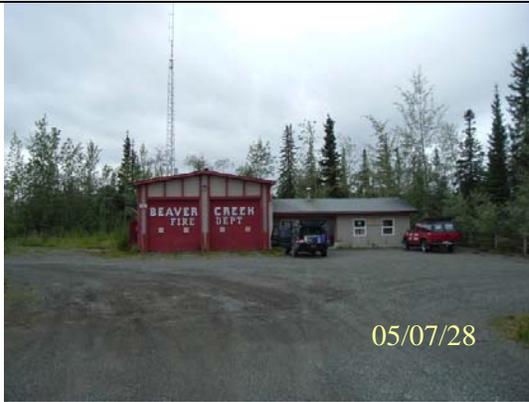
Photo 0574: 3102 Beaver Creek Fire Hall looking west

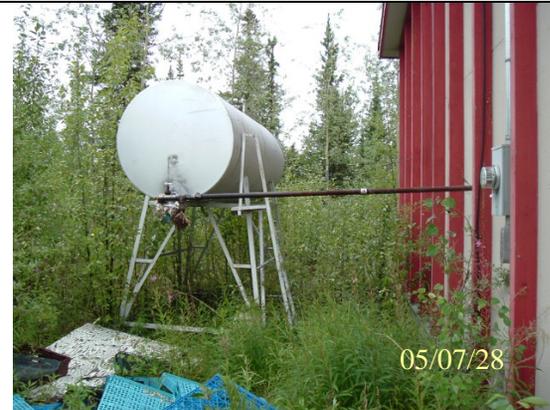
- A above ground fuel storage tank (AST) located at 3.5 m;
- A septic tank or leach pit at 16 m; and,
- Fuel and chemical handling and vehicle parking within very close proximity to the wellhead.

Potential Source 1: AST; Distance from well to Potential Source 1: ~3.5m

Photo 0575: 3102 Above ground fuel storage tank behind firehall

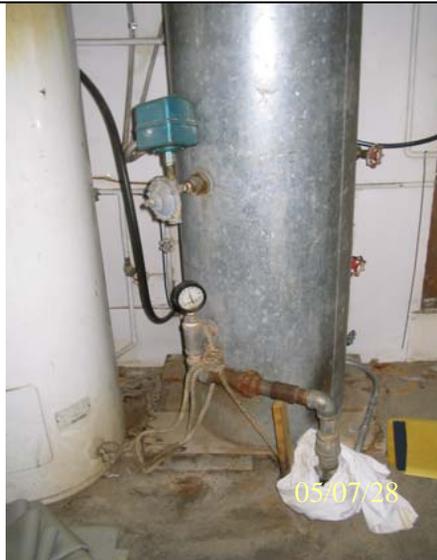
- Poor surface completion of the well (located in fire hall garage only 40 mm above grade, there is no cap on the casing);
- There is no surface sanitary seal (grout or bentonite seal as required by the Canadian Groundwater Association's Guidelines for Water Well Construction);
- There is no well log available to review well construction or lithology;
- By definition of the Draft Yukon GUDI Assessment Guideline, the well is potentially under the direct influence of surface water because the depth of the well is unknown and the well construction does not meet the requirements of the Guidelines for Water Well Construction;
- Well is located within 30 m of potential contaminant sources, including an AST at 3.5 m, a leach pit located at approximately 16 m, and garage activities immediately adjacent to the wellhead;

Entrance by animals? Yes No
No cap ~ 4cm above grade

- i. Is the well head below grade? describe in detail ~40 mm above grade
- ii. Are there signs of ponding on the enclosure(e.g. water stains, etc.)? Yes No
- iii. Is the wellhead enclosed by fiberglass insulations? Yes No
- iv. Any evidence of rodents? Specify Access possible
- v. Does the well casing have a proper seal cap? Yes No
If no, describe condition Cloth forced in casing

Photo 0104: 3102 Wellhead (bottom), pressure tank (top). Note well casing is covered with a piece of cloth

- The casing should be extended to at least 500 mm above the concrete floor grade, and if not already completed, a proper fitting well cap must be installed;
- The plumbing system should be re-plumbed such that the domestic water comes of the system prior to entering the tank;
- Backflow prevention should be installed to prevent backflow from the water tanks to the domestic system;

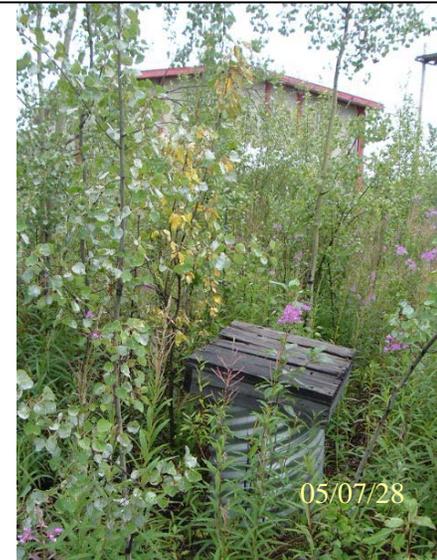
j. Distance from well to nearest point of known field: Septic tank or leach pit @ 16m

Photo 0576: 3102 Looking east at septic tank or leach pit (front), fire hall (rear)

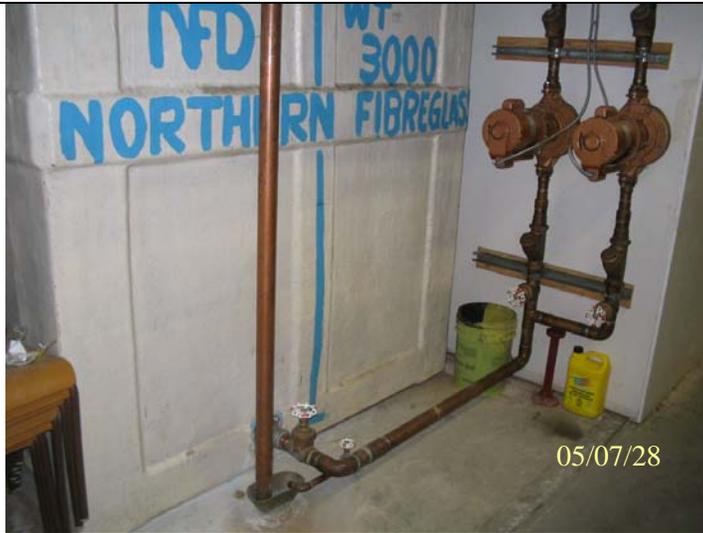
Photo 0106: 3102 Water storage tank

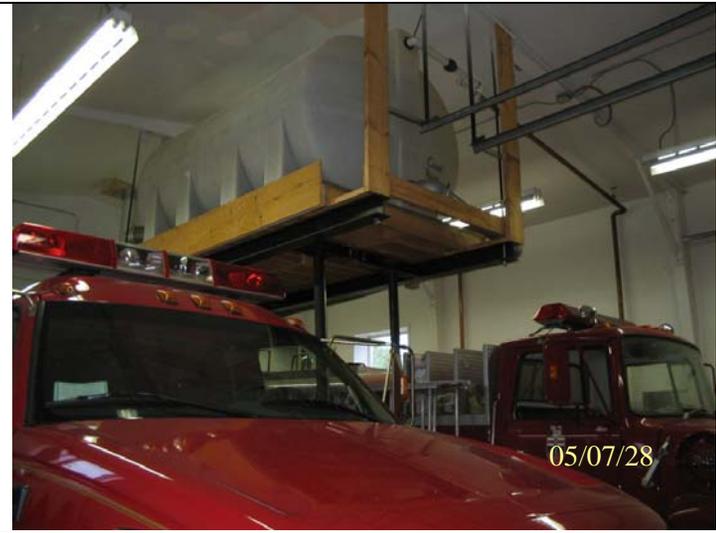
Photo 0111: 3102 Elevated water storage tank
