17.0 BUILDING 3204: BURWASH LANDING FIRE HALL

SMALL PUBLIC WATER SYSTEMS ASSESSMENT
WESTERN REGION

BURWASH LANDING FIRE HALL
BUILDING # 3204
SITE LOCATION DIAGRAM
WELL ID: 3204

Yukon Highways and Public Works Property Management Branch		TITLE WATER SYSTEM DISTRIBUTION/TREATMENT SCHEMATIC SYSTEM ID.: 3204 BURWASH LANDING FIRE HALL	
DATE	SEPT. 2005	DWN.	JSB
CHKD.	RMM	FILE NO.	1260002.003
		DWG.:	FIGURE 3204-B

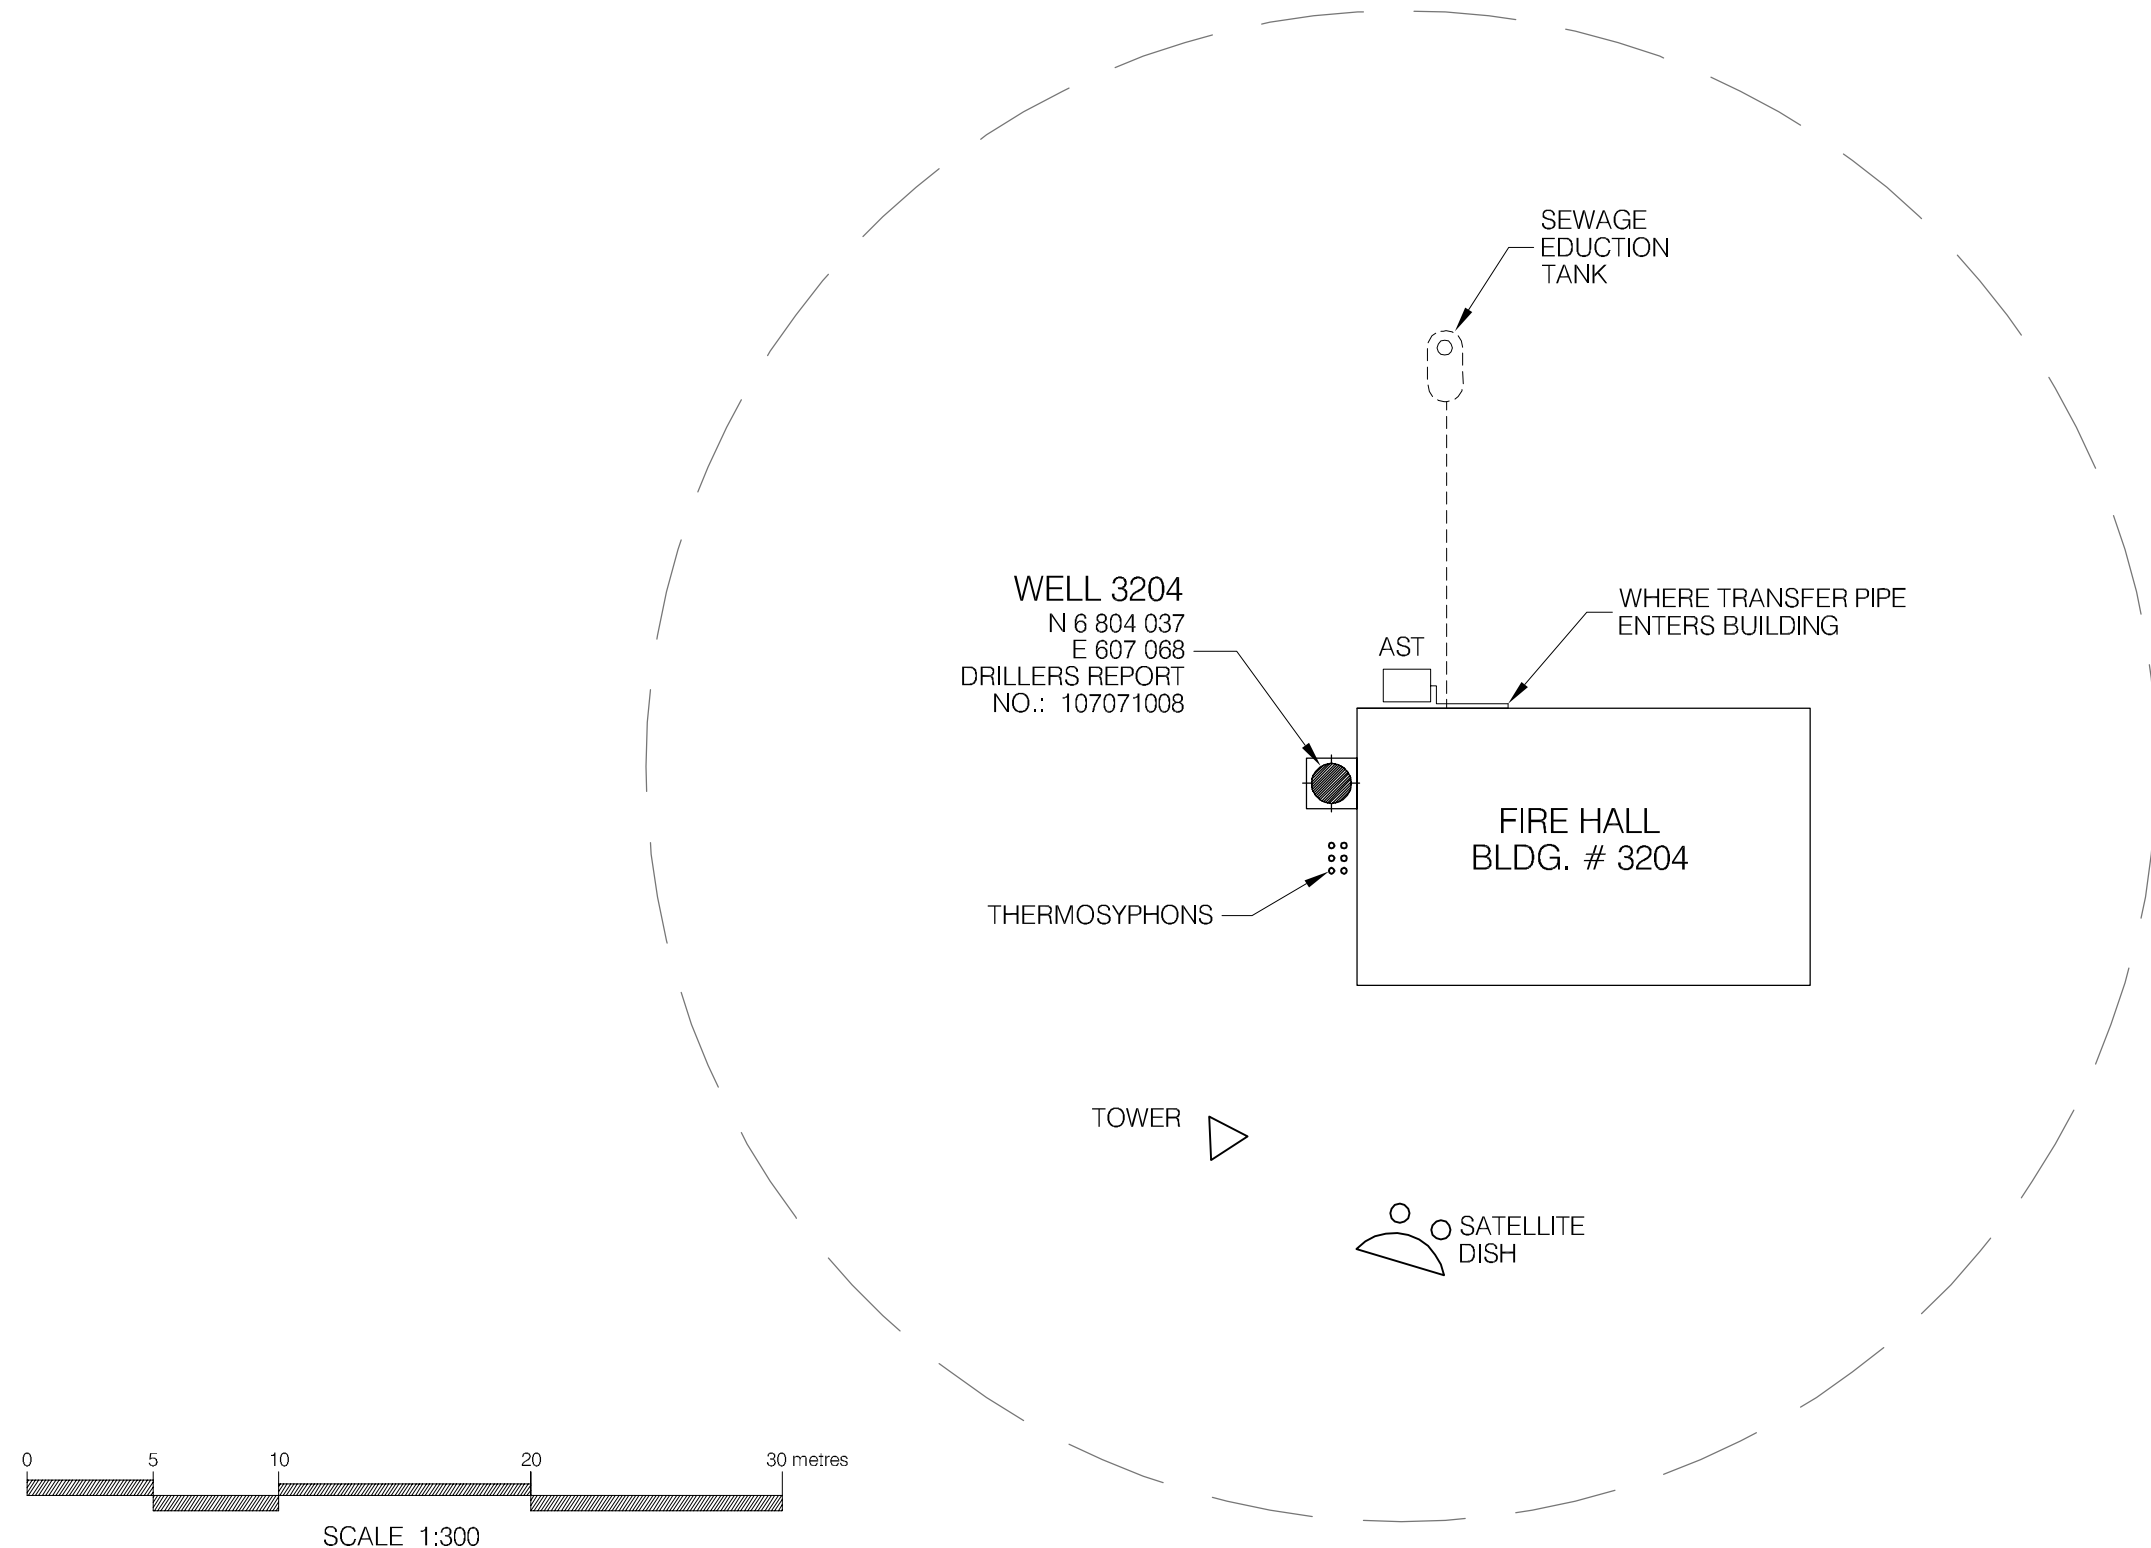
REVISION ISSUE
0
FIGURE No.
FIGURE 3204-A

The building is equipped with a sewage education tank located to the east of the fire hall. The education tank is approximately 15 m east and likely downgradient from the well. A site plan showing the septic system is given by Figure 3204-A in Appendix A17.

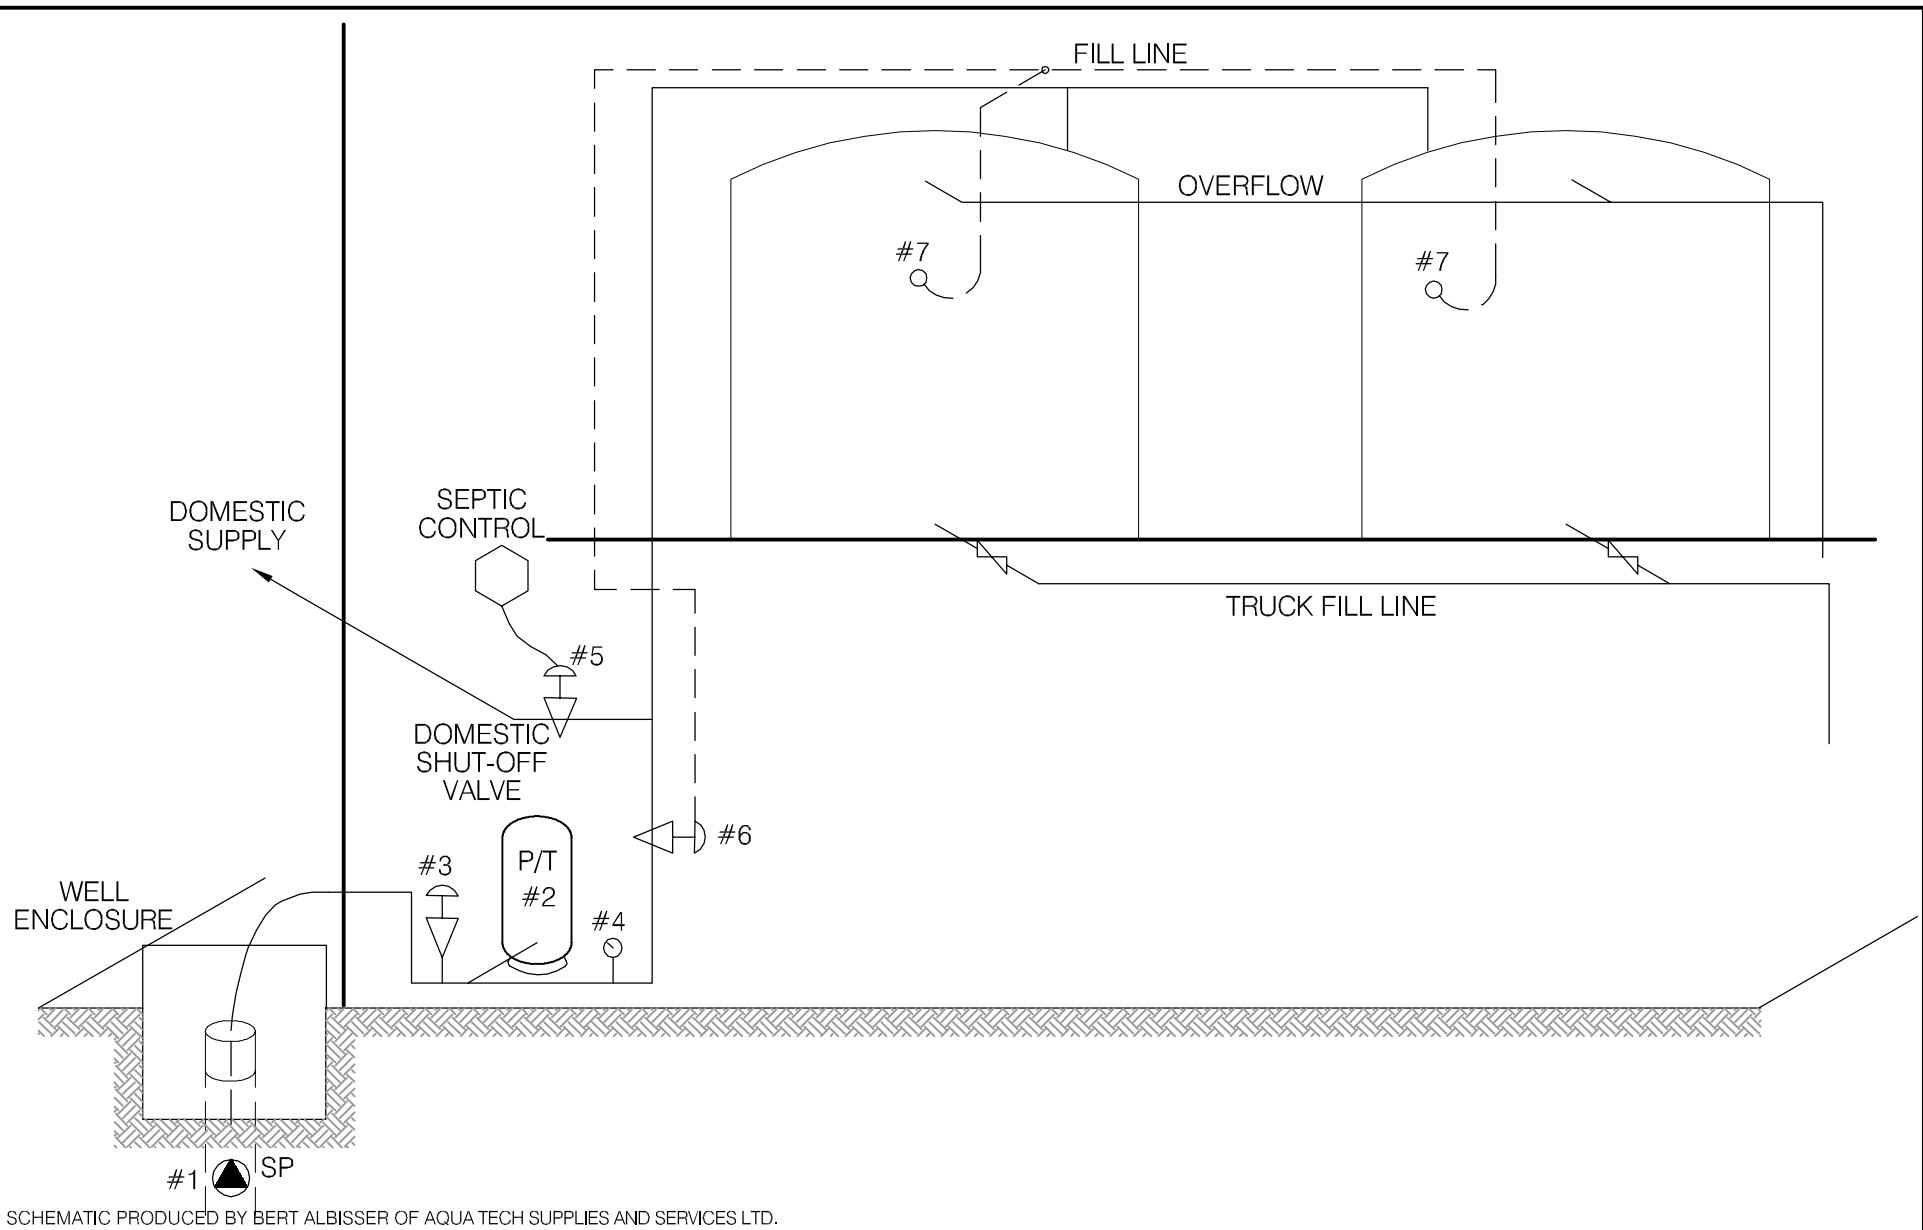
There is no treatment or disinfection system for the water supplying this system. The water system splits to serve the domestic system and the fire truck fill. There are two approximately 5000 L water storage tanks to store water used for fire fighting. A schematic detailing the water supply system is provided as Figure 3204-B in Appendix A17.

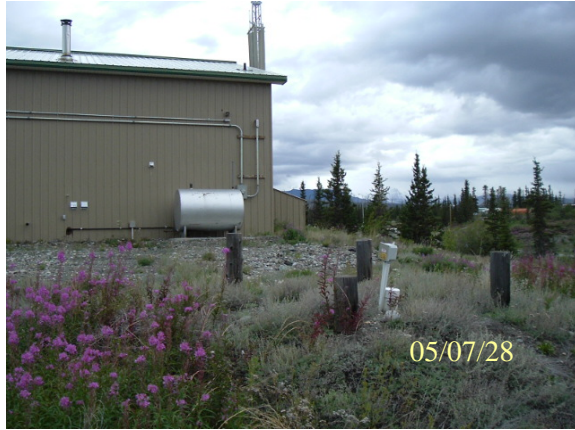
- One above ground fuel storage tank (AST).
- A sewage education tank is located 15 m away from the well.

Photo 0581: 3204 Burwash Landing Fire Hall.
Note: well enclosure on (right), AST (middle), septic (front).
