5.0 BUILDING 1137-CARCROSS FIRE HALL

SMALL PUBLIC WATER SYSTEMS ASSESSMENT WHITEHORSE REGION
GOVERNMENT OF YUKON HIGHWAYS & PUBLIC WORKS
CARCROSS FIRE HALL BUILDING 1137 SITE LOCATION DIAGRAM WELL ID: 1137
REVISION ISSUE 0
DRAWING No. FIGURE 1137A

SMALL PUBLIC WATER SYSTEM ASSESSMENT**PART A: EBA Site Inspection**Inspector: Ryan Martin
Luke LebelDate May 11, 2005

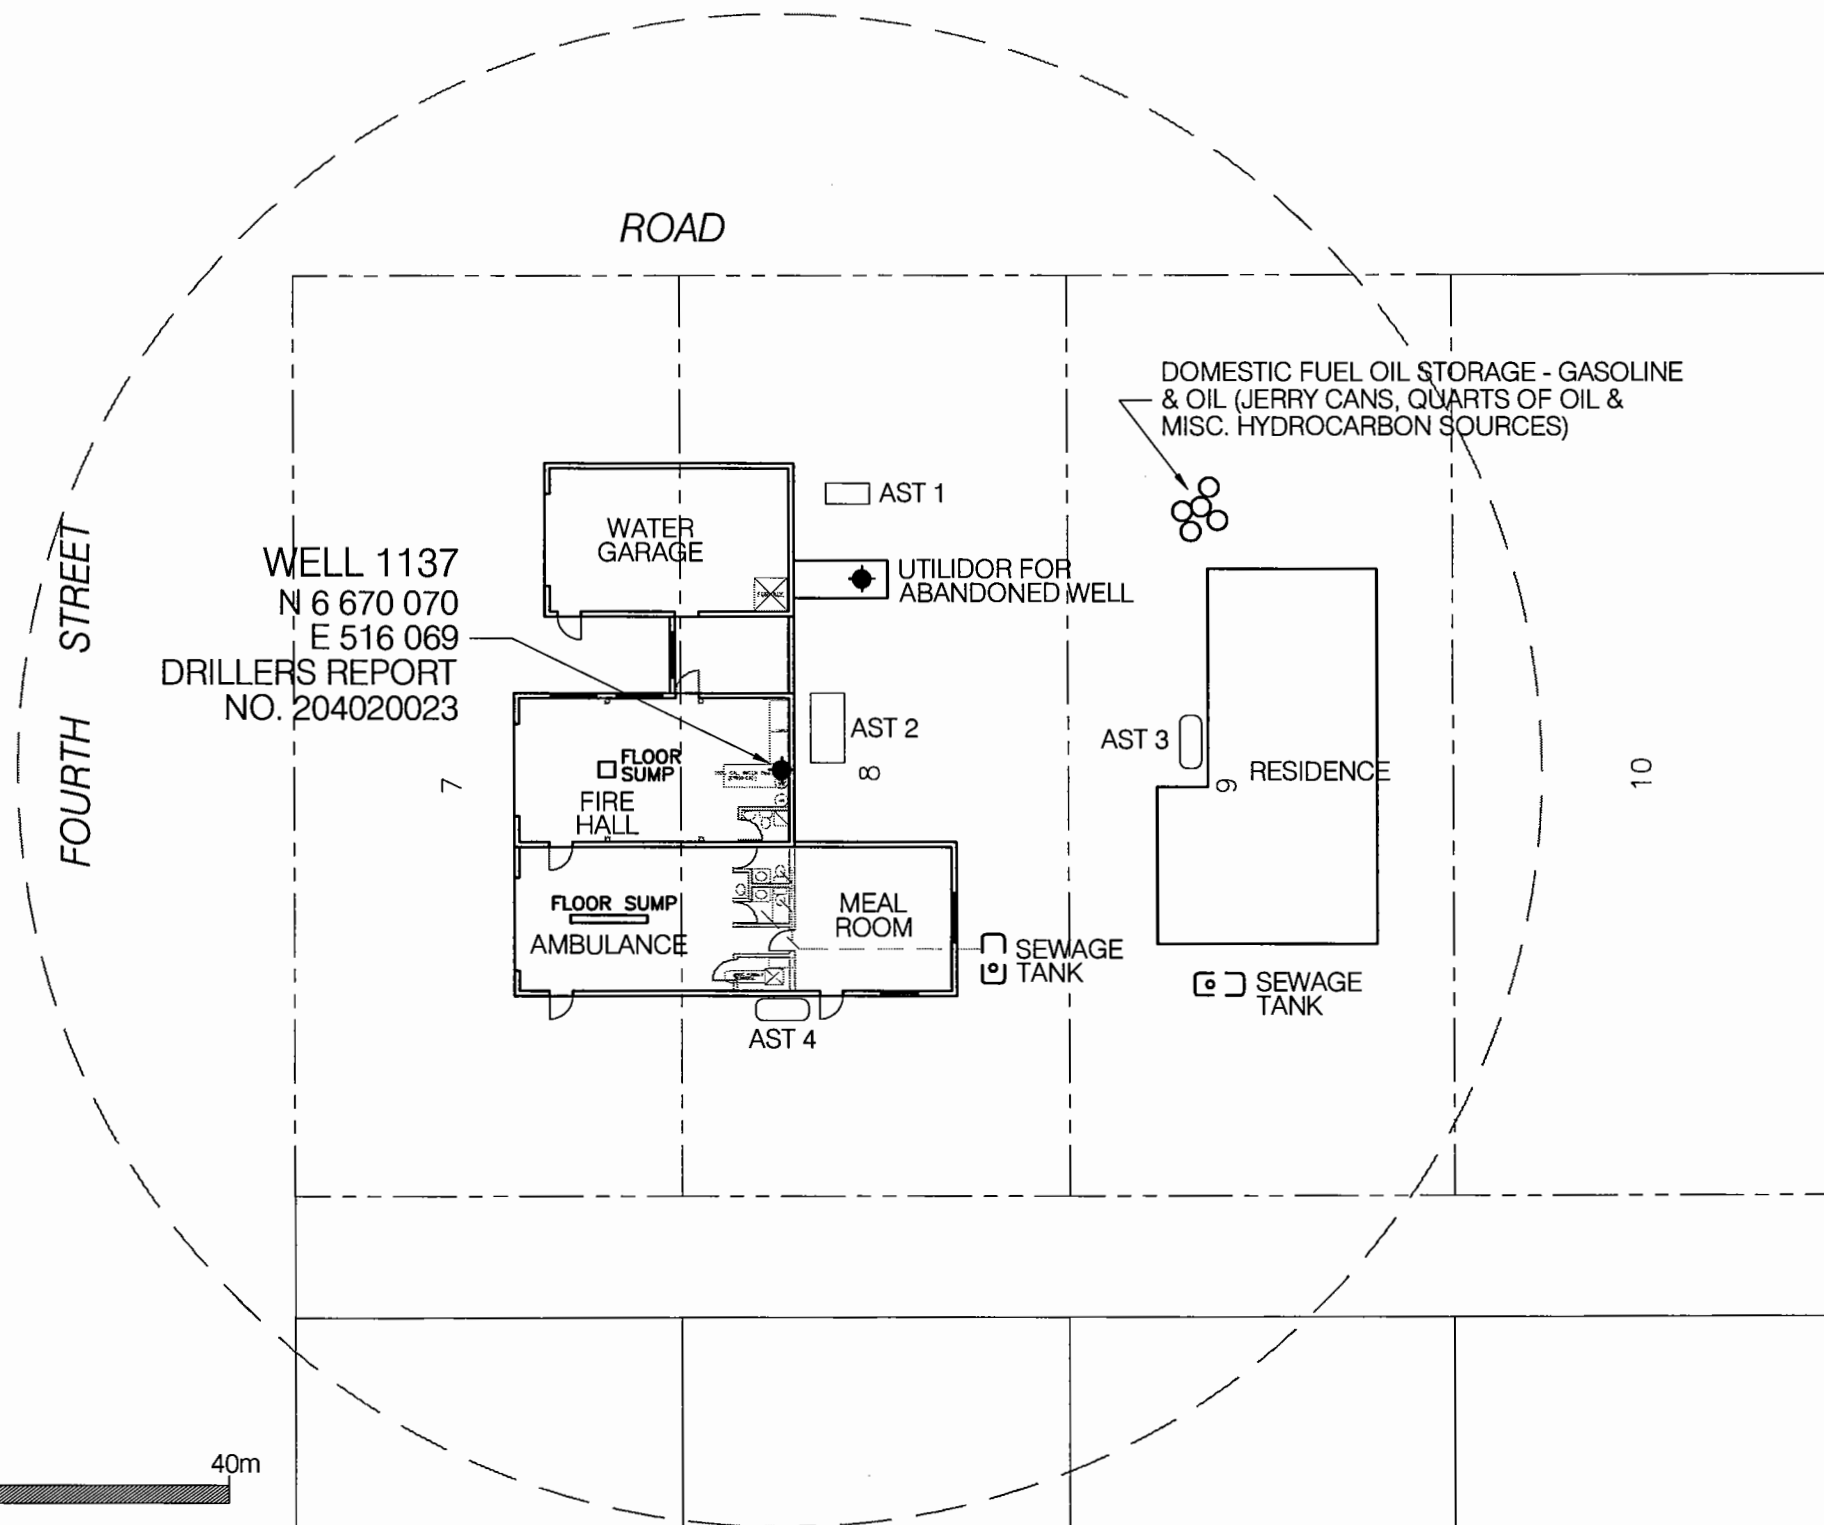
There are several residential septic tanks located in the vicinity of the Carcross Fire hall. One residential septic tank and the septic tank for the Fire hall are both located within 30 m of the well, as shown on Figure 1137-A. It appears that there are septic holding tanks that are maintained through a regular pump-out program and do not discharge effluent to nearby septic fields.

30 m RADIUS FROM WATER WELL FOR CONSIDERATION OF PROXIMITY TO POTENTIAL CONTAMINANT SOURCES.

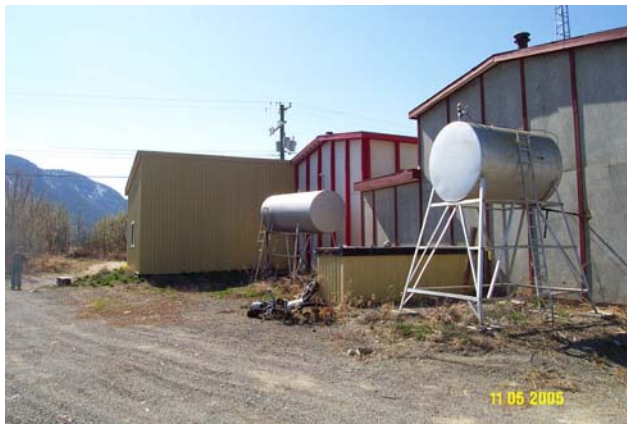
- Above ground fuel storage tanks at 2,10,10 and 20 m respectively.

The poor location of the well with respect to above ground fuel storage tanks and septic tanks is considered to be a Priority 2 risk deficiency.

**Photo 0124:** 1137 Above Ground Storage Tanks Adjacent to Well

The water distribution system for the Fire Hall and Ambulance Bay should be connected to the post-treatment water supply from Bennett Lake. A backflow preventer (double check valve) should be installed in the 3" line, and the solenoid moved so that the plumbing for potable water on the ambulance side can be plumbed in upstream of this flow switch. These are conceptual design recommendations based on the information available for the
