14.0 BUILDING 1953: TAGISH FIRE HALL

14.1 Description of Existing Water Supply System

SMALL PUBLIC WATER SYSTEM ASSESSMENT

PART A: EBA Site Inspection

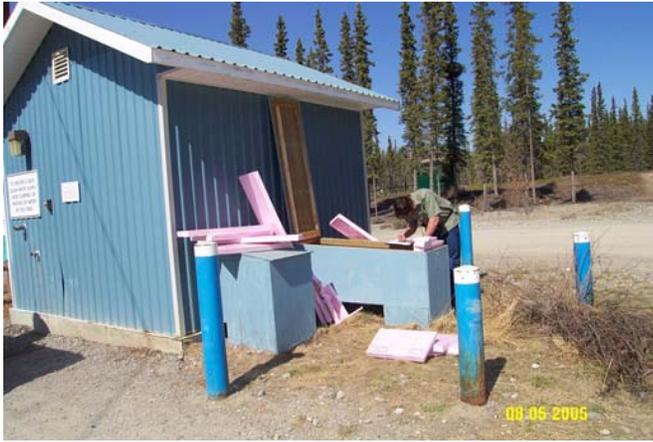
Photo 0062: 1953 Well Enclosure (right) and Pumphouse

Unauthorized access by humans? Yes No Entrance by animals? Yes No
Buildings, well head all lockable Evidence of mice in well enclosure

- well enclosure accessible to rodents

- design enclosure that is mouse proof
- consider raising casing slightly

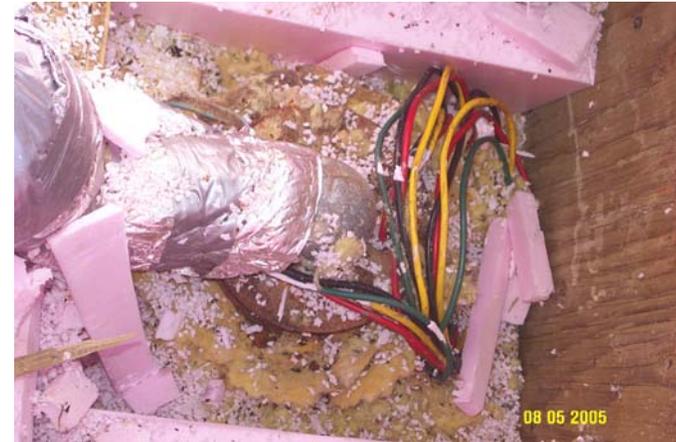
Photo 0059: 1953 Well Head

- i. Is the well head below grade? describe in detail Above grade (0.2 m)
- ii. Are there signs of ponding on the enclosure(e.g. water stains, etc.)? Yes No
- iii. Is the wellhead enclosed by fiberglass insulations? Yes No - styrofoam sm.
- iv. Any evidence of rodents? Specify Yes, mouse droppings.
- v. Does the well casing have a proper seal cap? Yes No

If no, describe condition SPLIT GASKET CAP -
NOTE MOUSE DROPPINGS ON TOP
OF CAP

- Clean the tank in the fire hall and undertake a regular cleaning program (every 6-12 months).
- Extend the well casing to a minimum of 500 mm above grade;

- Retrofit a surface seal around the well casing extending a minimum of 3 m below grade;
- Adjust site drainage to promote surface runoff away from the well;

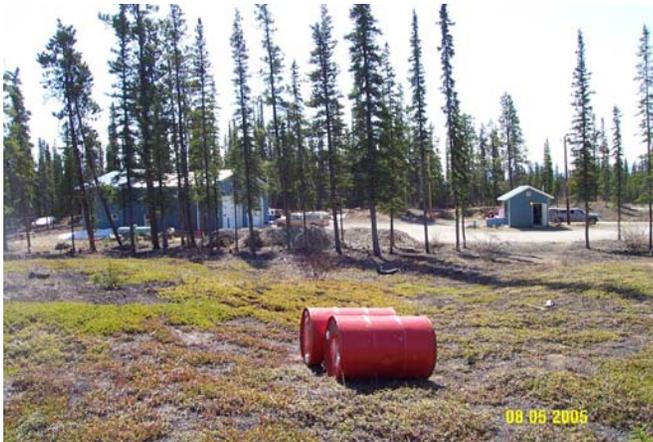
Photo 0061: 1953 45 gal. Aviation Fuel Drums (front), Pumphouse (back right), and Firehall (back left)

Potential Source 2: Av. gas; Distance from well to Potential Source 2: 48m

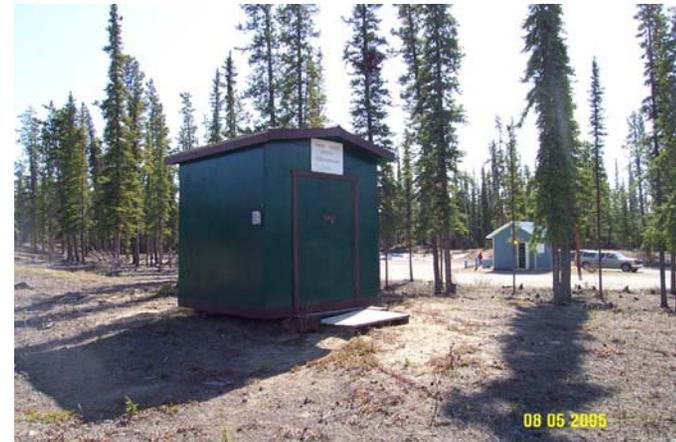
Photo 0060: 1953 Fire Equipment Cache (front), Pumphouse (back left)

Potential Source 1: fire equip. cache; Distance from well to Potential Source 1: 30m

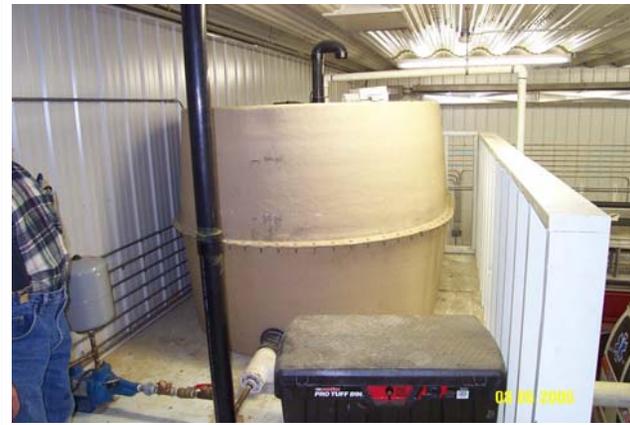
Photo 0066: 1953 Firehall 1250gal Water Storage Tank

Comments: SOME RUST SEDIMENT

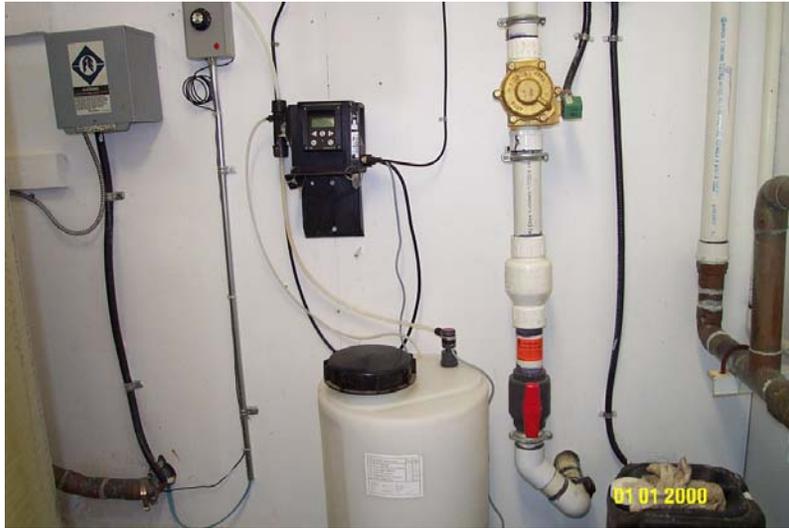
Photo 0069: 1953 Grundfos DME Chlorinator

At the time of the assessment, the residual chlorine concentration from a sample collected within the Fire hall was found to be 0.02 mg/L. The chlorine injector was also noted to be damaged, and has reportedly since been repaired. The observed residual chlorine concentration is significantly less than the required concentration of 0.2 mg/L at the point of consumption.

- Install a backflow prevention device on the 50 mm line inside the pumphouse; and,
- Initiate a residual chlorine-monitoring program and adjust chlorination system as required to maintain residual chlorine concentration above 0.2 mg/L at the fire hall, and above 4 mg/L at the truck fill.
