10.0 BUILDING 1391: HOOTALINQUA FIRE HALL

**SMALL PUBLIC WATER SYSTEMS ASSESSMENT
WHITEHORSE REGION**

**HOOTALINQUA FIRE HALL
BUILDING 1391
SITE LOCATION DIAGRAM
WELL ID: 1391**

SMALL PUBLIC WATER SYSTEM ASSESSMENT

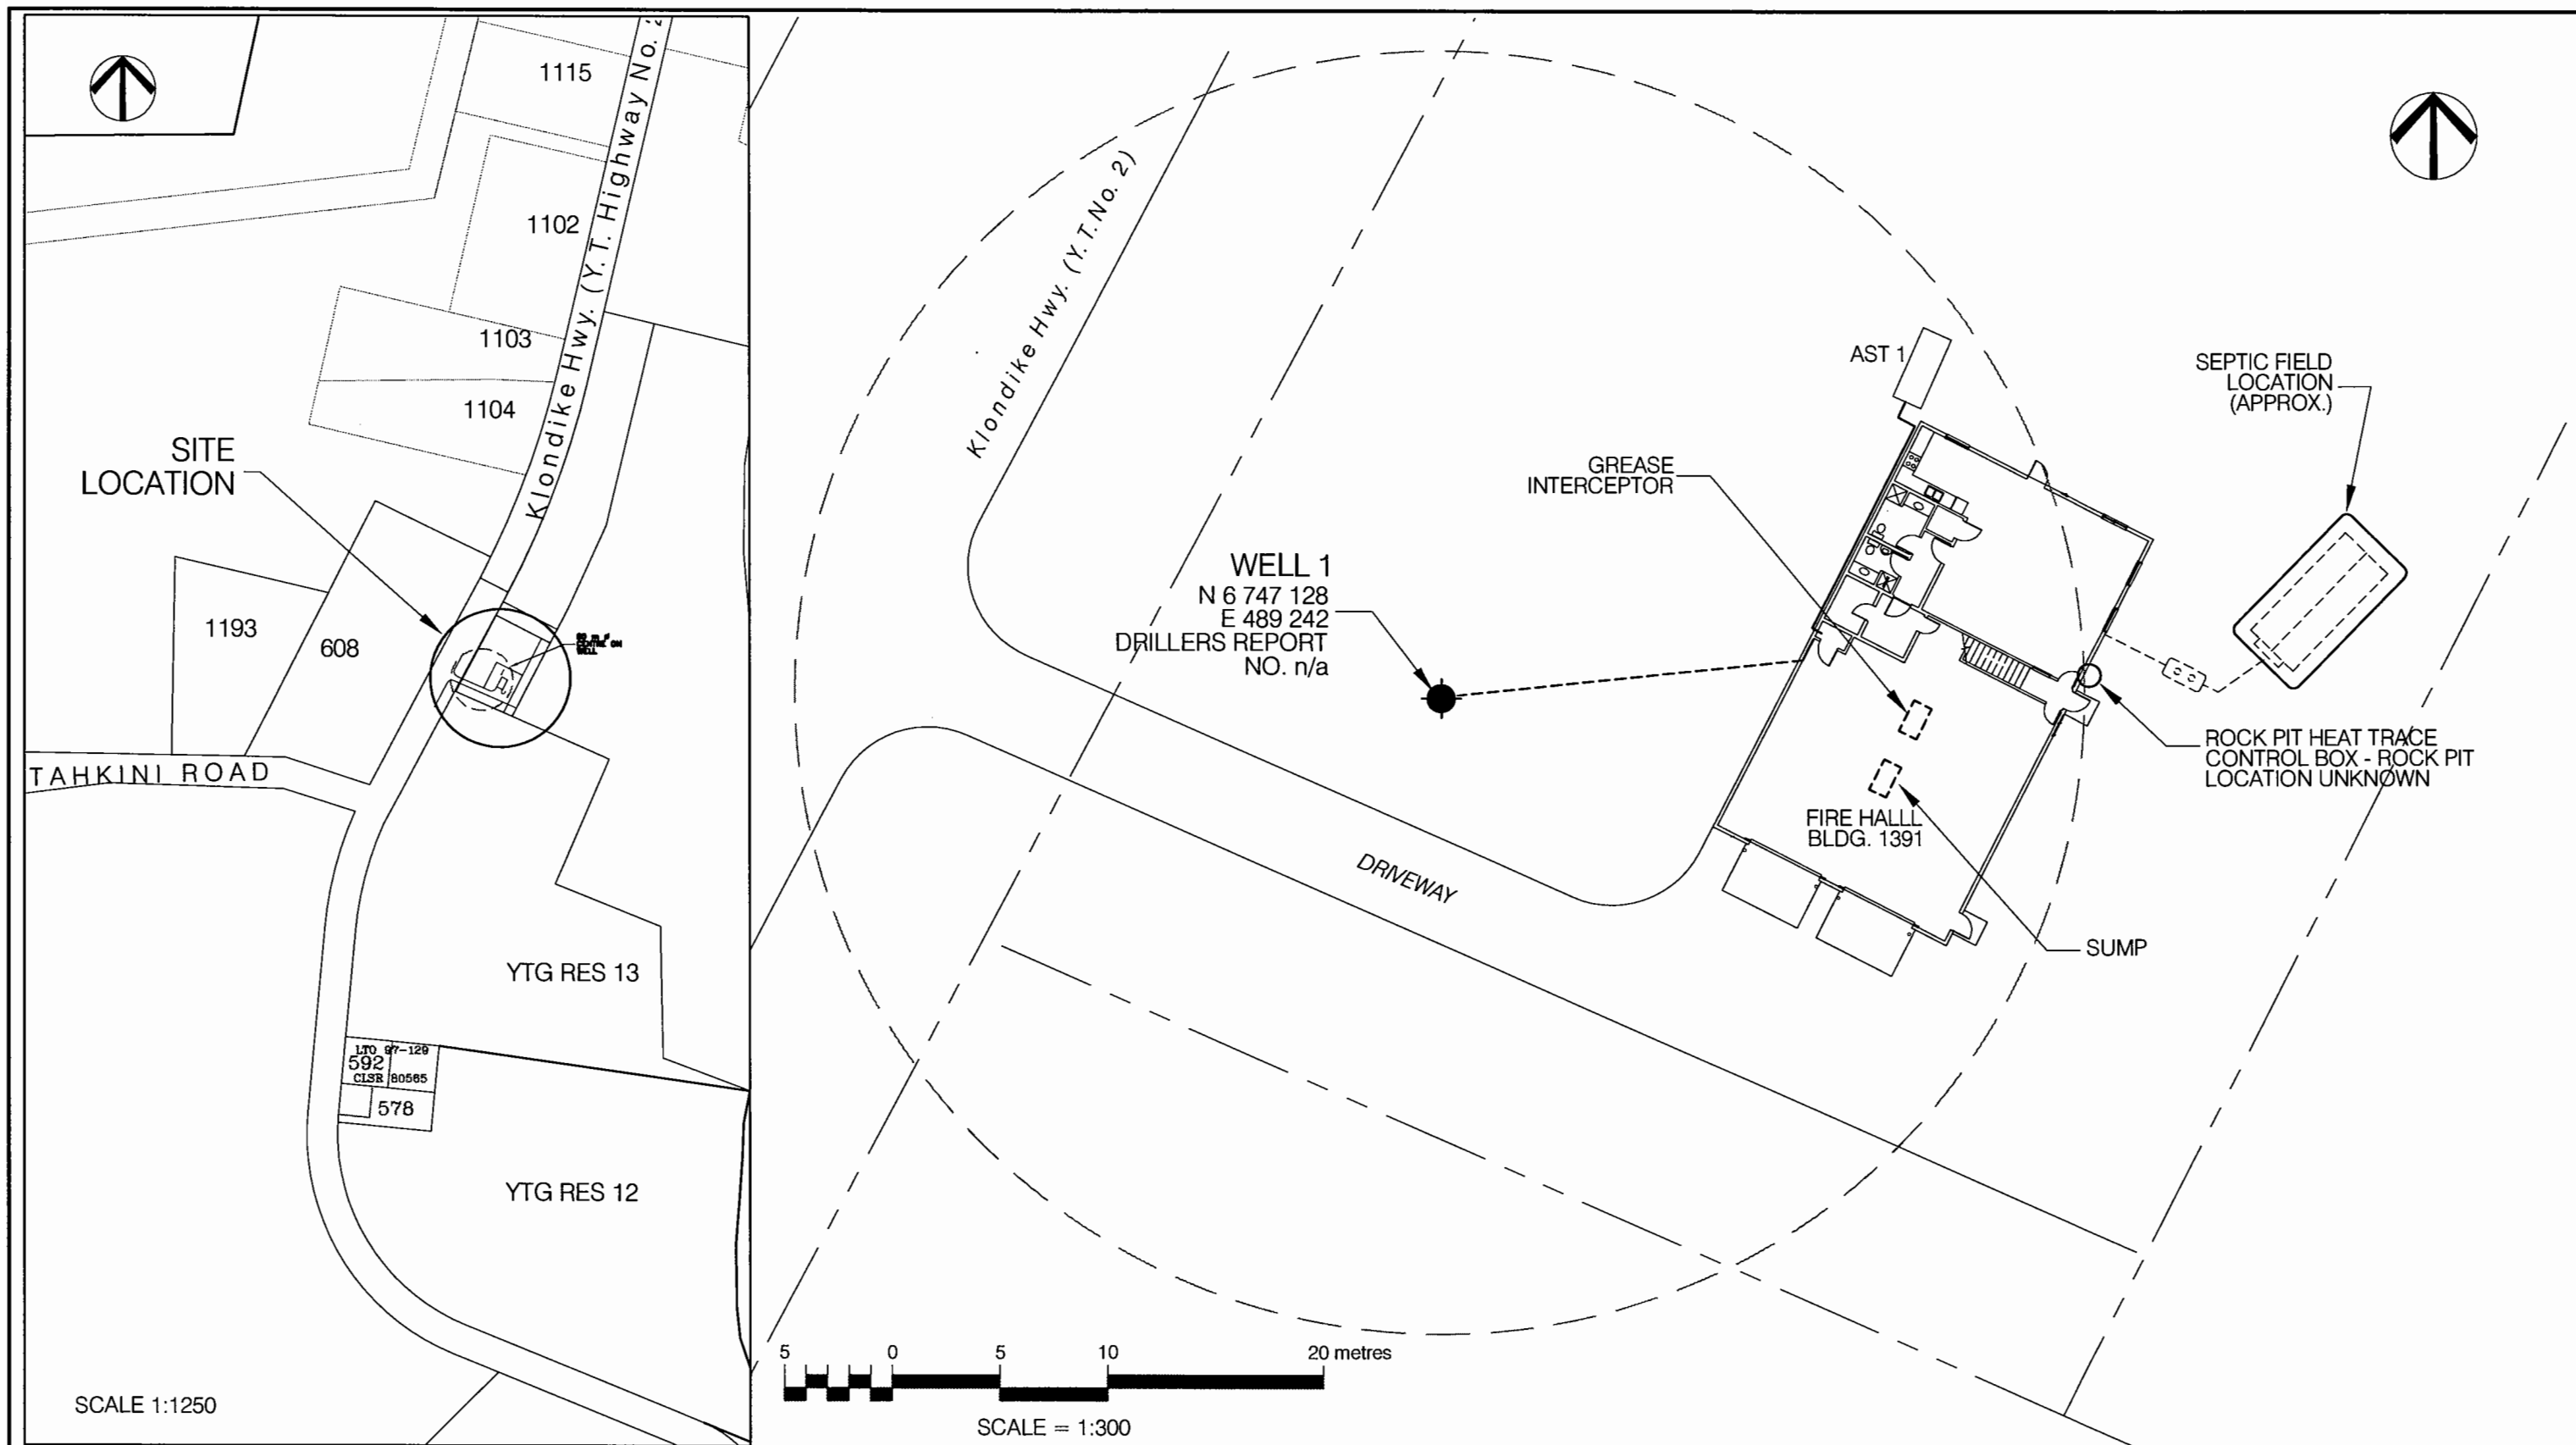
REVISION ISSUE
0
DRAWING No.
FIGURE 1391A

The Hootalinqua Fire Hall is serviced by a water supply system that delivers water from a 156 m deep well with static water level of approximately 30 m below grade. A site plan is included as Figure 1391-A in Appendix A10. The well was drilled in 2002 by Cathaway Resources using a cable tool drill rig and is equipped with a surface seal to prevent contamination from surface sources. The wellhead is located in a pit that is approximately 14 m away from the fire hall. The coordinates of the wellhead, as measured by a handheld GPS device, are:

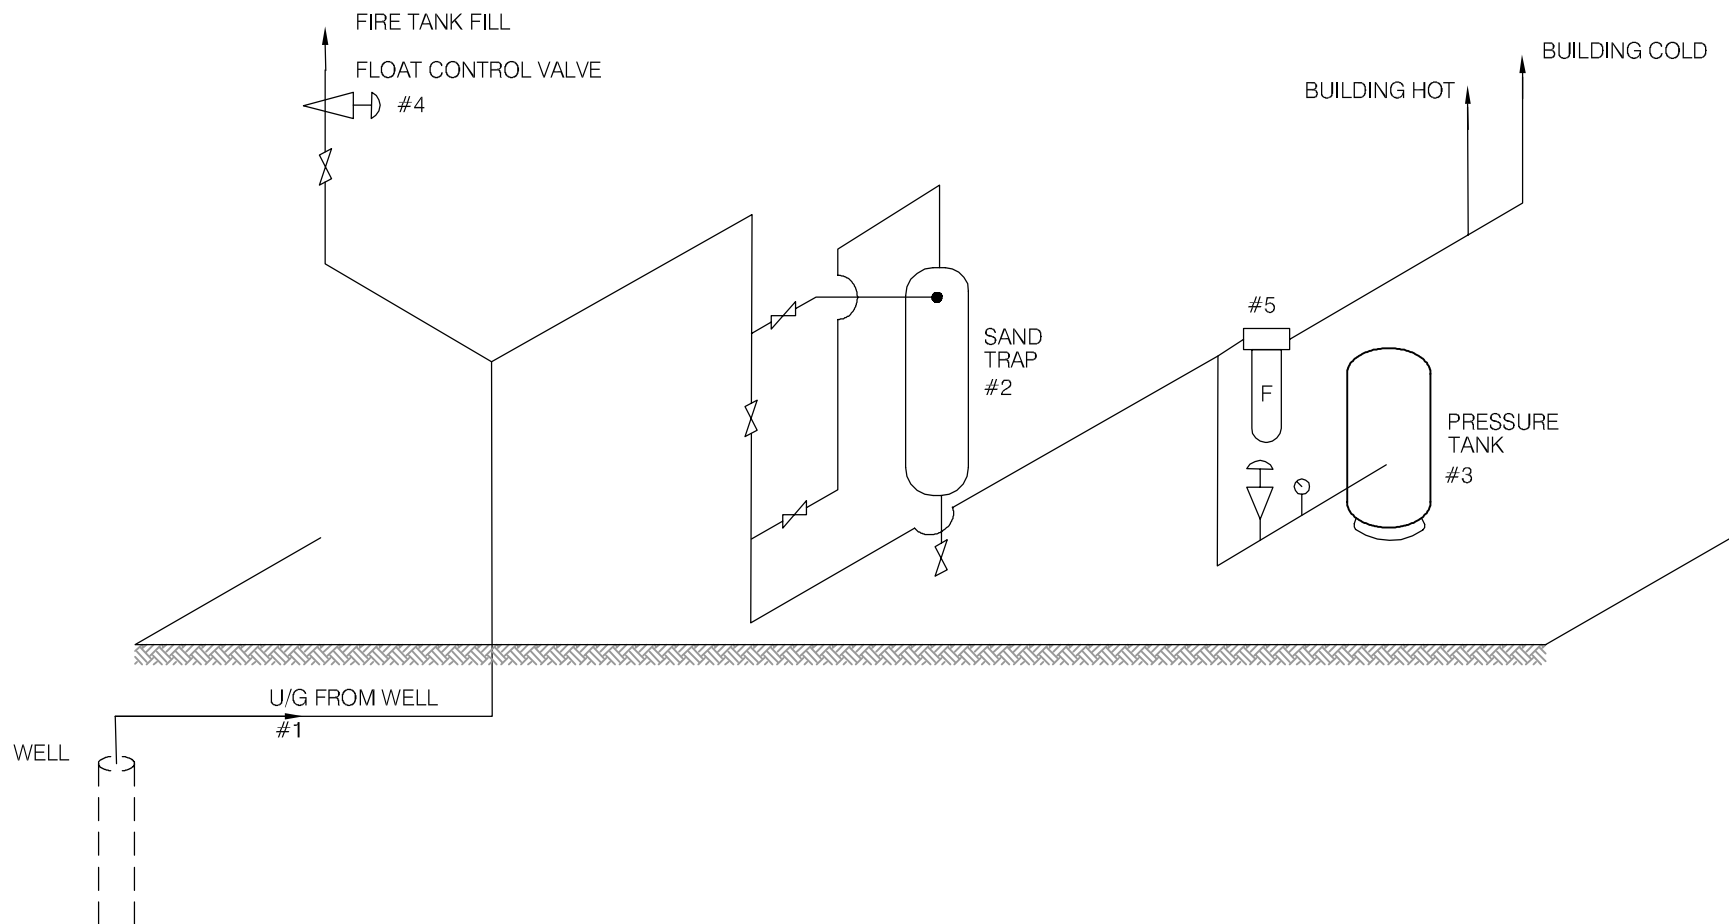
DWG.: FIGURE 1391B

From the wellhead, the water system splits to service the two water storage tanks for fire fighting use, and to service the domestic water supply for the fire hall. There is no treatment in the system for water delivered to the water storage tanks, but to reduce biofouling, chlorine “pool pucks” are added directly to the water tanks. The domestic system is equipped with a sand trap and an inline 5-micron filter, but there is no disinfection system anywhere on the domestic system. A system schematic is provided as Figure 1391-B in Appendix A10.

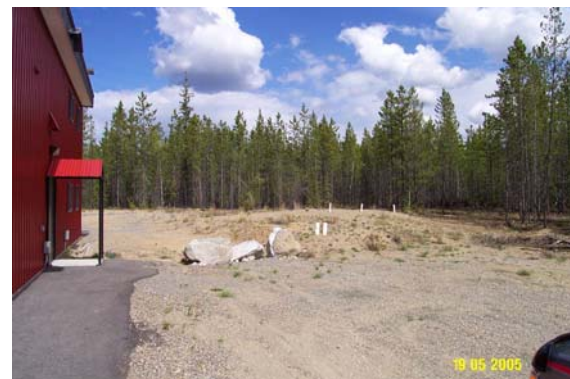
The septic tank for the Hootalinqua Fire Hall is located on the east side (opposite the well) of the fire hall, approximately 36 m from the wellhead. The septic tank discharges effluent to a field located to the east of the tank. The septic tank and effluent field are at approximately the same surface elevation as the ground surface at the wellhead; however they are likely both downgradient from the wellhead based on the inferred hydrogeology.

With the exception of the above-mentioned AST, there were no other potential contaminant sources identified within 30 m of the wellhead. All parts of the sanitary sewer (discharge pipe, tank and absorption field) are greater than 30 m from the wellhead, downgradient from the well, and the hydrogeological conditions indicated a low risk of impact of the water source.

Photo 0189: 1391 Septic Field

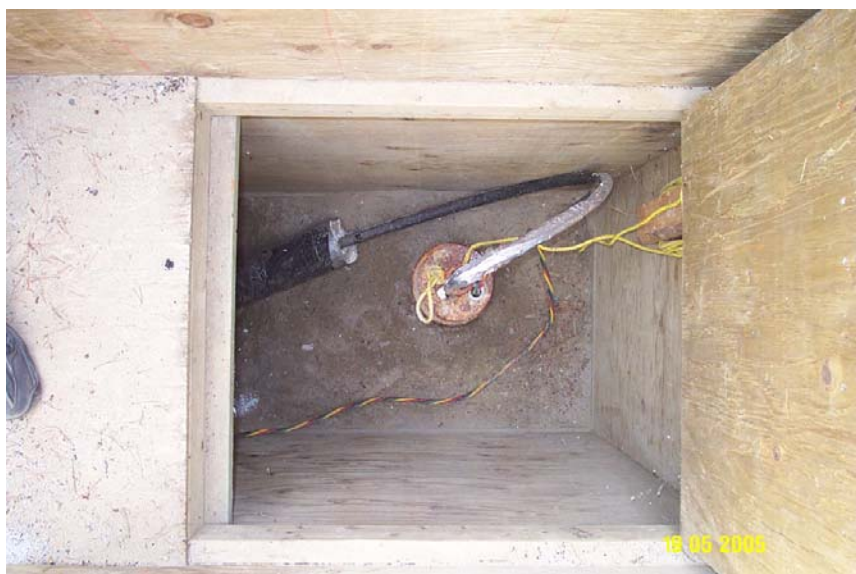
- The wellhead is completed in a pit, which is not considered acceptable according to the Guidelines for Water Well Construction. Well casings must extend at least 500 mm above the ground surface. This is only a medium risk deficiency because the well has a double casing, and is reported to have a steel plate welded over the annulus at surface and the well is very deep. At the time of the upgrade, a bentonite grout seal should be installed between the 150 mm and 200 mm casings, and a surface seal retrofitted in the upper 2 m of the well. It was noted during the field assessment and field chemistry testing that a gaseous substance (likely carbon dioxide) was off gassing from the water when it was exposed to the atmosphere. Off gassing of CO₂ could potentially cause a risk of oxygen depletion in the well pit vault. All well pits should be considered as confined spaces, and the necessary precautions taken during wellhead upgrades.

- i. Is the well head below grade? describe in detail Yes 1.5m below grade
- ii. Are there signs of ponding on the enclosure(e.g. water stains, etc.)? ☐ Yes ☒ No
- iii. Is the wellhead enclosed by fiberglass insulations? ☒ Yes ☐ No
Inside walls only. None directly protecting well head. There is an extra compartment above compartment enclosing well head
- iv. Any evidence of rodents? Specify Mouse droppings present. Since wood it is accessible
- v. Does the well casing have a proper seal cap? ☒ Yes ☐ No
split cap
If no, describe condition _____

Photo 0190: 1391 Well Head

The wellhead completion should be improved to decrease the susceptibility to surface contamination. This would involve welding an extension onto the existing casing to bring the well casing to a minimum of 500 mm above ground level. Two options are provided below:

- Option 1: An above grade completion with a culvert, blown in foam insulation, bentonite surface seal (above the existing surface seal) and a fiberglass cover.

- Option 2: Pitless unit with vented locking lid, and bentonite surface seal above the existing surface seal.
- For both options, the following upgrades should also be completed:

- The annulus between the 150 mm and 200 mm casing should be sealed with a grout or bentonite grout mixture for either of the above options.
 - When work on the wellhead is conducted, the well should be re-developed, cleaned and shock chlorinated. Mechanical agitation during chemical cleaning will assist in reaching anaerobic zones within the aquifer. This would likely result in improved well quality and yield.

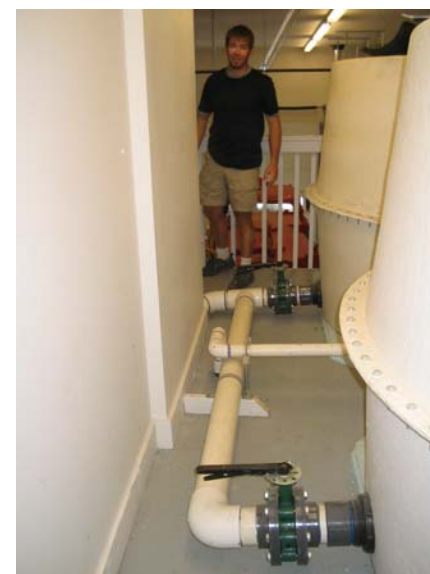
Are there signs of staining or biofouling? ☒ YES ☐ NO

Photo 0013: 1391 Water Storage Tanks

- The fire truck fill tanks should be cleaned on a regular schedule; every 12 months is likely sufficient. Include this as a routine operation and maintenance task.
