## **16.0 BUILDING 2544: DAWSON CITY AIRPORT TERMINAL BUILDING**

SMALL PUBLIC WATER SYSTEMS ASSESSMENT  
 NORTHERN REGION

DAWSON AIR TERMINAL BUILDING  
 BUILDING # 2544  
 SITE LOCATION DIAGRAM  
 WELL ID: 2544

## SMALL PUBLIC WATER SYSTEM ASSESSMENT

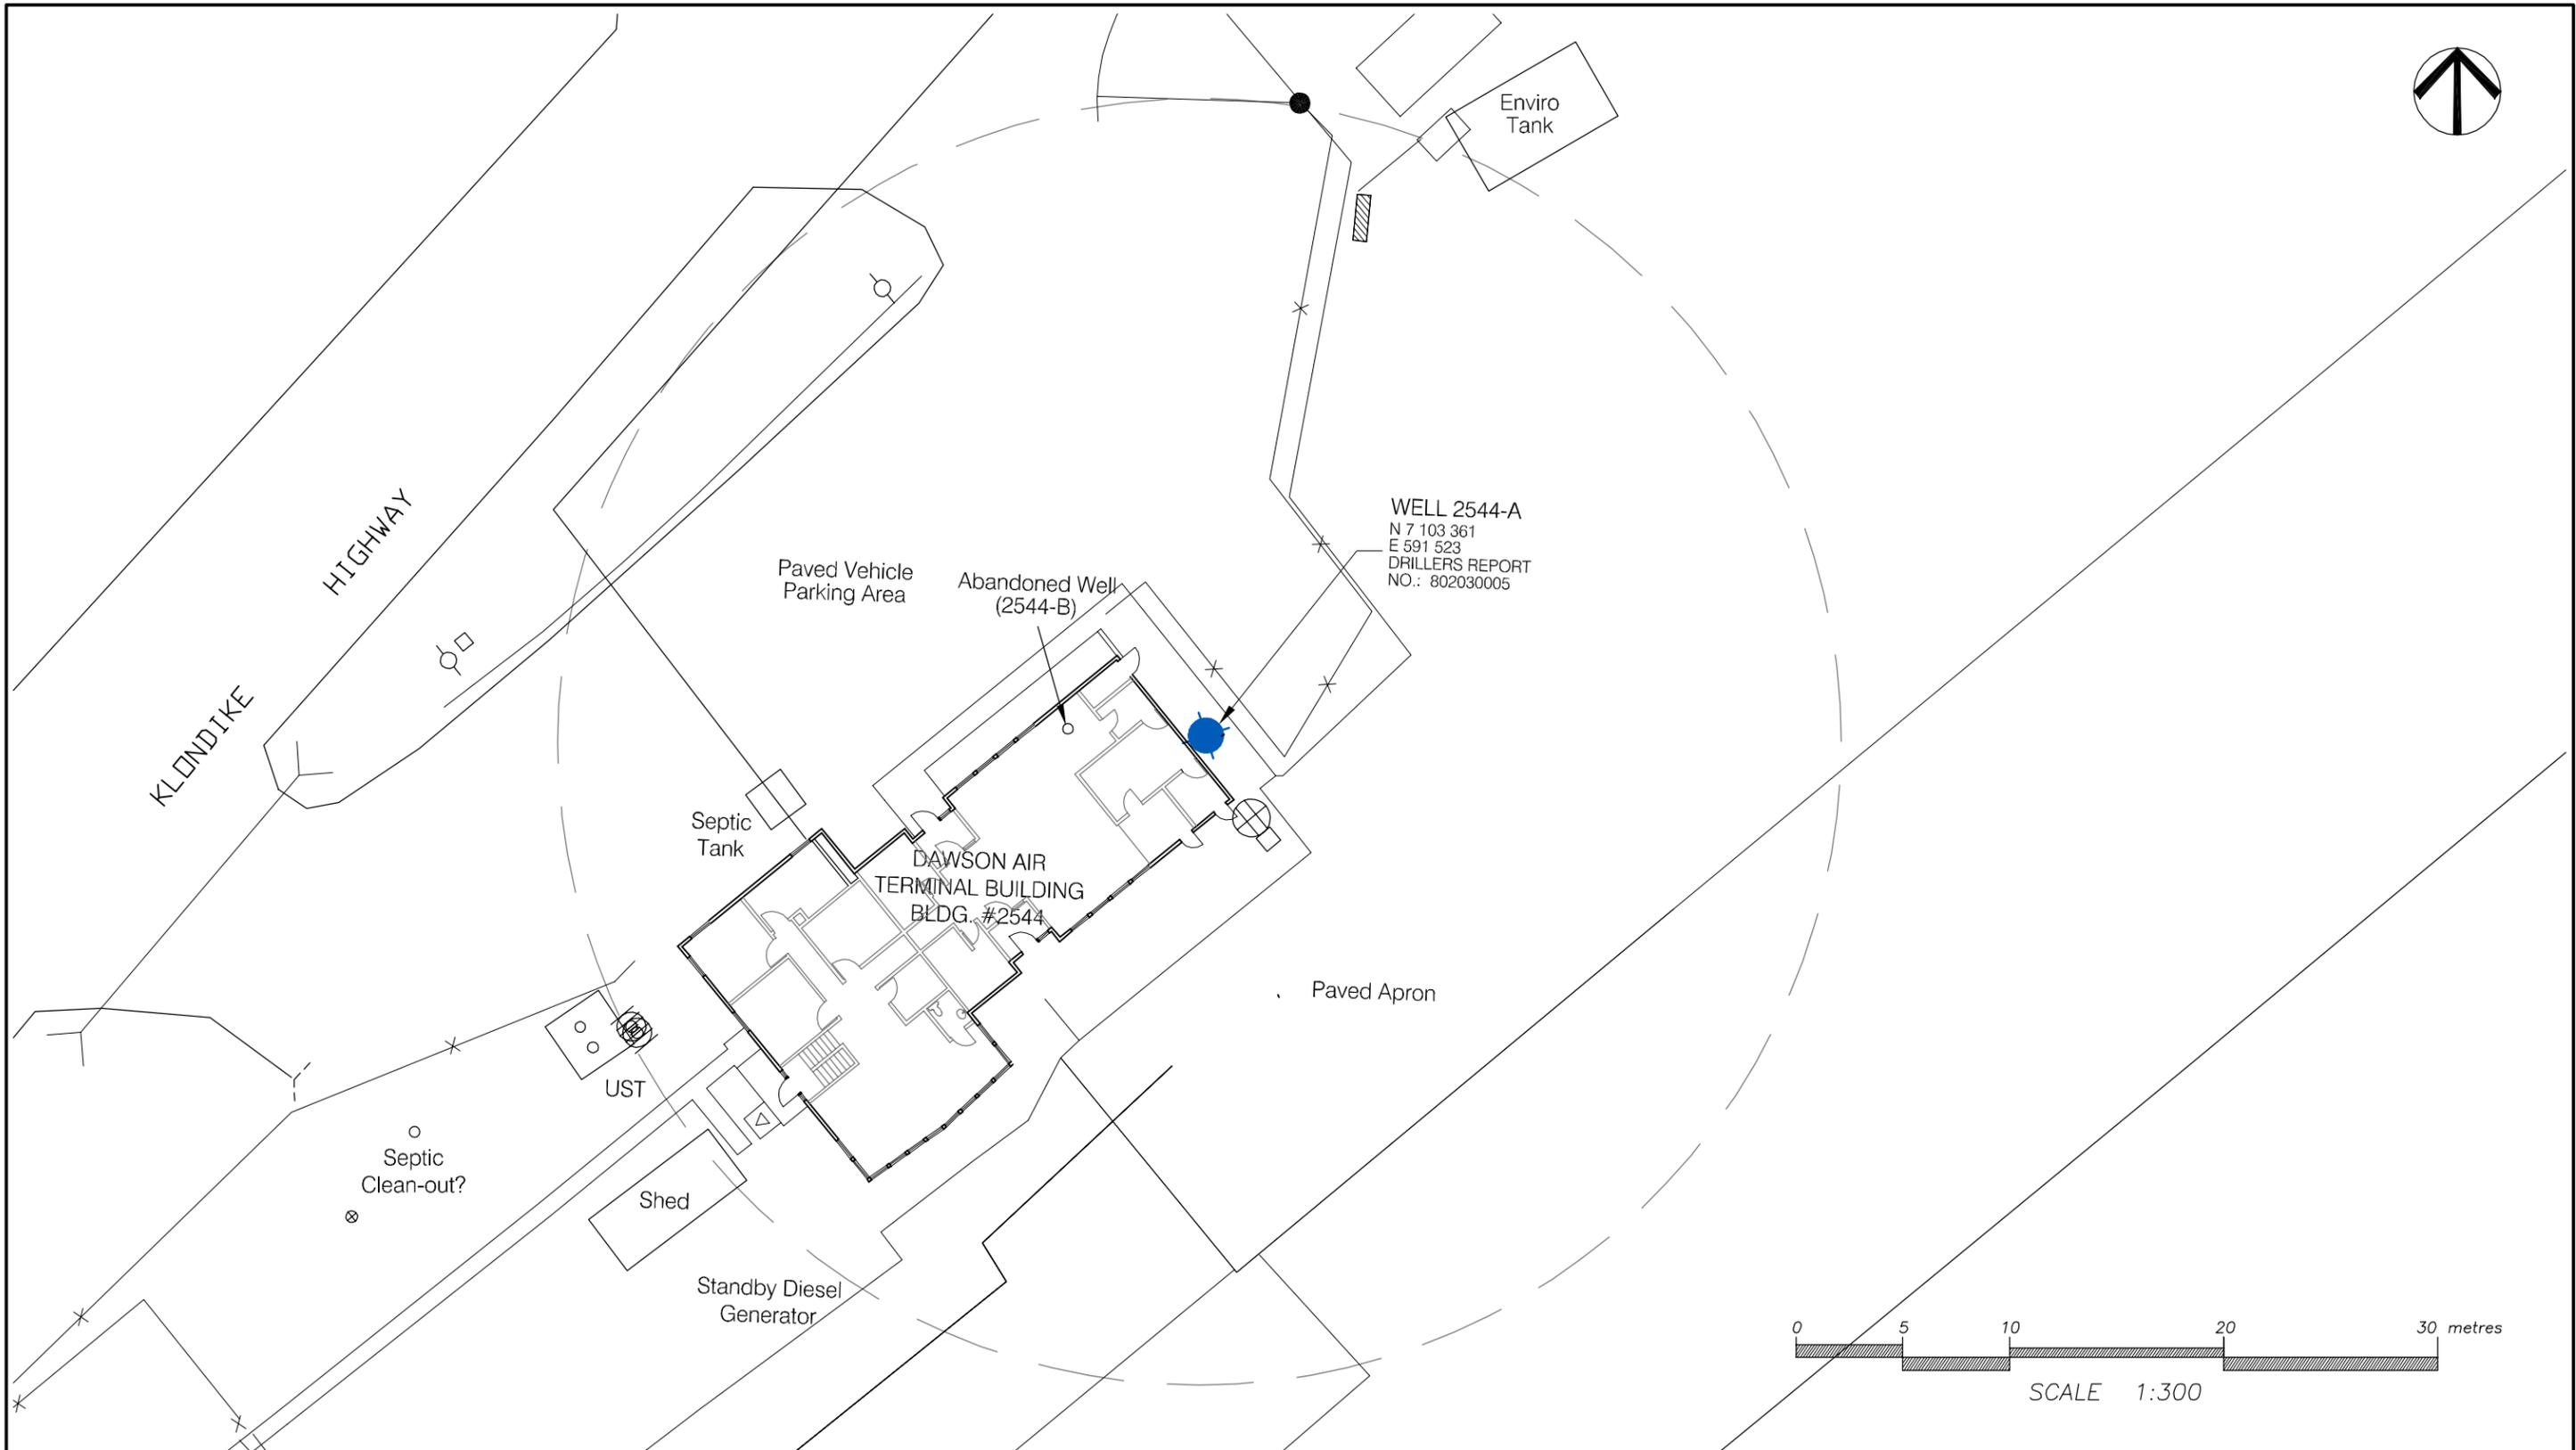
FIGURE No.  
 FIGURE 2544-A

A septic holding tank serving the Airport Terminal is located near the northwest corner of the building, approximately 28 m west of the well. The septic system location is indicated on Figure 2544-A in Appendix A16. It is unclear whether there is an in-ground septic disposal field associated with this tank. If there is a septic field, it may be within 30 m of the well. A steel casing, which may indicate the location of a septic field was observed protruding from the ground to the west of the airport building. The purpose of this casing should be determined.

30 m RADIUS FROM WATER WELL FOR CONSIDERATION OF PROXIMITY TO POTENTIAL CONTAMINANT SOURCES.

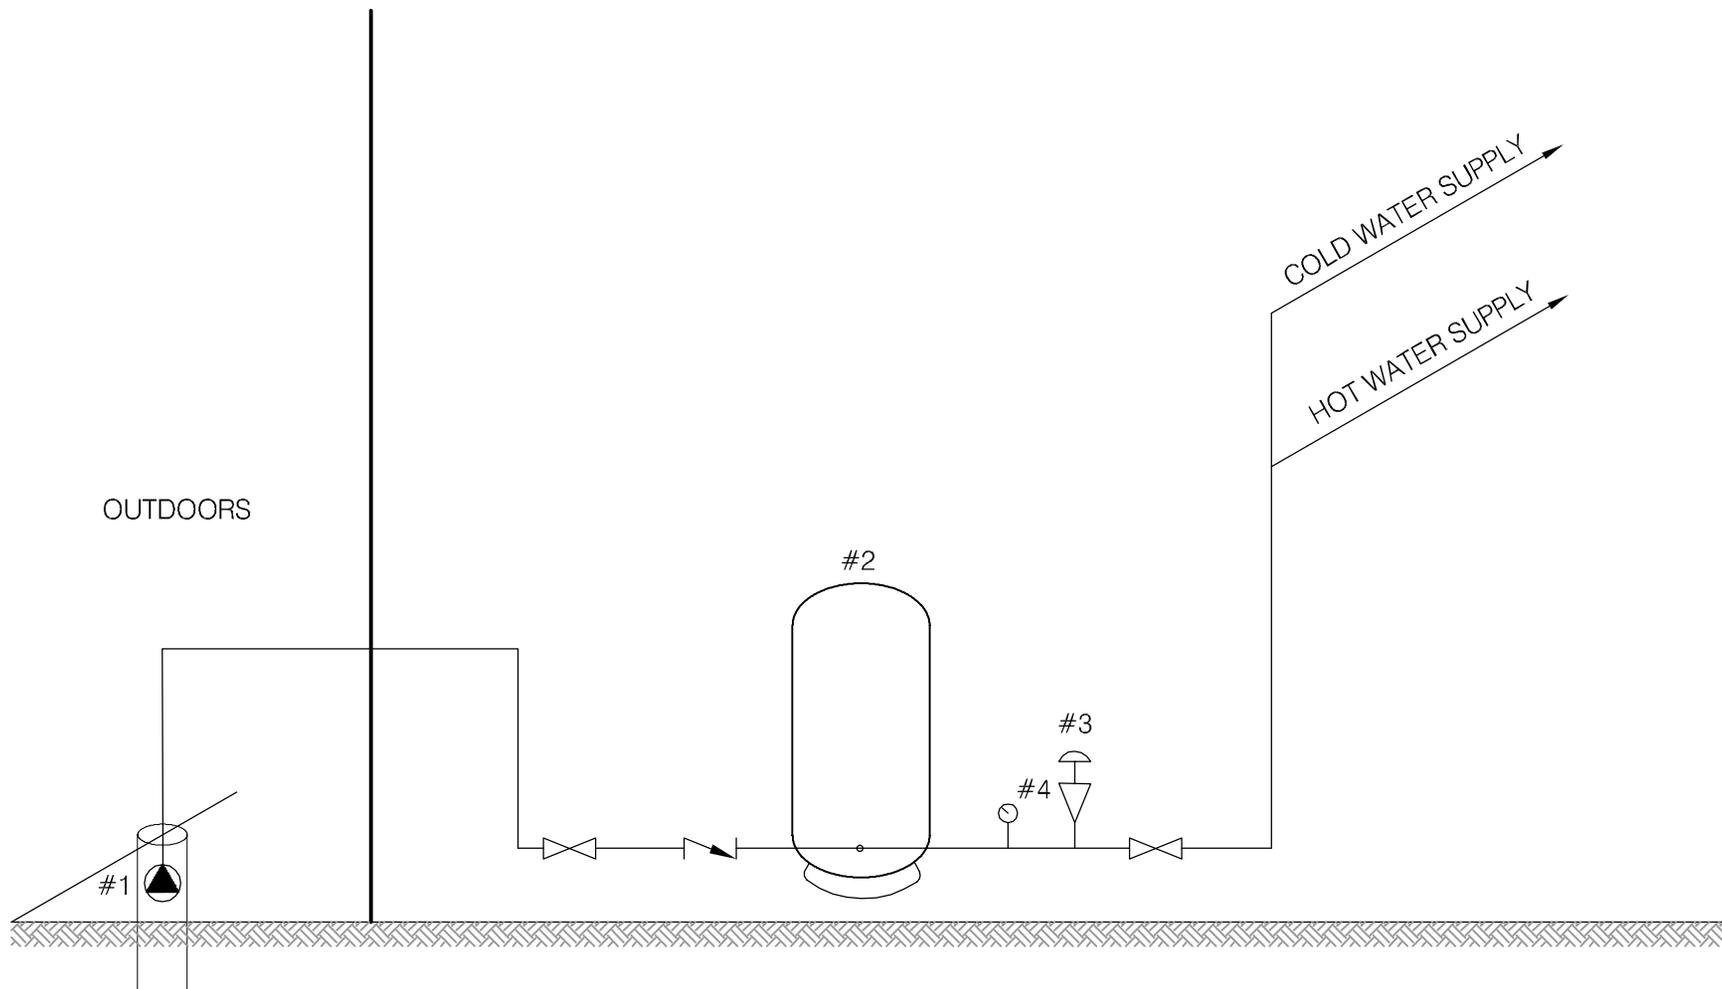
TITLE WATER SYSTEM DISTRIBUTION/TREATMENT SCHEMATIC SYSTEM ID.: 2544 AIR TERMINAL BUILDING - DAWSON, YT.	
DATE	SEPT. 2005	DWN.	JSB
CHKD.	FMM	FILE NO.	1260002.004
		DWG.:	FIGURE 2544-B

There are no treatment or disinfection components to this water system. A schematic detailing the water supply system is provided as Figure 2544-B in Appendix A16. An 8.1 m deep abandoned well is located in the crawl space underneath the terminal building approximately 9 m from the well that is in use. Photos of the well and water system are also included at the back of Appendix A16.

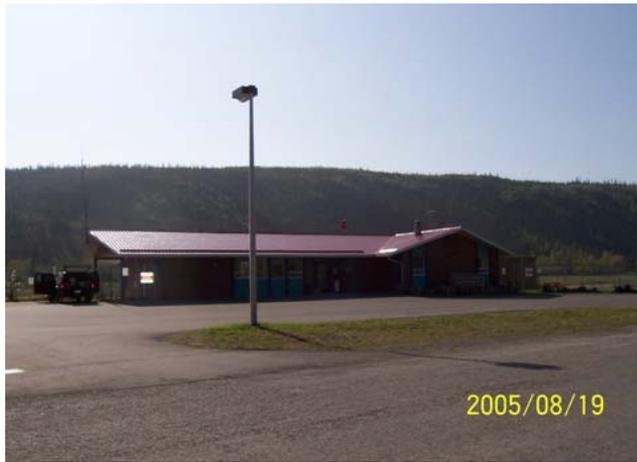
**Photo 088:** 2544 Dawson City Air Terminal Building.

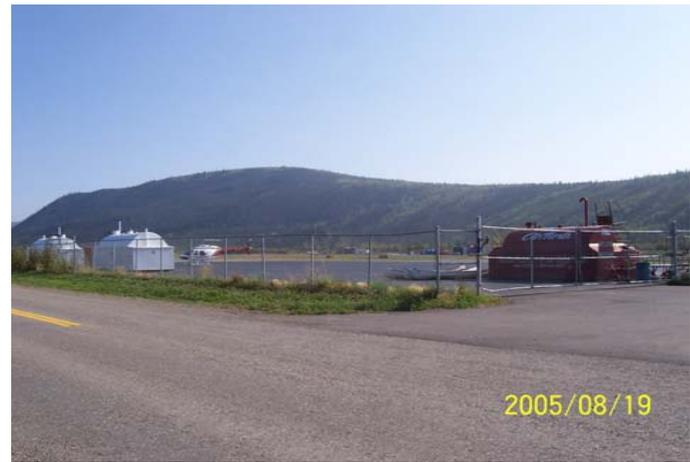
- A septic holding tank at 28 m;
- An above ground fuel storage tank (AST) at 30 m; and
- An abandoned well at 9 m.

- The well is located within 30 m of potential contaminant sources, including an abandoned well and an AST and fueling area;
- There have been several historical spill events on the airport property, some of which were in relatively close proximity to the well; and,

**Photo 089:** 2544 Enviro ASTs for bulk fuel storage.

- Capital costs for regulation of activities within the well capture zone including the relocation of proposed fuel storage and handling facilities would cost in the order of **\$10,000**. There would be ongoing costs to continue to regulate activities at this are of the site, which are difficult to quantify at this time. Development of contingency plans can be incorporated into the standard spill response plan for airport operations. Depending on contingency measures provided, costs may be variable.

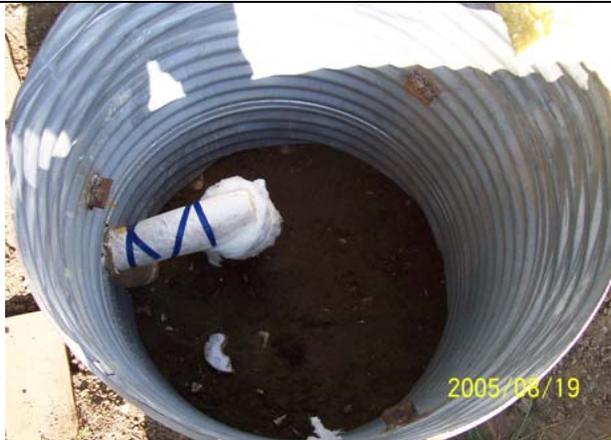
- Poor surface completion of the wellhead (located in a pit below grade);
-

- There is no surface sanitary seal (grout or bentonite seal as required by the Canadian Groundwater Association's Guidelines for Water Well Construction;

- i. Is the well head below grade? describe in detail ~ 0.45m below grade
- ii. Are there signs of ponding on the enclosure(e.g. water stains, etc.)?  Yes  No
- iii. Is the wellhead enclosed by fiberglass insulations?  Yes  No
- iv. Any evidence of rodents? Specify No, but access possible
- v. Does the well casing have a proper seal cap?  Yes  No  
If no, describe condition split gasket cap

**Photo 090:** 2544 Wellhead.

- Standard wellhead upgrades consisting of pitless adapter (snappy type), casing extension, retrofitting of a bentonite/grout surface sanitary seal, casing insulation and installation of a high visibility lockable PVC stick-up casing protector.
- Decommissioning of abandoned wells in accordance with proposed regulations.

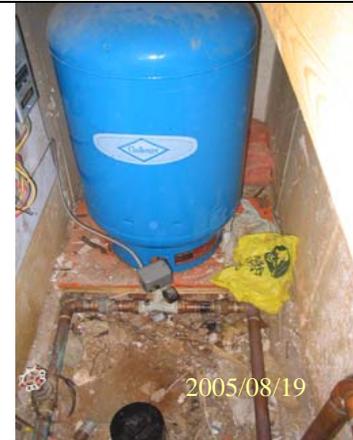
**Photo 234:** 2544 Abandoned well (bottom) pressure tank & pump controls (top).

- The recommended standard wellhead upgrades would cost approximately **\$3,000** for materials and labour;
- Decommissioning of two abandoned shallow wells would cost approximately **\$500** per well including materials and labour as long as this work is completed at the same time as the wellhead upgrades (e.g. mob/demob costs are shared).
