4.0 BUILDING 3440: BLANCHARD GRADER STATION

SMALL PUBLIC WATER SYSTEMS ASSESSMENT
 WESTERN REGION

BLANCHARD CAMP GRADER
 STATION BUILDING # 3440
 SITE LOCATION DIAGRAM
 WELL ID: 3440

SMALL PUBLIC WATER SYSTEM ASSESSMENT

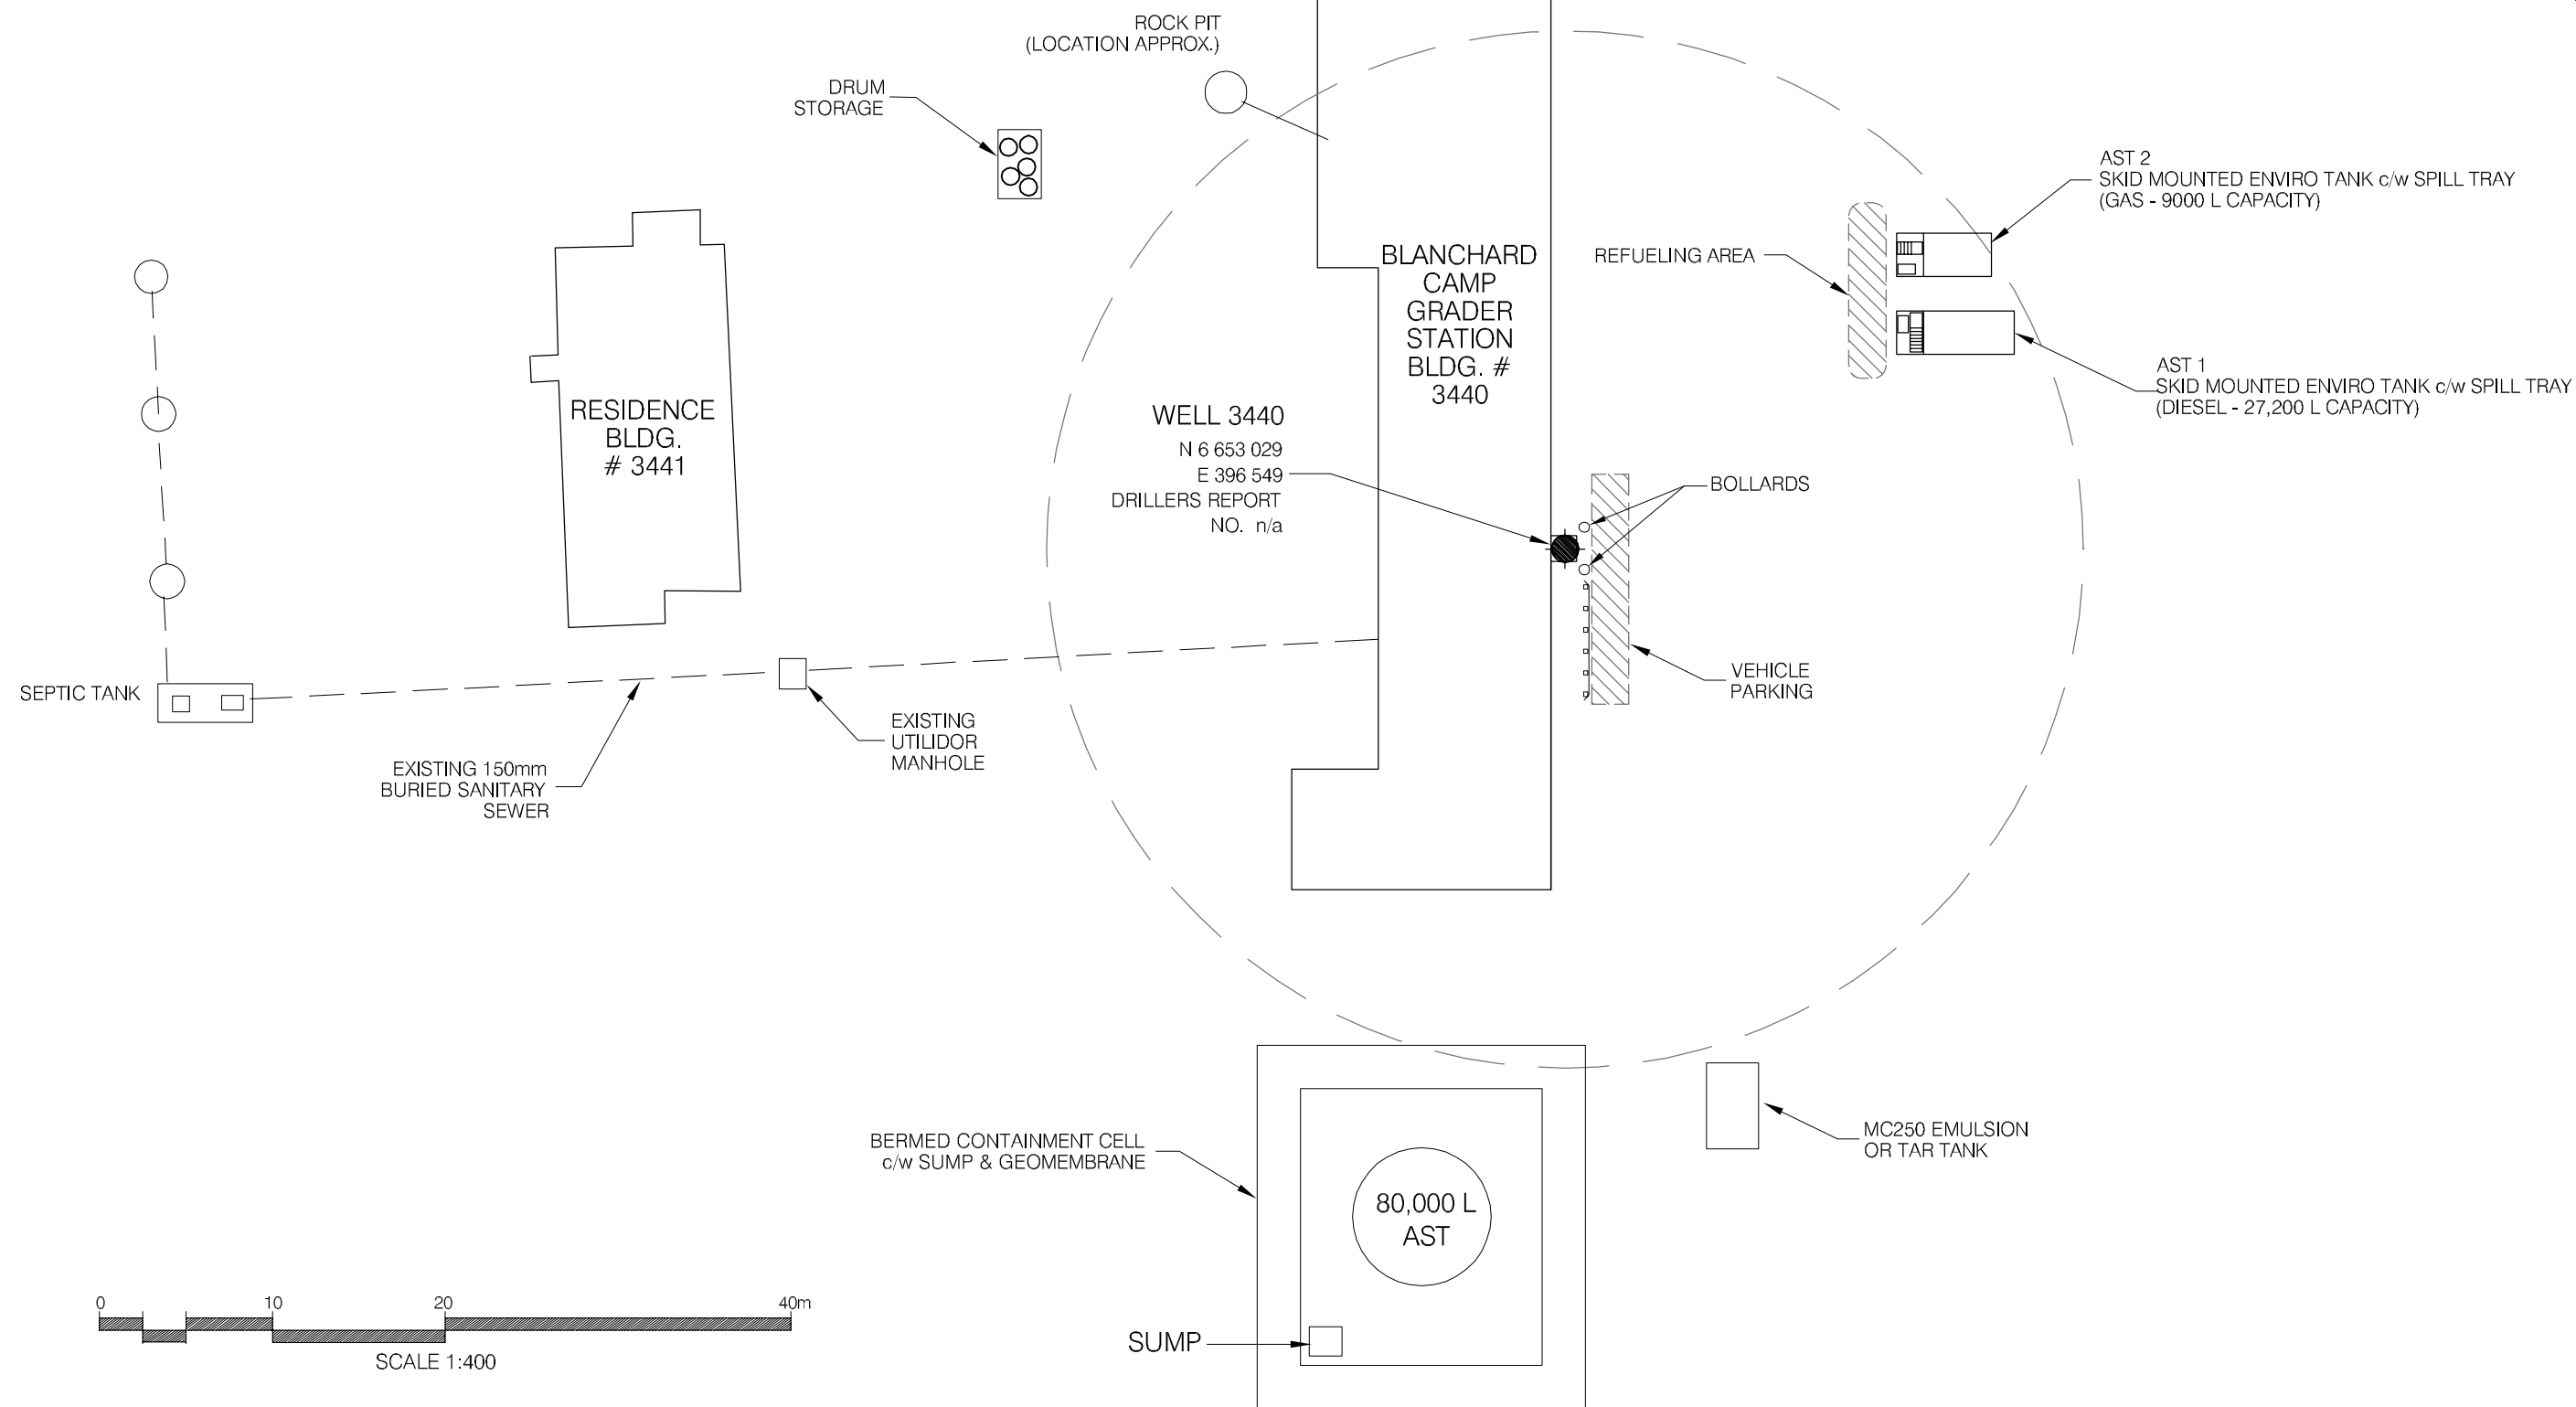
FIGURE No.
 FIGURE 3440-A

Septic effluent from both the maintenance garage and the living complex is piped to a communal discharge system north of both the maintenance garage and living complex. The septic discharge system is greater than 80 m cross-gradient from the well. A site plan showing the septic system is given by Figure 3440-A in Appendix A4.

In addition, a tar emulsion above ground storage tank is located 31 m away from the wellhead, and bulk fuel storage tank is located at 36 m. The bulk fuel tank is located within a secondary containment berm to contain spillage/ leaks. The closest portion of a septic system to the wellhead is a septic line located 30 m away. The closest septic field is approximately 80 m away from the wellhead.

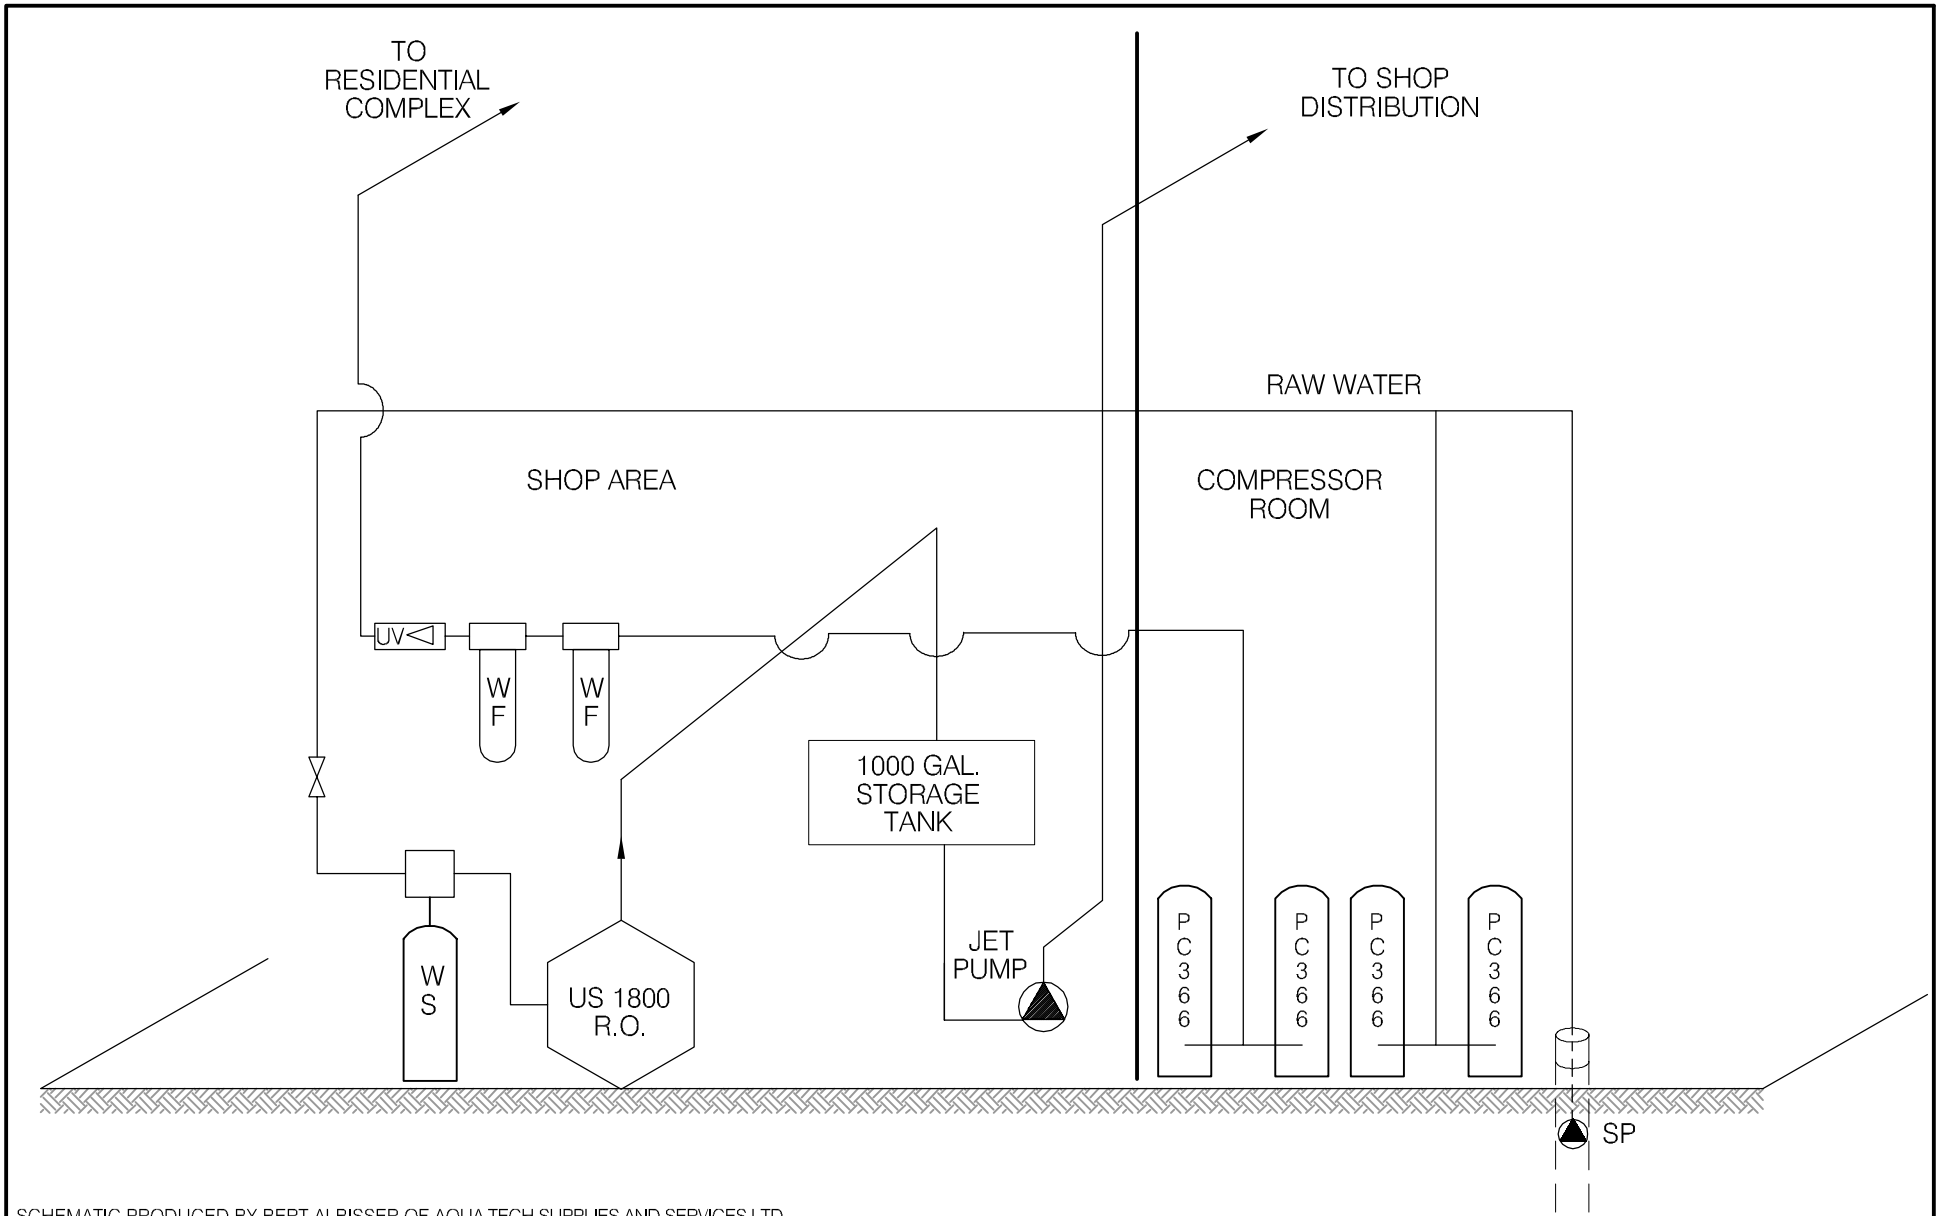
TITLE WATER SYSTEM DISTRIBUTION/TREATMENT SCHEMATIC SYSTEM ID.: 3440 BLANCHARD CAMP GRADER STATION	
DATE	SEPT. 2005	DWN.	JSB
CHKD.	RMM	FILE NO.	1260002.003
		DWG.:	FIGURE 3440-B

There is no treatment or disinfection system for the water supplying the maintenance garage. As such, the kitchen area in the lounge of the Grader station receives untreated water. The water system that supplies the living complex is equipped with a NSF 61 filtration system that is followed by a UV disinfection system and a reverse osmosis treatment system. The treatment system is located in the maintenance garage and post-treatment water is stored in a 5000 L water storage tank before being piped to the living complex. A schematic detailing the water supply system is provided as Figure 3440-B in Appendix A4.

- Re-plumb the treated water to provide potable water to dedicated taps in the bathroom and kitchen area of the maintenance garage.
- A further attempt should be made to obtain the well record to assess aquifer and well vulnerability. If a well record cannot be obtained, the overall well depth should be determined at the very least.

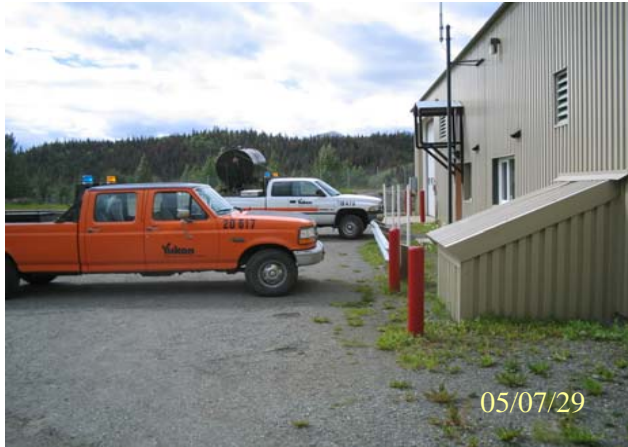
Photo 0139: 3440 Blanchard Grader Station maintenance garage

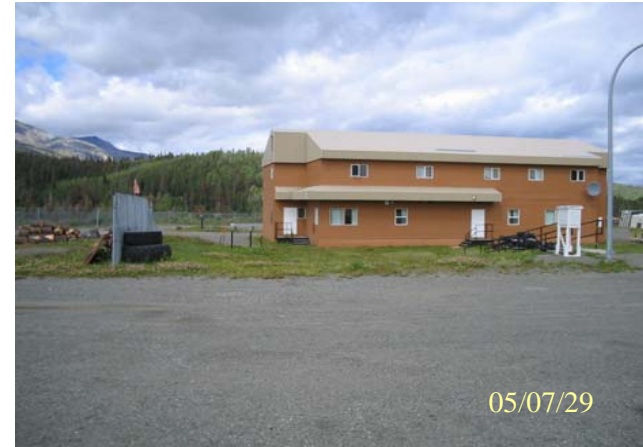
Photo 0134: 3440 Blanchard Grader Station living complex

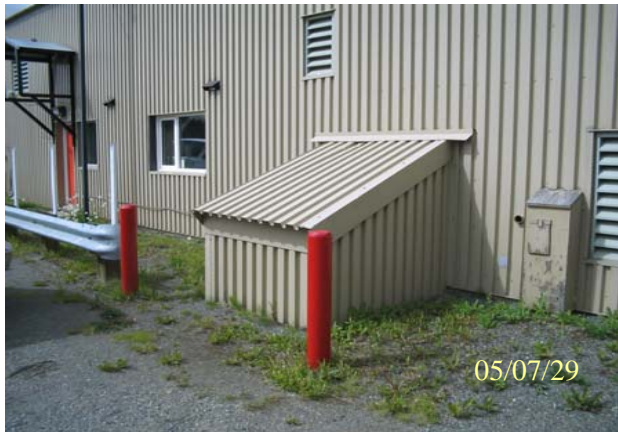
- The wellhead is only approximately 150 mm above grade, but is located in an appropriately constructed enclosure with a low risk of flooding, and is approximately 450 mm above the floor of the enclosure.

Photo 0138: 3440 Wellhead enclosure

- To limit potential contaminants entering the wellhead, or traveling down the outside of the casing, it is recommended that the casing be extended to 500 mm above grade, and the concrete floor elevation be raised to grade.

- To extend the wellhead to at least 500 mm above grade, and to raise the elevation of the concrete floor to grade level, would cost in the order of **\$400** for materials and labour.

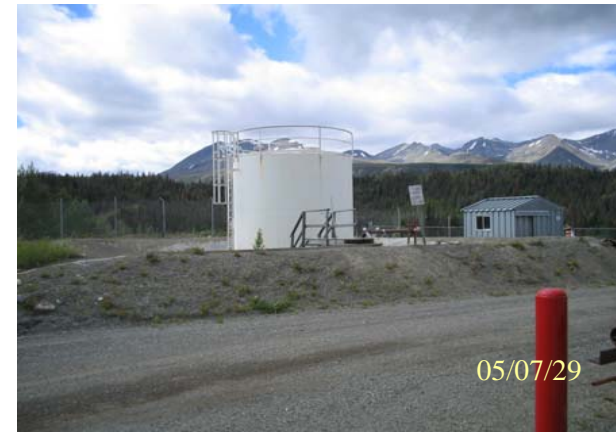
Photo 0135: 3440 Bulk fuel storage tank with geomembrane and berm

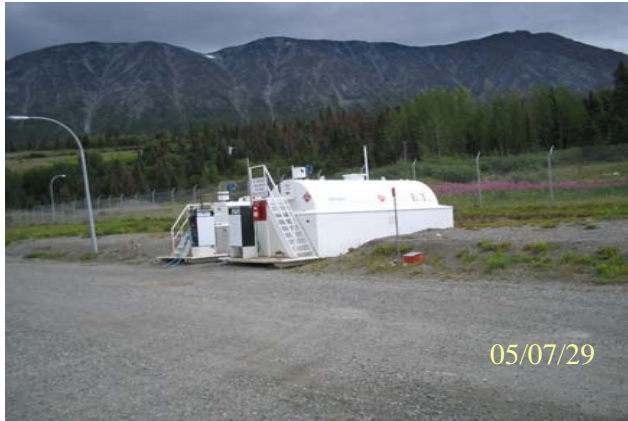
- There is no treatment or disinfection on the water system supplying the maintenance garage;
- There is a vehicle fueling area located approximately 21 m upgradient from the well;
- There is no well log available to review well construction and lithology; and,
- By definition of the Draft Yukon GUDI Assessment Guideline, the well is potentially under the direct influence of surface water because the completion depth is unknown, and the well construction does not meet the requirements of the CGWA Guidelines for Water Well Construction.

Photo 0137: 3440 Above ground fuel storage tank

- As indicated previously, two large Enviro Tanks and a fueling area are located approximately 20 m in a direction that is inferred to be upgradient of the well. Although the tanks are double walled, and there is a secondary containment tray beneath the fuel pumps, it is evident that vehicles are re-fueled in front of this fueling area. There is a risk of overfilling, and potential contamination of the subsurface and aquifer that provides water to the buildings at the site. It would be prudent to relocate the fueling area downgradient, or cross gradient and at least 60 m from well to protect the water quality.

- To relocate the Enviro-tanks to an area that is at least 60 m west, or 30 m south of the well location would cost approximately **\$600**.

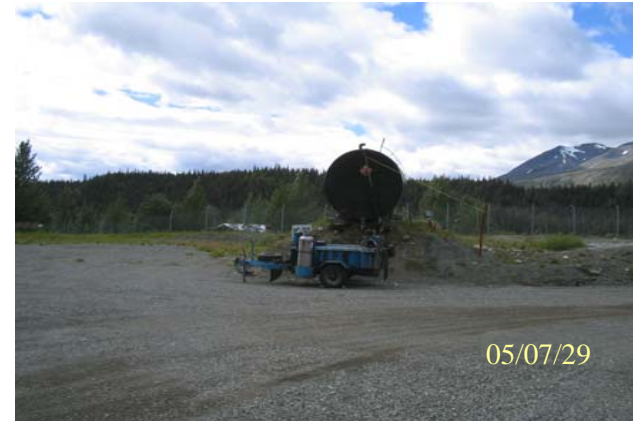
Photo 0136: 3440 Emulsion or tar tank

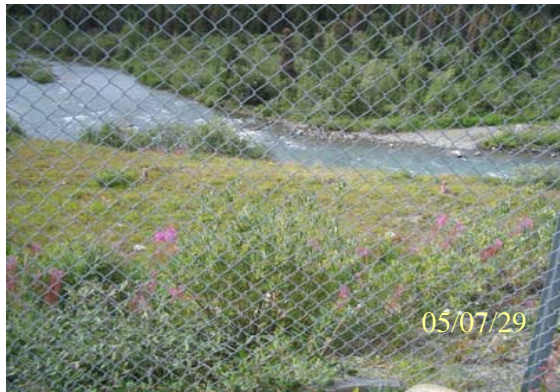
Photo 0141: 3440 Blanchard River

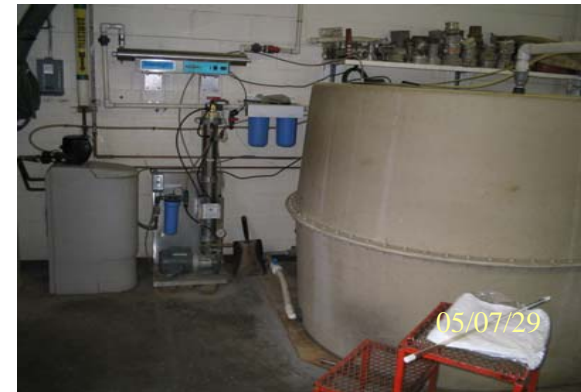
THIS IS A REASONABLE INSTALLATION. IT PROVIDES
TO QUALITY WATER TO THE RESIDENCE

Photo 0132: 3440 Water storage tank (right), duplex filter (centre), UV disinfection system (top centre), reverse osmosis treatment system (bottom centre), water softener (left)

INITIATE A PROPER MAINTENANCE SCHEDULE
BI-ANNUAL FOR WELL SHOCK CHLORINATION
TANK CLEANING AND UV CLEANING.
CHANGE UV BULB YEARLY.
SET UP MAINTENANCE CHECK LIST
& TRAINING FOR PEOPLE RESPONSIBLE FOR
THE SYSTEM.
LASTLY CHECK WATER QUALITY REGULARLY.
