19.0 BUILDING 3172: DESTRUCTION BAY FIRE HALL

**SMALL PUBLIC WATER SYSTEMS ASSESSMENT
WESTERN REGION**

**GOVERNMENT OF YUKON
HIGHWAYS & PUBLIC WORKS**

**DESTRUCTION BAY FIRE HALL
BUILDING # 3172
SITE LOCATION DIAGRAM
WELL ID: 3172**

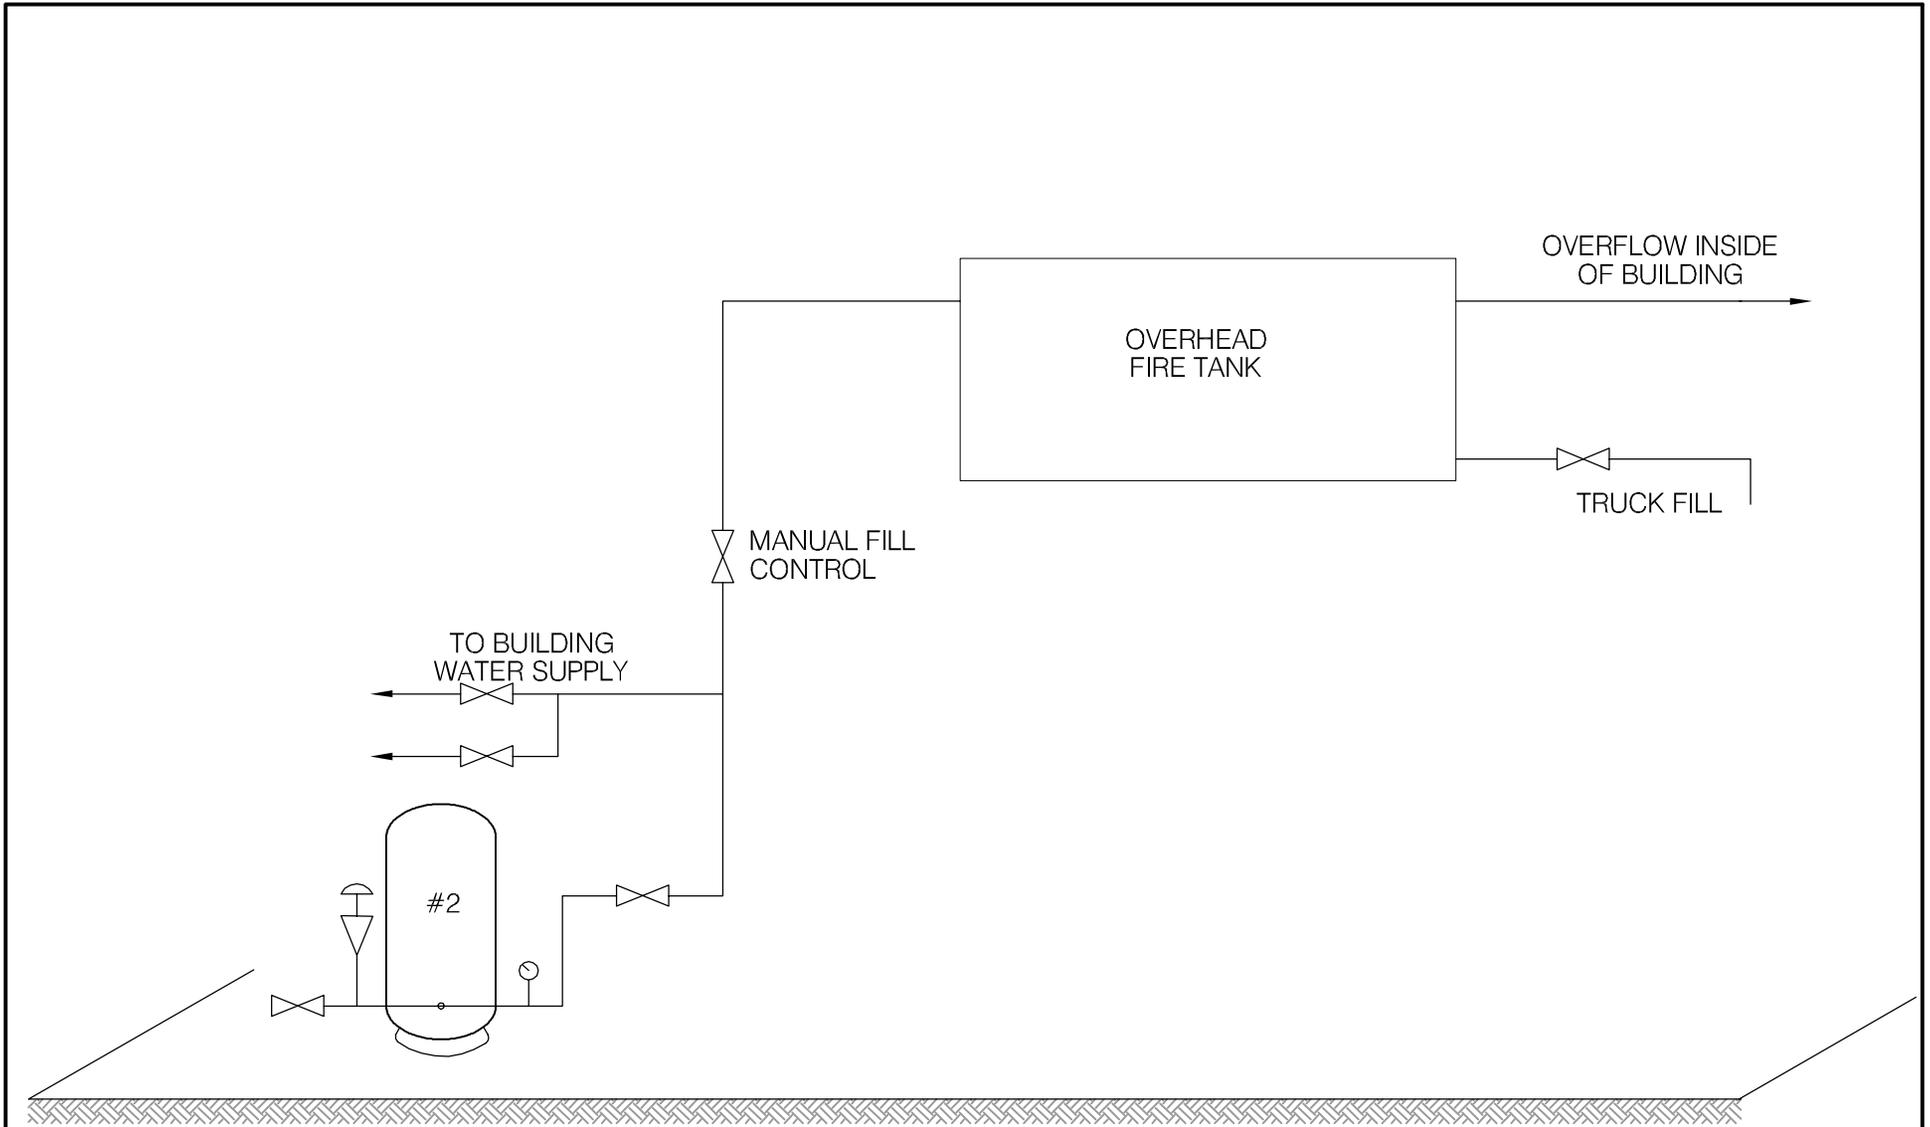
TITLE WATER SYSTEM DISTRIBUTION/TREATMENT SCHEMATIC SYSTEM ID.: 3172 DESTRUCTION BAY FIRE HALL	
DATE	SEPT. 2005	DWN.	JSB
CHKD.	FMM	FILE NO.	1260002.003
		DWG.:	FIGURE 3172-B

There is no treatment or disinfection system for the water supplying this system. The water system splits to supply the domestic system and the system for fire fighting use. The system for fire fighting use is equipped with an elevated 22,500 L water storage tank. A schematic detailing the well supply system is provided as Figure 3172-B in Appendix A19.

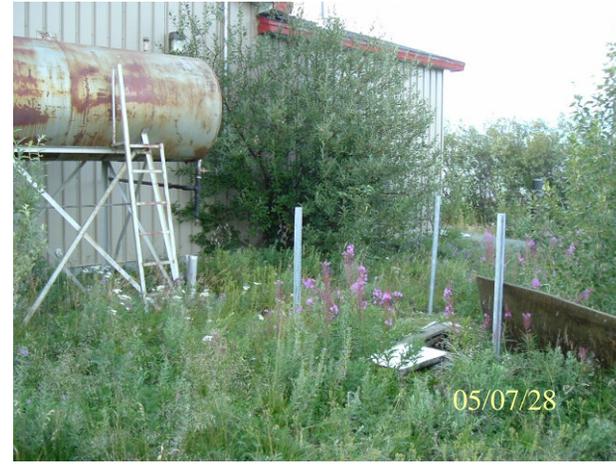
- The well is within 30 m of potential sources of contamination, including an above ground fuel storage tank at 2 m, an underground fuel storage tank at 18 m, and scrap cars within 20 m;

Photo 0611: 3172 Above ground fuel storage tank (left), wellhead enclosure (right)

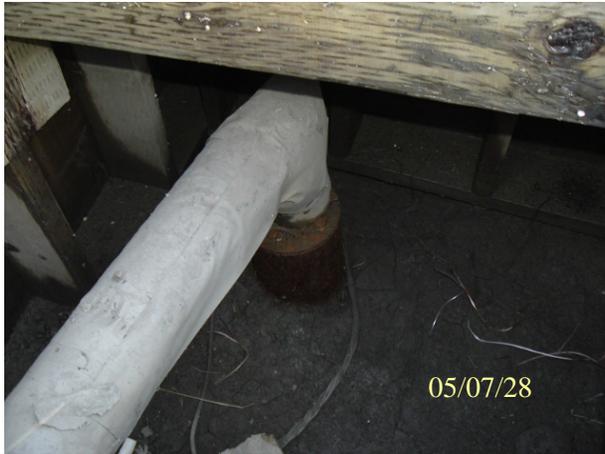
- Poor wellhead construction (located in a pit below grade);
- There is no surface sanitary seal (grout or bentonite seal as required by the Canadian Groundwater Association's Guidelines for Water Well Construction);

- i. Is the well head below grade? describe in detail ~ 0.7 m below grade
- ii. Are there signs of ponding on the enclosure(e.g. water stains, etc.)? Yes No
- iii. Is the wellhead enclosed by fiberglass insulations? Yes No
- iv. Any evidence of rodents? Specify Access possible
- v. Does the well casing have a proper seal cap? Yes No
If no, describe condition split gasket cap

Photo 0612: 3172 Wellhead in pit

- Following Priority 1 upgrades to the adjacent Kluane School water supply system, it is recommended that a new service line consisting of 1 inch insulated and heat traced pipe should be installed below grade between the School and the Fire Hall. The system should be re-plumbed so that the domestic water supply and the fire fighting supply are independent. An option for emergency back-up use of the domestic water for fire fighting purposes should be considered.
- The well casing should be extended to at least 500 mm above grade and the portion of the well pit that is below grade should be backfilled with a low permeability material such as bentonite or grout.

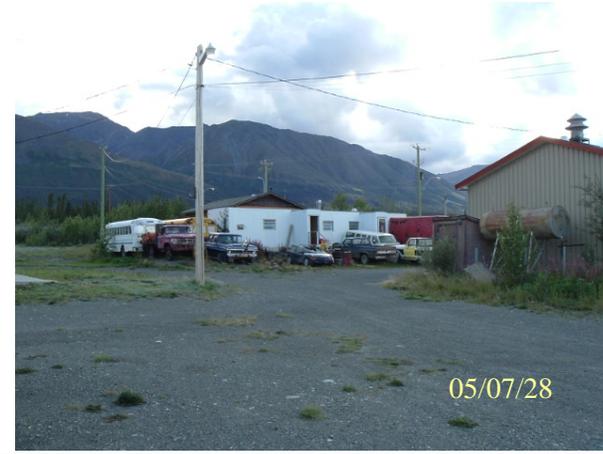
Other potential contaminant sources in the vicinity of the wellhead are a number of scrap cars are located approximately 20 m away from the wellhead, an above ground fuel storage tank located at 39 m, and septic lines located within 30 m of the wellhead.

Photo 0613: 3172 Junk cars (centre), fire hall (right)

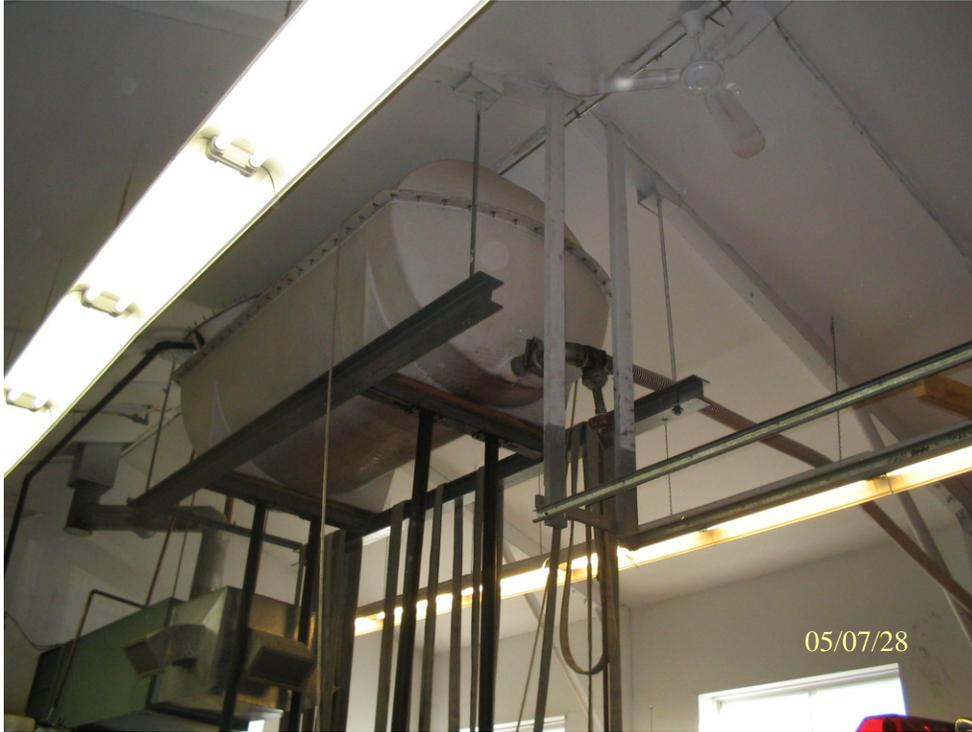
- The color had previously exceeded the CDWQG aesthetic objective; and,
- It is unlikely that the supports for the elevated water storage tank are earthquake or collision proof.

Photo 0122: 3172 Elevated water storage tank

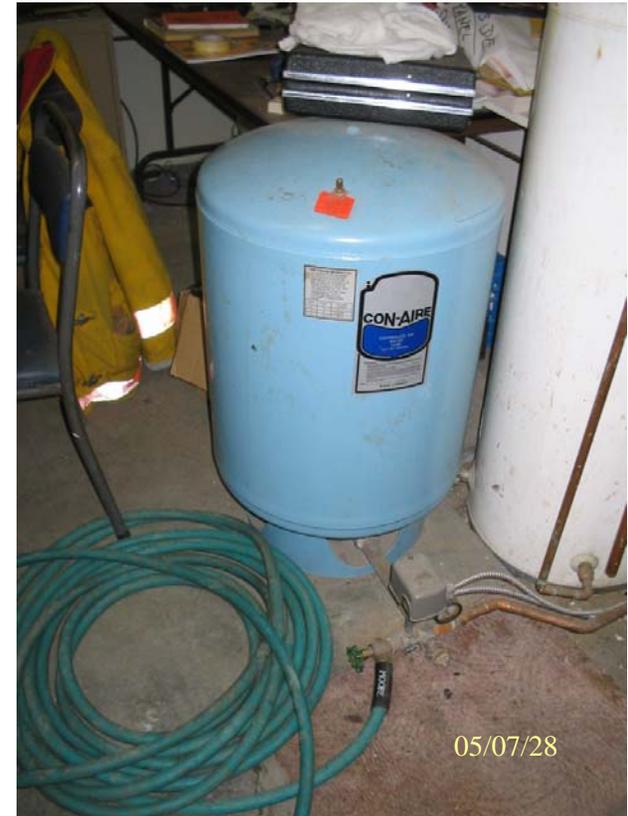
Photo 0119: 3172 Pressure tank
