18.0 BUILDING M0093: CARMACKS RCMP DETACHMENT

PROJECT SMALL PUBLIC WATER SYSTEMS ASSESSMENT
WHITEHORSE REGION

SMALL PUBLIC WATER SYSTEM ASSESSMENT

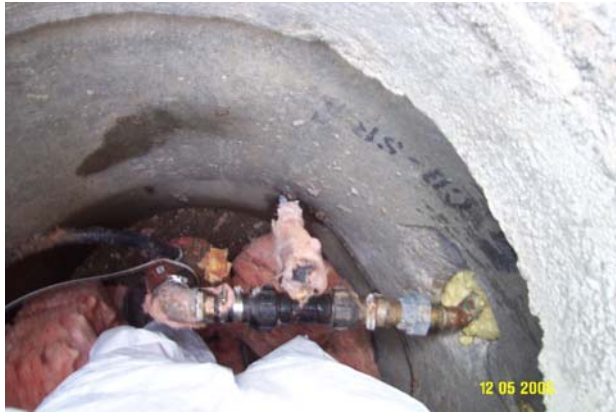
- The wellhead is located within 30 m of potential sources of contamination. There are two above ground fuel storage tanks located 9 m from the well.
- There is no surface sanitary seal (grout or bentonite seal as required by the Canadian Groundwater Association's Well Construction Guidelines).

it's underground and there is evidence of water entering the well pit

- i. Is the well head below grade? describe in detail 114cm below grade
- ii. Are there signs of ponding on the enclosure(e.g. water stains, etc.)? Yes No
There is some moisture and evidence of water seeping into the enclosure
- iii. Is the wellhead enclosed by fiberglass insulations? Yes No
The enclosure is filled with loose fiberglass insulation pieces
- iv. Any evidence of rodents? Specify very little
- v. Does the well casing have a proper seal cap? Yes No

Photo 0144: M0093 Wellhead in Pit

- Rehabilitating the wellhead construction to retrofit a surface seal to 3 m in depth (6 m would not be possible), and extending the casing to 500 mm above grade.

- The cost for the wellhead upgrades, including raising the wellhead, installing a surface seal to 3 m below grade, and installing a 150 mm pitless adapter would likely cost in the order of **\$5,000**.
