## **21.0 BUILDING 6512: CARMACKS GRADER STATION**

SMALL PUBLIC WATER SYSTEMS ASSESSMENT  
 WHITEHORSE REGION

## SMALL PUBLIC WATER SYSTEM ASSESSMENT

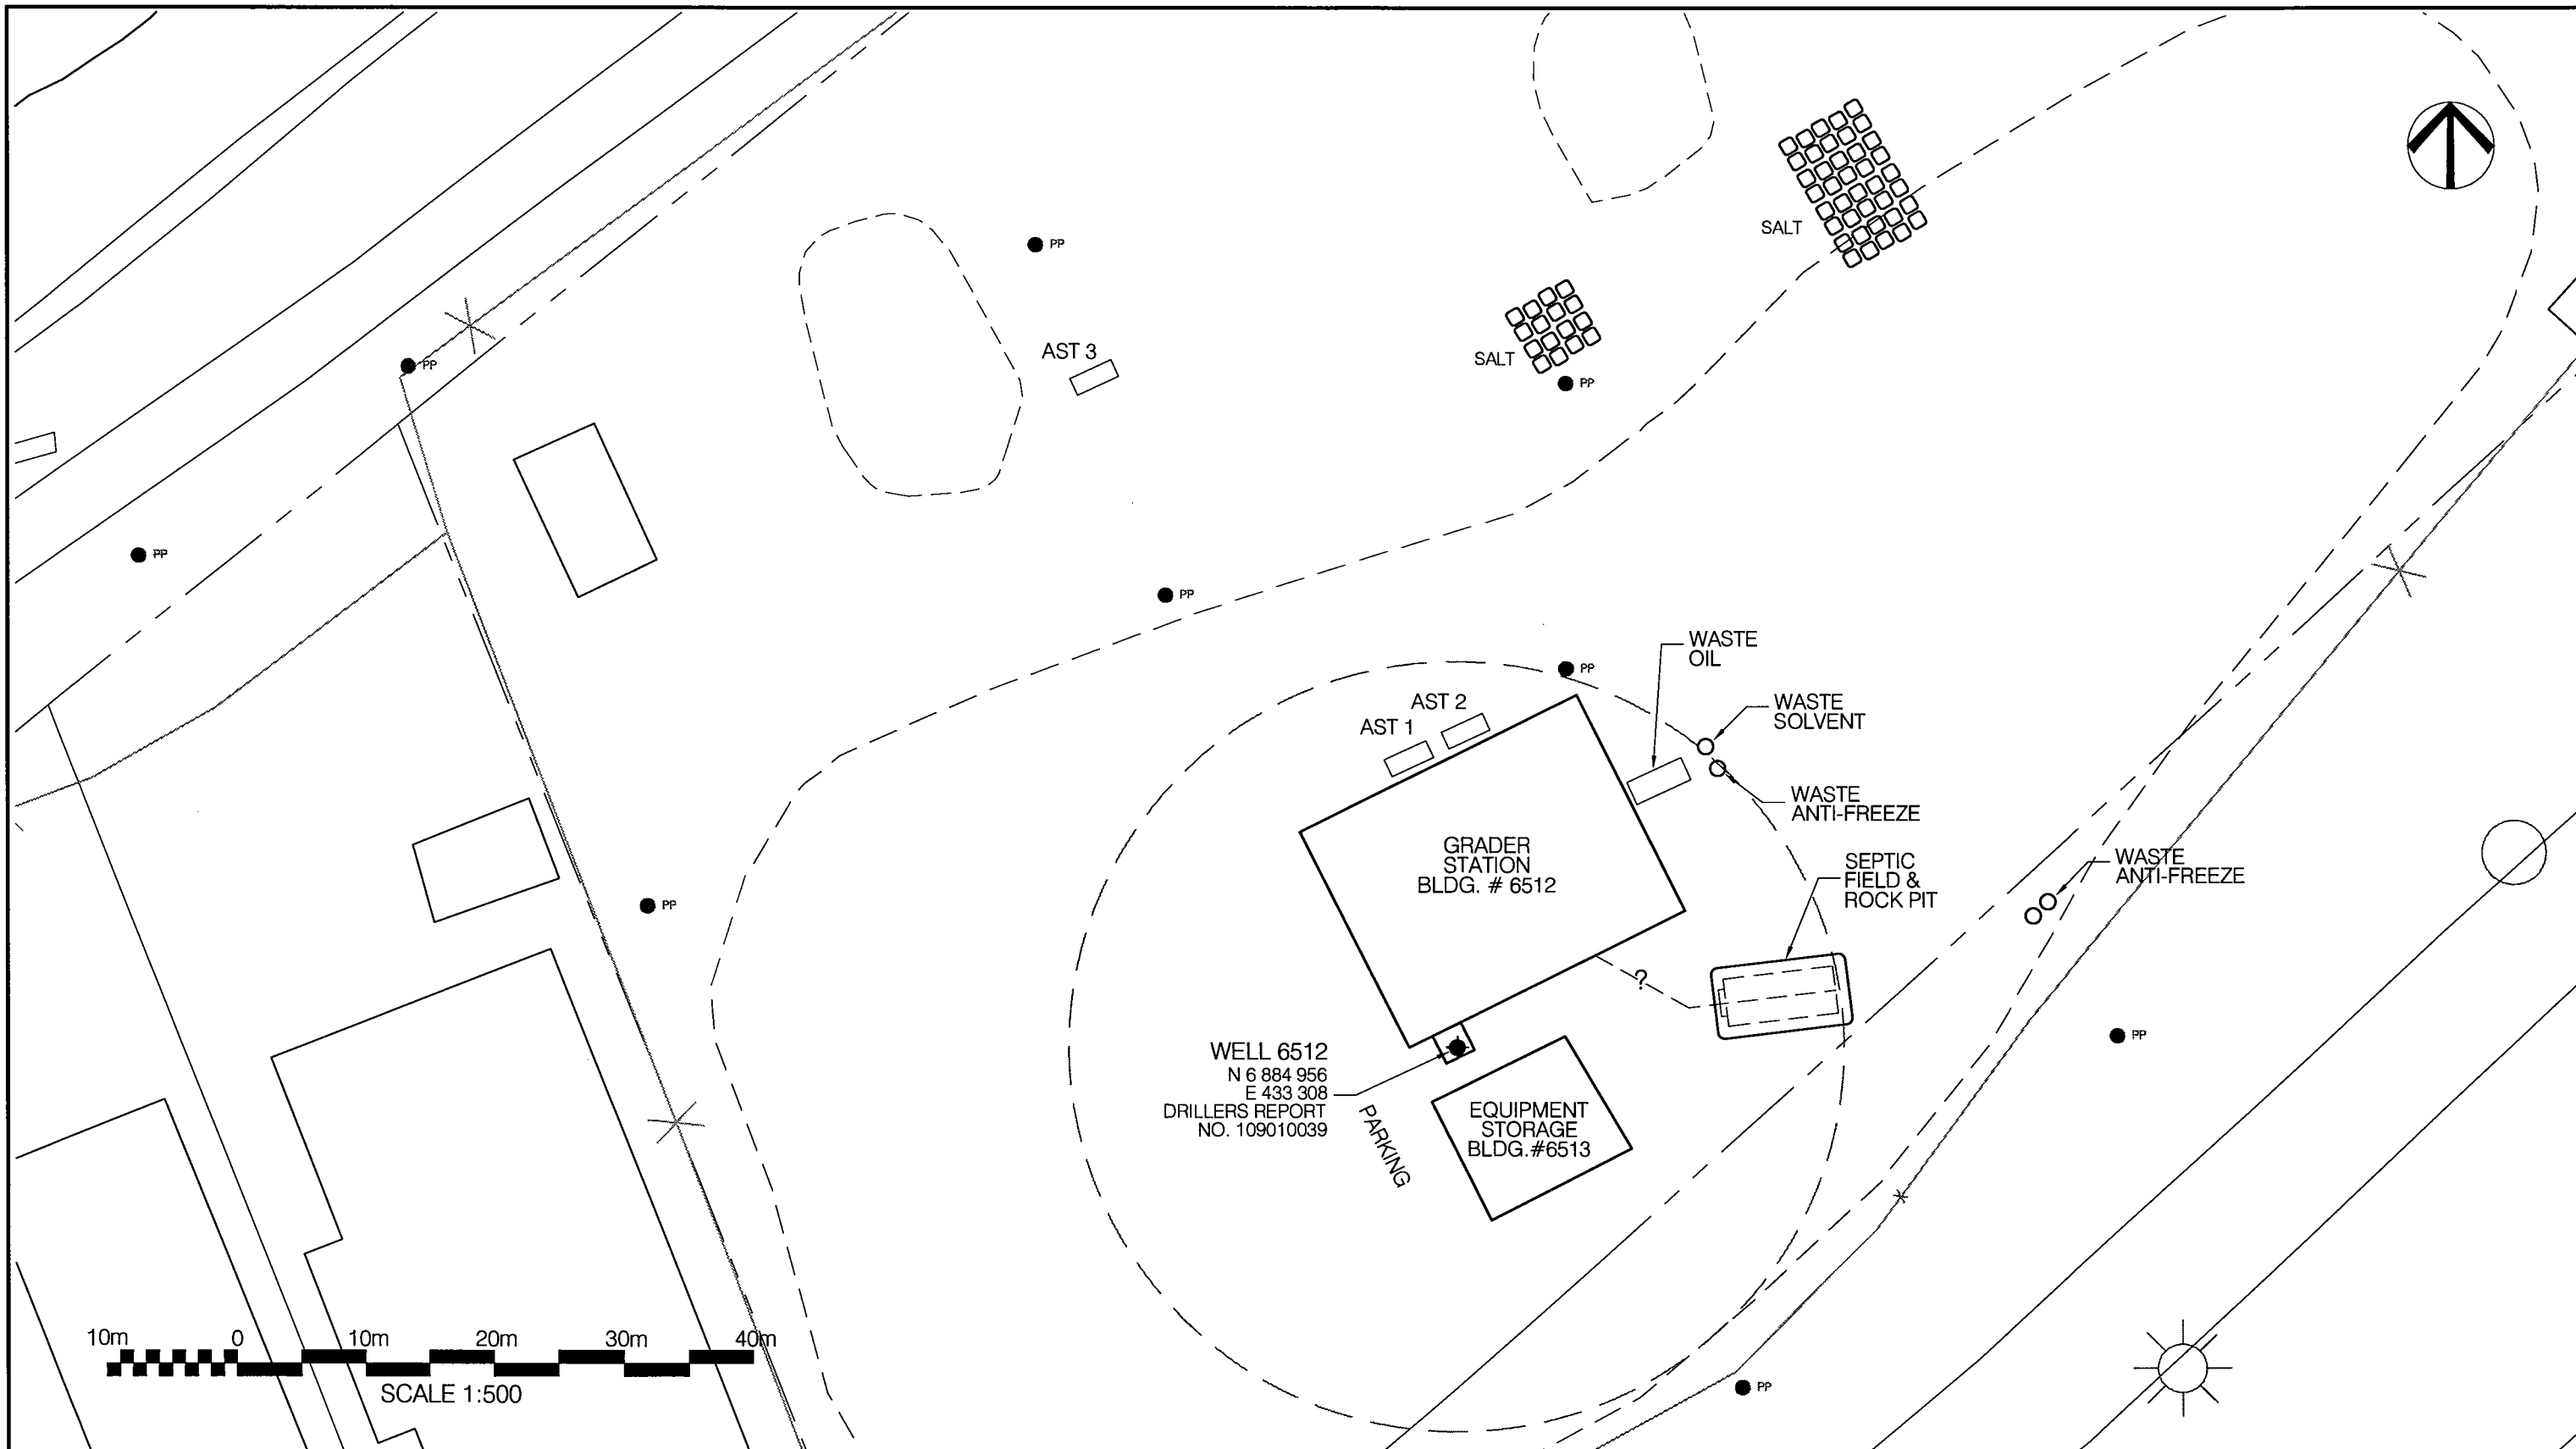
REVISION ISSUE  
 0  
 DRAWING No.  
 FIGURE 6512A

30 m RADIUS FROM WATER WELL FOR CONSIDERATION OF PROXIMITY TO POTENTIAL CONTAMINANT SOURCES.

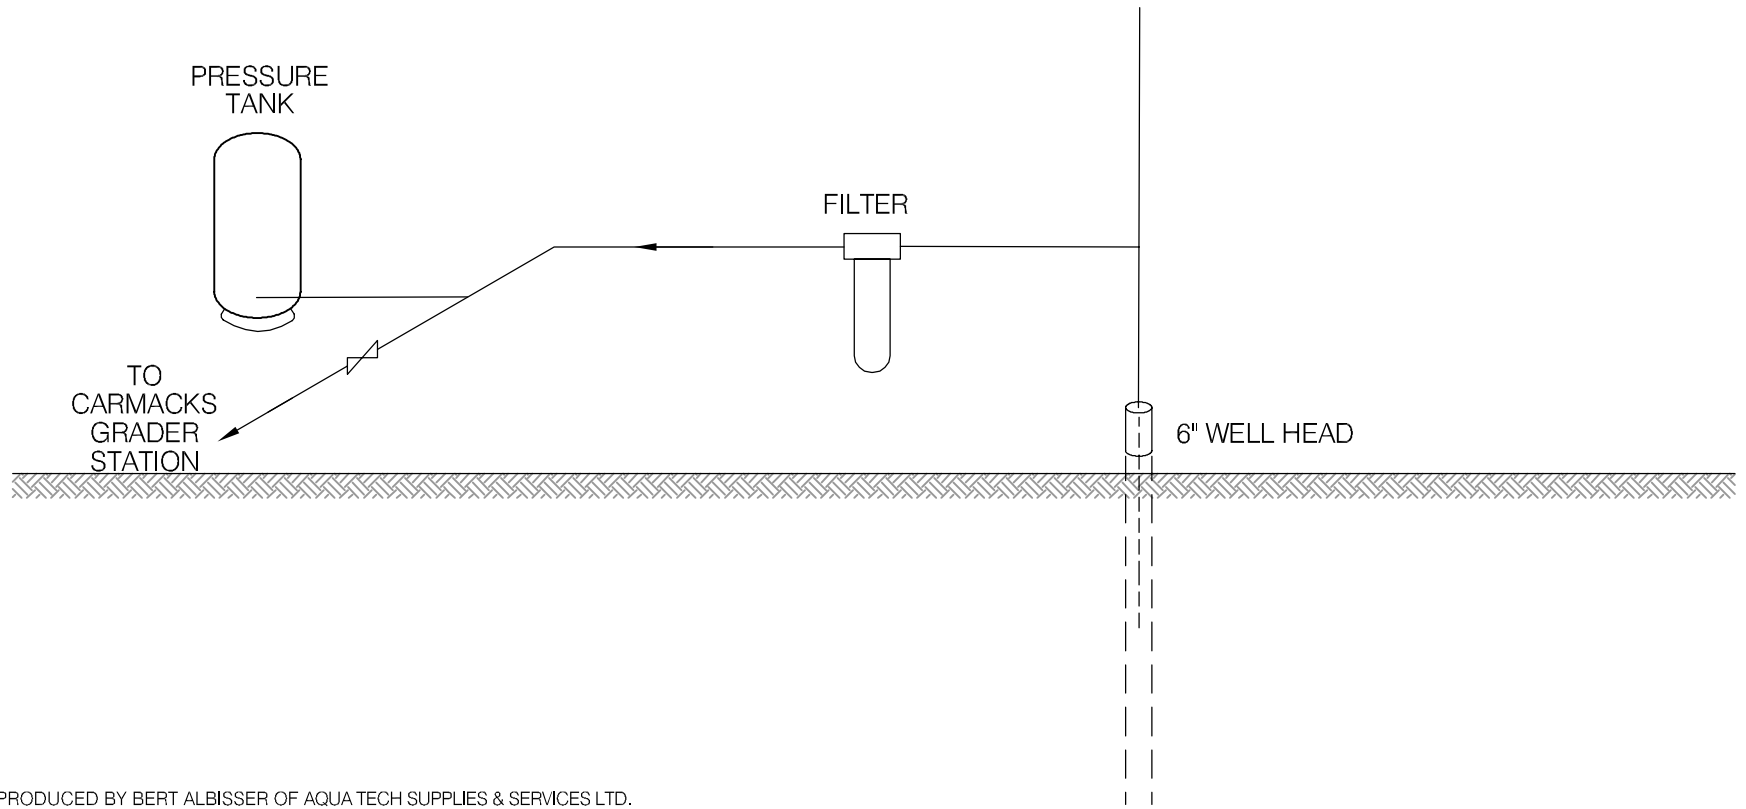
TITLE WATER SYSTEM DISTRIBUTION/TREATMENT SCHEMATIC SYSTEM ID.: 6512 CARMACKS GRADER STATION	
DATE	APRIL 2006	DWN.	JSB
CHKD.	FMM	FILE NO.	1260002.001
		DWG.:	FIGURE 6512B

The water is filtered with an inline cartridge type filter. The submersible pump system is controlled by a pressure tank and pump controls. A system schematic is provided as Figure 6512-2 located in Appendix A21.

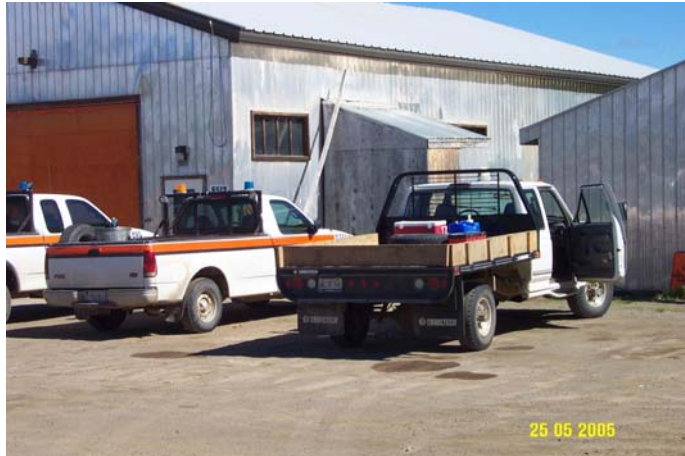
**Photo 0196:** 6512 Carmacks Grader Station and Well house Addition (back), Parking (front)

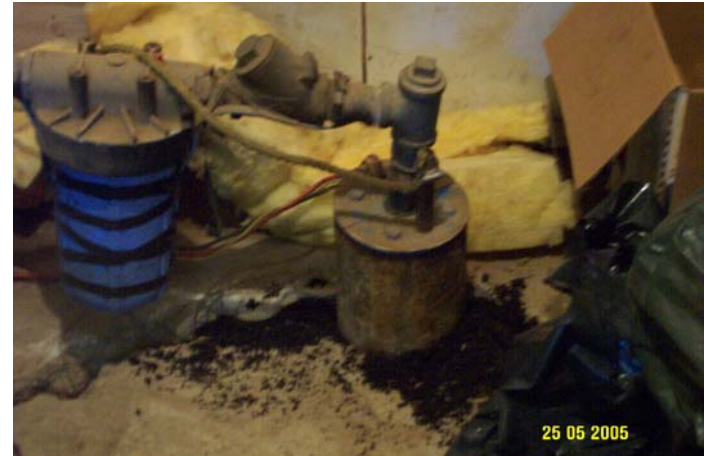
- There is no surface sanitary seal (grout or bentonite seal as required by the Canadian Groundwater Association's Well Construction Guidelines);
- Poor surface completion of the wellhead (located in an attachment to the maintenance garage, concrete floor is cracked around the casing);

Comments: CONCRETE CRACKED AROUND WELL CASING, FILLED WITH COLD MIX (PAVEMENT)

**Photo 0197:** 6512 Wellhead (center) and Filter (left)

- ① REPAIR CRACKS IN CONCRETE FLOOR IN WELL HOUSE.
- ② RAISE CASING - CASING IS ONLY 7" ABOVE WELL HOUSE FLOOR AND IS APP. 13" ABOVE FLOOR OF SHOP.
- ③ TO CLEAN WELL (REDEVELOP) YOU WOULD HAVE TO REMOVE ROOF OR REMOVE THE WHOLE ADD ON WELL ROOM BUILDING, IN ORDER TO GET EQUIPMENT OVER HOLE.

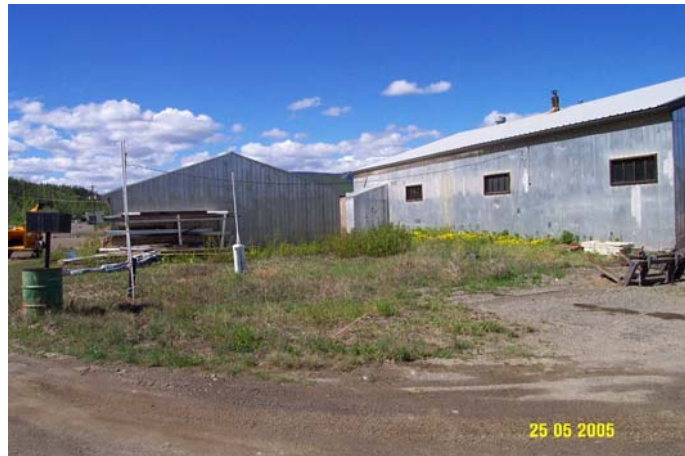
Yes  No  
All waste from grader station effluent and floor grease, flows into the septic tank/rock pit that is ~20m away

The effluent field 20m away does not only take in domestic waste from the grader station, but also hydrocarbon/solvent waste from the drainage inside the garage. The effluent field therefore doubles as a rock pit as all of the waste coming directly from the grader station drains into it.

**Photo 0205:** 6512 Septic Field and Rock Pit (left), Carmacks Grader Station (back right)

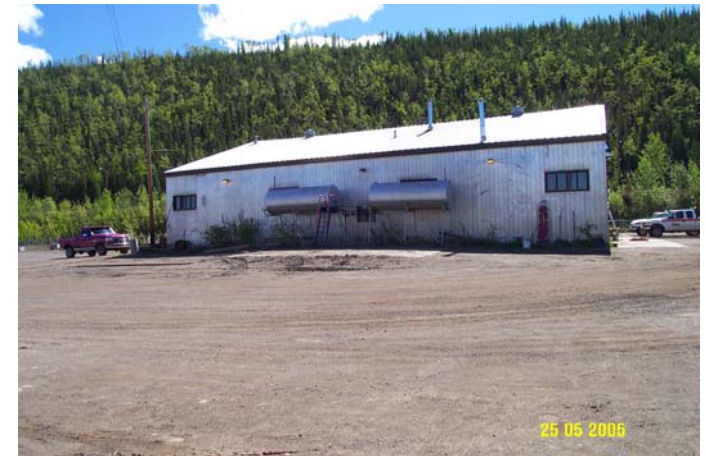
- The wellhead is located within 30 m of potential sources of contamination. There are two above ground fuel storage tanks located 25 m from the well. There is a used oil tank, as well as a used solvent drum and a used antifreeze drum located approximately 30 m from the well. The septic system including the filed is within 30 m of the well. Additionally, the septic system also acts as a rock pit and may receive some hydrocarbon wastes from the garage sumps along with the domestic effluent into the septic system;

**Photo 0202:** 6512 Above Ground Fuel Storage Tanks (2) and Carmacks Grader Station (behind)

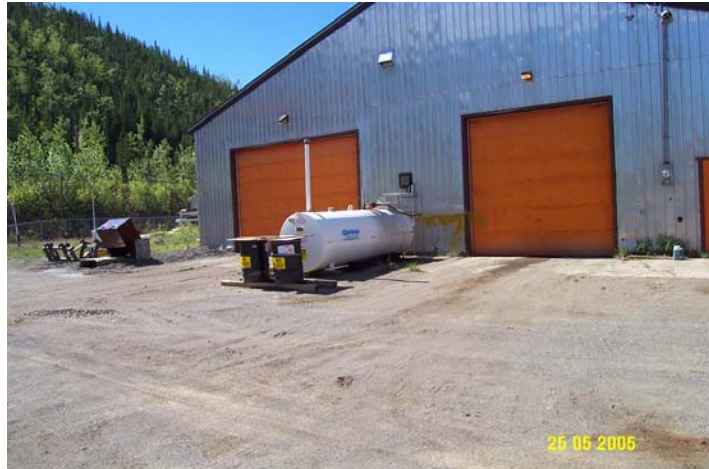
- Septic field/rock pit at 20 m,
- Used oil tank at 28 m,
- Waste solvent drum at 30 m,
- Waste antifreeze drum at 30 m, and
- Two above ground fuel storage tanks at 25 m.

**Photo 0204:** 6512 Used Oil Tank, Used Antifreeze Drum and Used Solvent Drum, Carmacks Grader Station (behind)

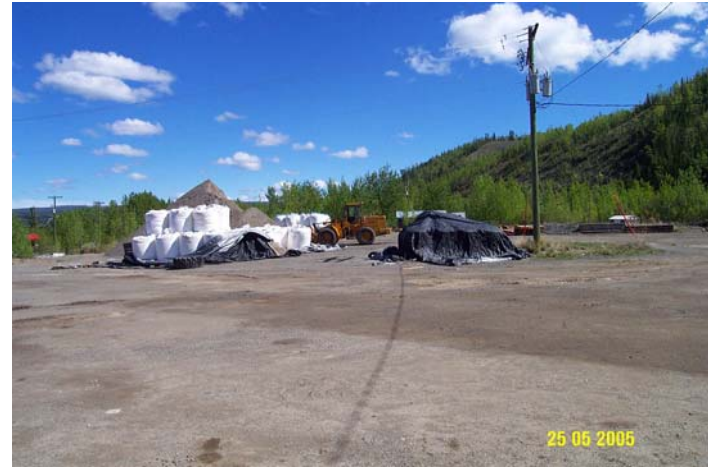
**Photo 0203:** 6512 Salt Storage

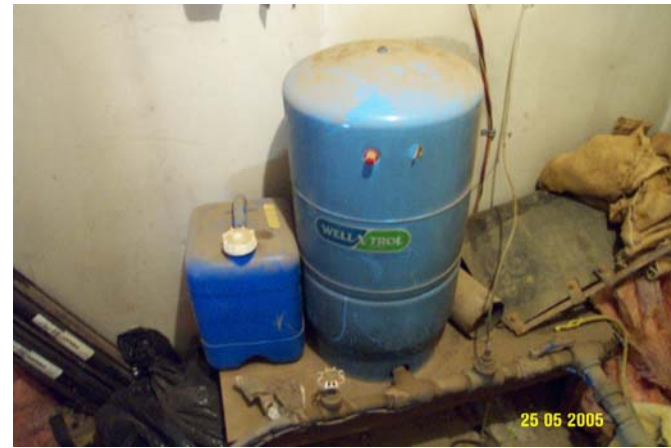
**Photo 0198:** 6512 Pressure Tank
