25.0 BUILDING 6975: CARMACKS HEALTH CENTRE

EBA Engineering Consultants Ltd.		PROJECT SMALL PUBLIC WATER SYSTEMS ASSESSMENT WHITEHORSE REGION	
CLIENT

TITLE WATER SYSTEM DISTRIBUTION/TREATMENT SCHEMATIC SYSTEM ID.: 6975 CARMACKS HEALTH CENTRE	
DATE	APRIL 2006	DWN.	JSB
CHKD.	FMM	FILE NO.	1260002.001
		DWG.:	FIGURE 6975B

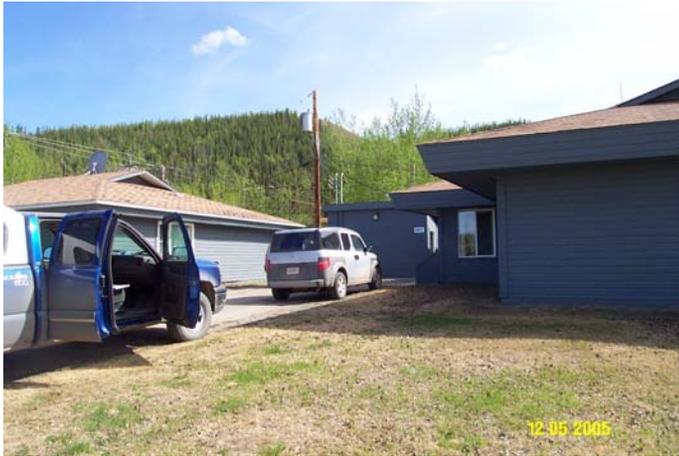
Photo 0137: 6975 Health Center (right), Wellhouse (center) and Nursing Residence (left)

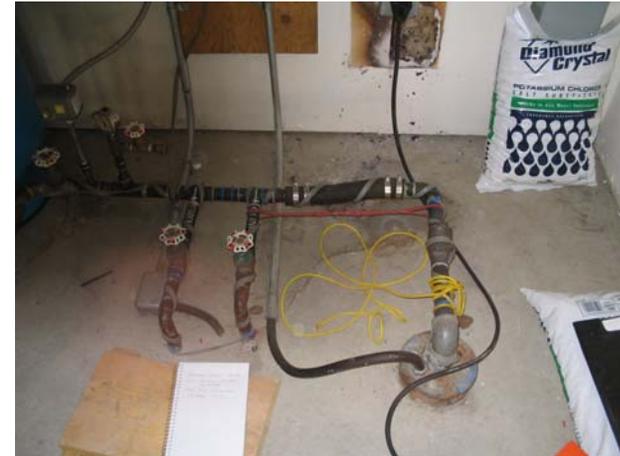
- The well is not equipped with a surface sanitary seal (grout or bentonite seal as required by the Canadian Groundwater Association's Well Construction Guidelines);

- The wellhead is located in a pump house that contains a back-up generator for the health centre and the well casing only extends 60 mm above floor level.

Photo 0002: 6975 Wellhead

- It would not be possible to install a proper surface seal to 6 m below grade. The well casing should; however, be extended to at least 500 mm above the pump house floor, and a secondary containment system should be installed around the generator to mitigate any risk of fuel leakage.

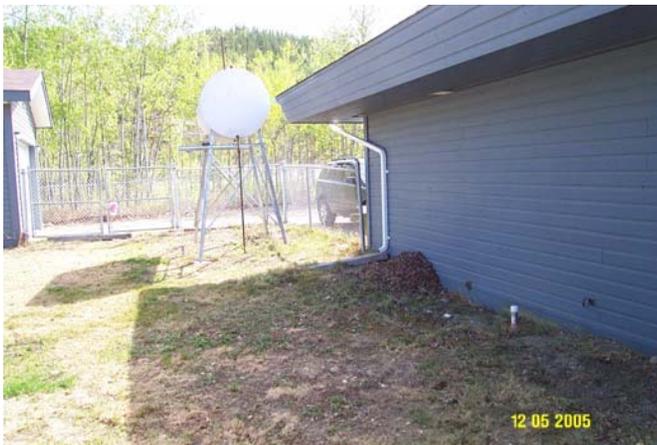
- The wellhead is located within 30 m of potential sources of contamination. There is an above ground storage tank located 11 m from the well, and the fuel line that runs to the health centre has leaked in the past;

Photo 0138: 6975 Above Ground Fuel Storage Tank and Hydrocarbon Spill Site

- Secondary containment should be installed on the above ground storage tank, or else the tank should be replaced with double walled fuel storage tanks.

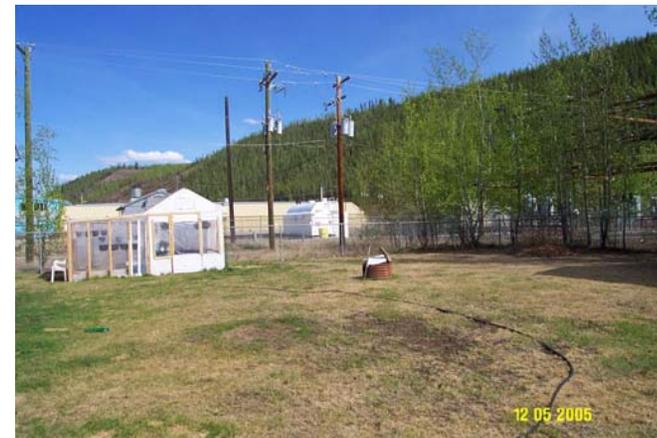
Photo 0139: Substation and Above Ground Fuel Storage Tank (back)

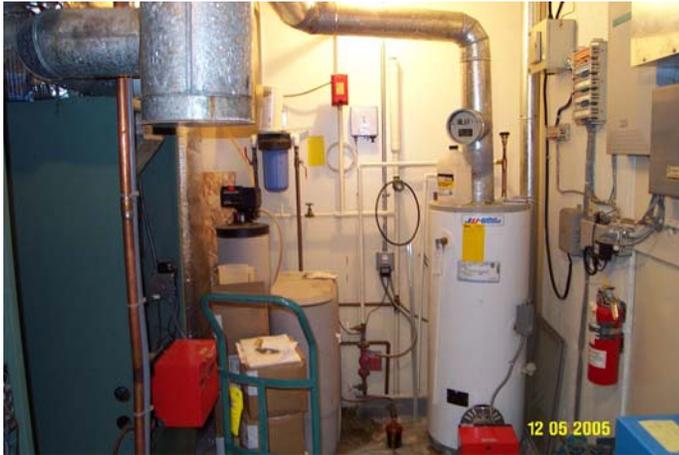
Photo 0142: 6975 Health Center Water Treatment System

- The existing 20-micron filtration system should be replaced with an NSF 61 certified inline commercial filtration system capable of removing particles down to 1 micron (absolute) in size.

- A NSF/ANSI 55 certified UV disinfection system should be installed, and the existing water softener should be adequate for use as a pretreatment system. This is a conceptual design recommendation based on the information available for planning and budgeting purposes. Engineering input will be required for final system specifications.

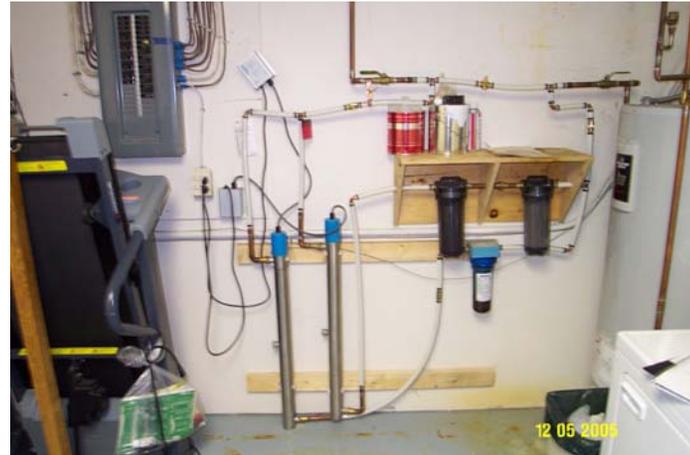
UV SYSTEM INSTALLATION REQUIRES ATTENTION. THE TWO UV REACTORS DO NOT HAVE FLOW RESTRICTORS INSTALLED TO ASSURE FULL UV EXPOSURE, NO UV MONITOR IS PRESENT TO MEASURE UV STRENGTH. THE PIPING FEEDING THE REACTORS PROMOTES UNEVEN FLOW DISTRIBUTION AGGRAVATING THE ABOVE PROBLEM.

Photo 0143: 6975 Nursing Residence Water Treatment System

RENEW THE PIPING SYSTEM. INSTALL ONE FILTER SYSTEM TO HANDLE THE FULL FLOW. INSTALL UV MONITORS ON BOTH REACTORS ALONG WITH THE APPROPRIATE FLOW RESTRICTORS.
INSTALL PRETREATMENT IF REQUIRED
THIS SYSTEM IS AN ACCIDENT WAITING TO HAPPEN.

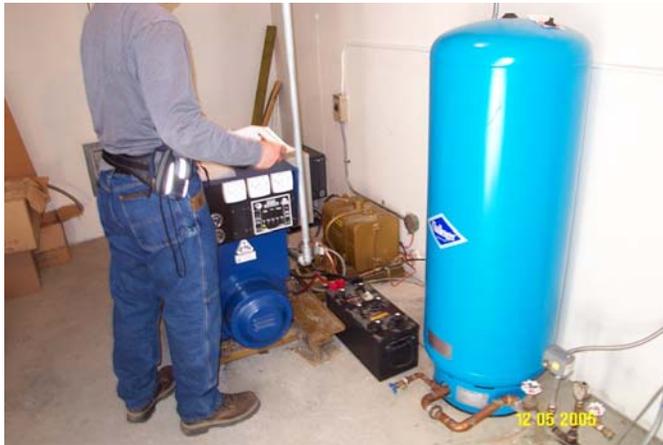
- Fuel powered generator at 2 m; and,
- Above ground fuel storage tank at 11 m.

Photo 0141: 6975 Pressure Tank (right) and Backup Electrical Generator

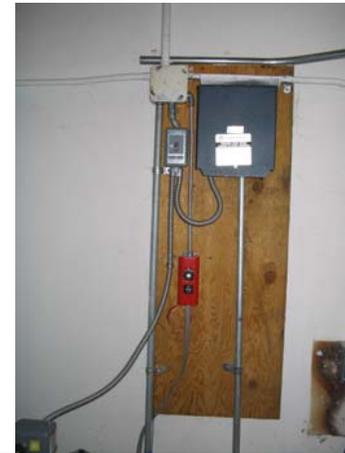
Photo 0001: 6975 Pump Control Box
