23.0 BUILDING 6536: CARMACKS FORESTRY CREW QUARTERS

SMALL PUBLIC WATER SYSTEMS ASSESSMENT
 WHITEHORSE REGION

CARMACKS FORESTRY CREW QUARTERS
 BUILDING 6536
 SITE LOCATION DIAGRAM
 WELL ID: 6536

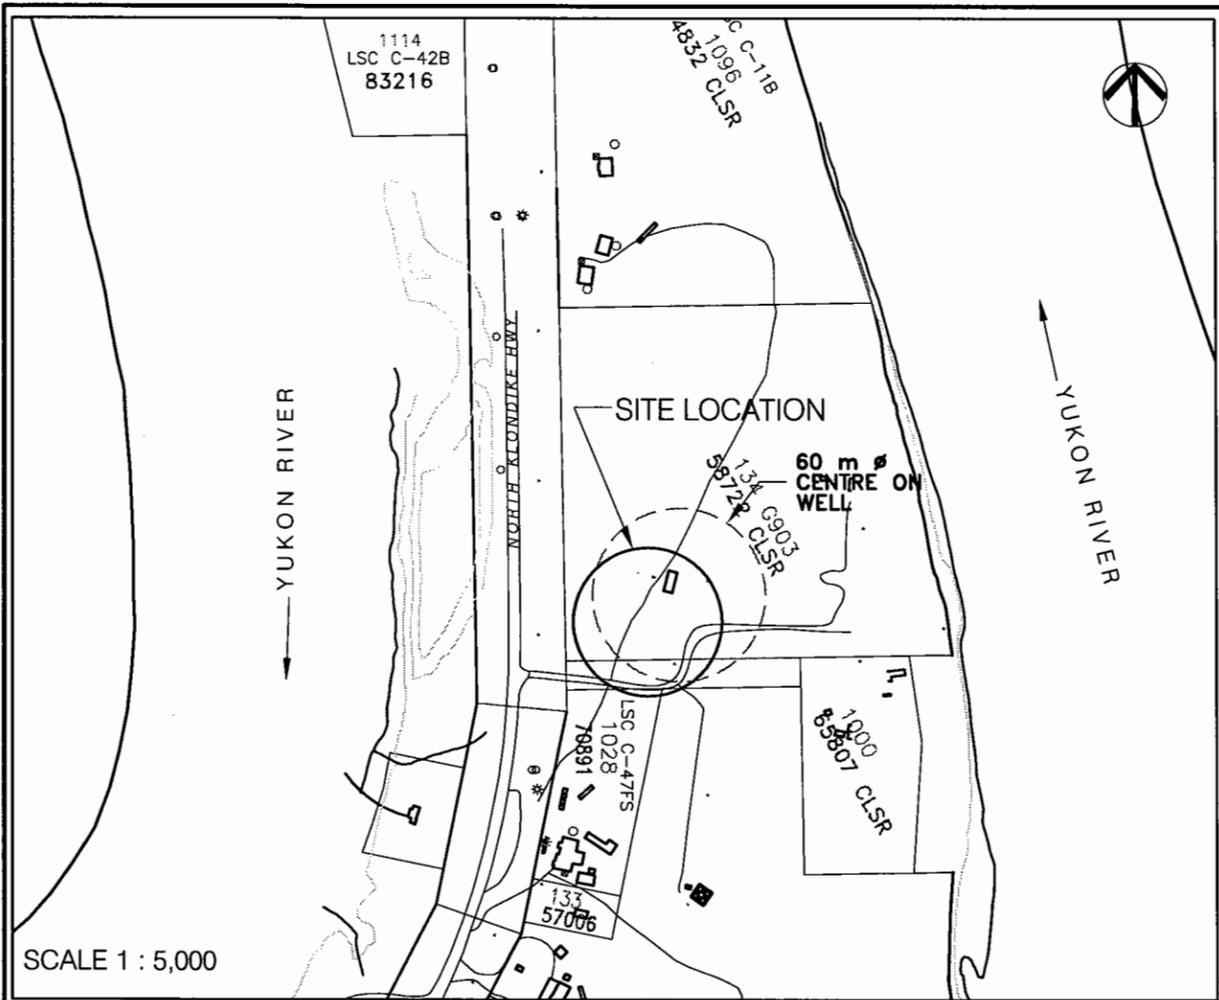
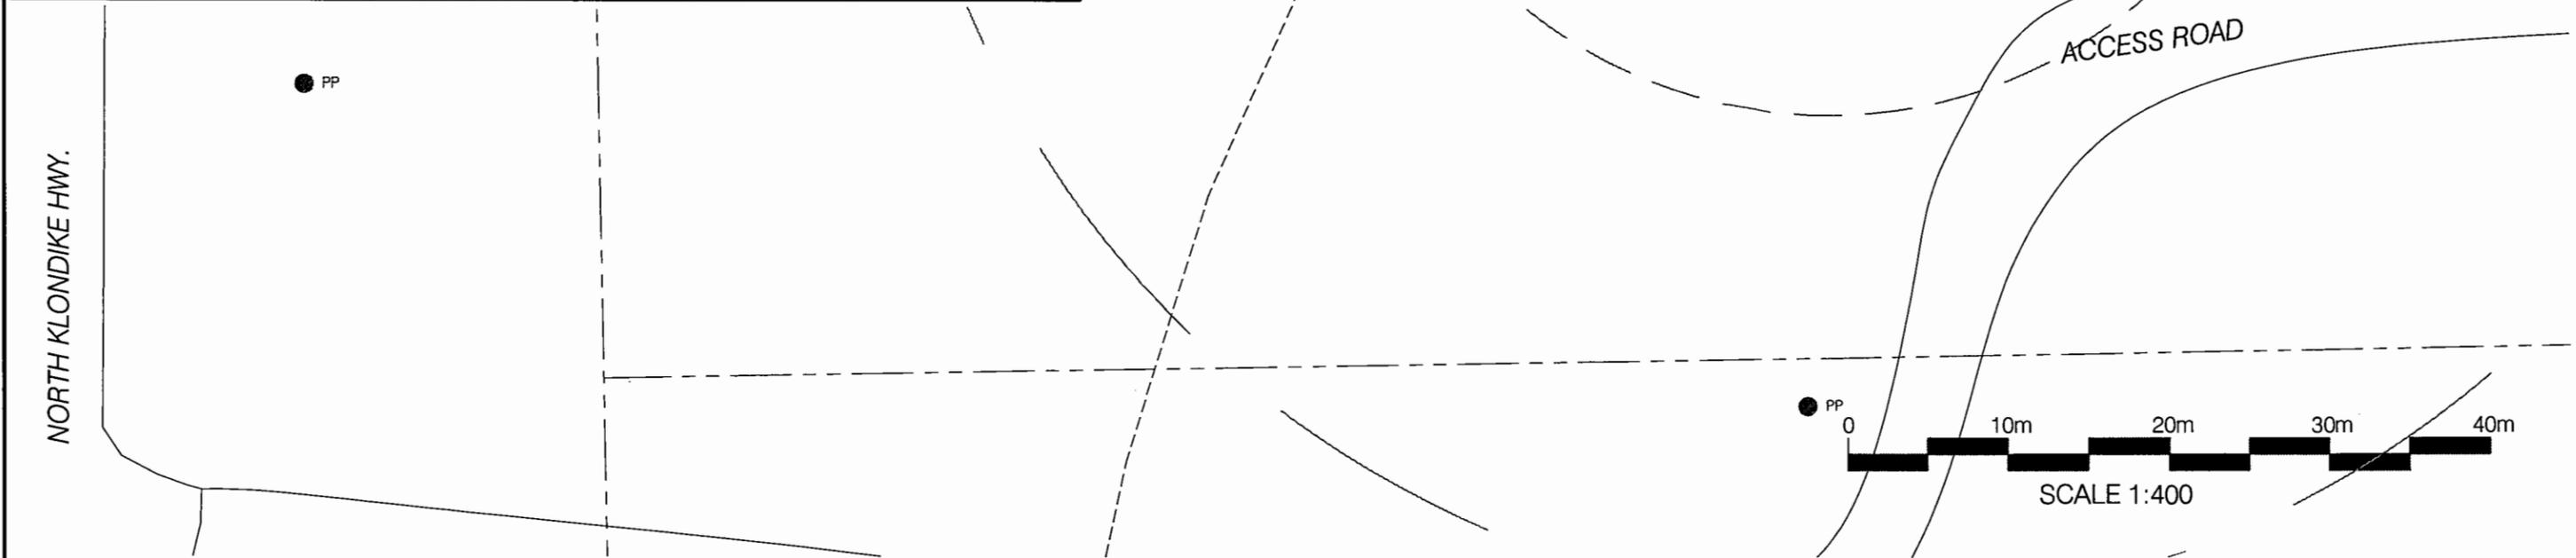
DRAWING No.
 FIGURE 6536A

The septic tank for the Carmacks Forestry Department Crew Quarters is located east of the crew quarters building (opposite to the well). The wellhead is located approximately 20 m from the septic tank. The septic tank discharges effluent to a field located east of the tank and approximately 20 m from the well. Septic field construction is unknown, however, it may consist of a leach pit. The septic tank and effluent field are both likely upgradient from the well. Figure 6536-A, located in Appendix A23, details the location of the septic system, well and other site features.

- Above ground fuel storage tank at 14 m;
- Septic Tank: 19 m (this meets existing and proposed regulation); and,
- Septic Field: starts at 20 m, which is in contravention of proposed regulation.

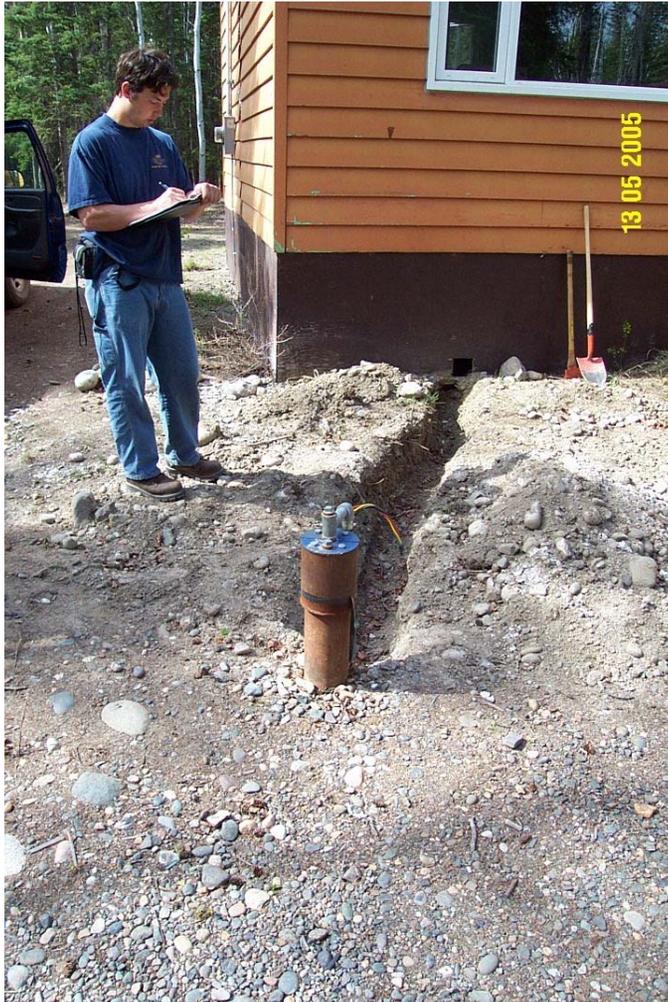
- The wellhead construction is poor. Currently all of the piping and wiring is exposed to the elements.

- There is no freeze-protection for the well or plumbing.
- The well is located directly in front of the parking area around the crew quarters and could be damaged by a vehicle.

Photo 0163: 6536 Wellhead (front) and Forestry Crew Quarters (back)

Because the well is a shallow well in close proximity to potential sources of contamination, it is recommended that a new well should be drilled:

- The new well must be located at least 30 m away from any potential source of contamination;
- The well should be equipped with a surface seal to at least 6 m and the casing should be extended above grade (500 mm) within a lockable enclosure that is not inaccessible to animals and unauthorized personnel;
- The water from the new well must meet all CDWQG health based guidelines. If there are any exceedences in the CDWQG health-based guidelines then a treatment system must be designed and installed as necessary. It is likely that a treatment and disinfection system will be recommended.
- If the new well is successful, the old well should be properly decommissioned in accordance with the Canadian Guidelines for Water Well Construction.

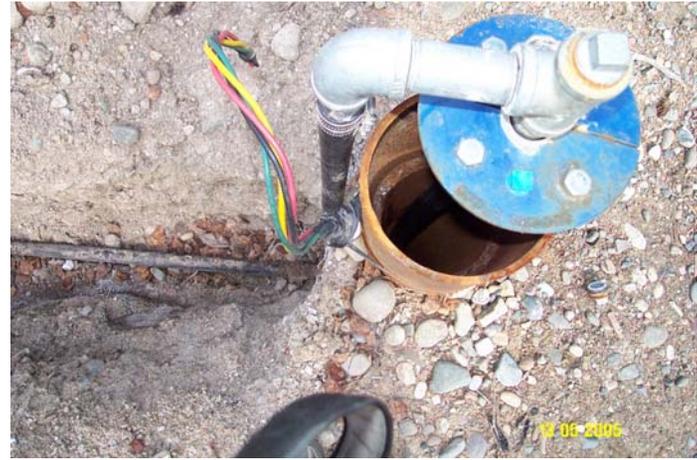
- There is no surface sanitary seal (grout or bentonite seal as required by the Canadian Groundwater Association's Well Construction Guidelines);
- By definition of the Draft Yukon GUDI Assessment Guideline, the well is potentially under the direct influence of surface water because it does not meet the requirements of the Guidelines for Water Well Construction;

Photo 0164: 6536 Wellhead

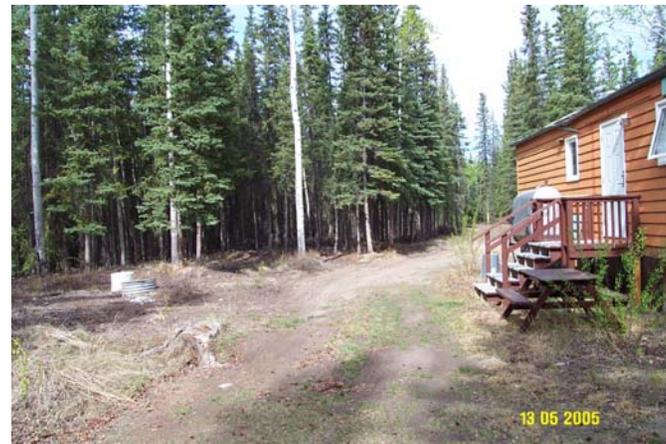
- The well is located within 30 m of potential sources of contamination. There is an above ground fuel storage tank located 14 m from the well, and there is also a septic tank and field located 20 m upgradient (inferred) from the well;

Photo 0165: 6536 Septic Field (left) and Forestry Crew Quarters (right)
