## **17.0 BUILDINGS M0064 AND M0094 CARMACKS RCMP HOUSING**

SMALL PUBLIC WATER SYSTEMS ASSESSMENT  
 WHITEHORSE REGION

## SMALL PUBLIC WATER SYSTEM ASSESSMENT

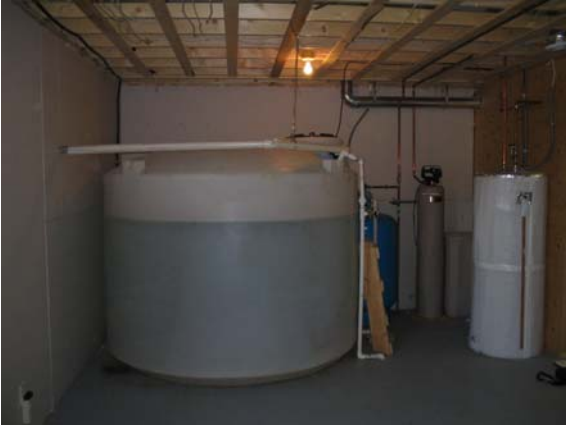
**Photo 0015:** M0064 Water System

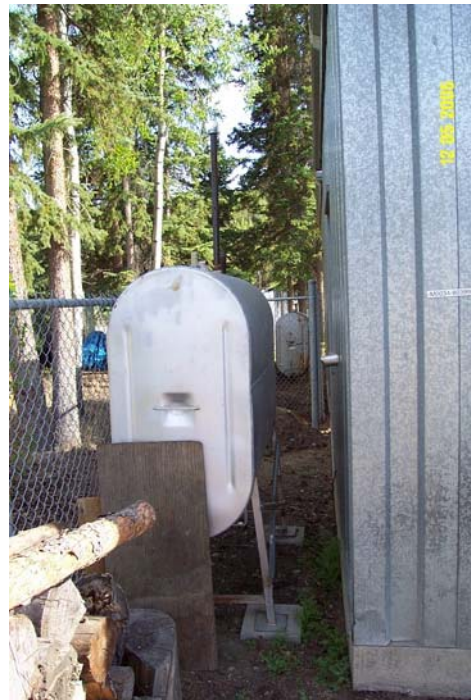
- The wellhead is located within 30 m of potential sources of contamination. There are two above ground fuel storage tanks located 18 m from the well;
- There is no surface sanitary seal (a grout or bentonite seal as required by the Canadian Groundwater Association's Well Construction Guidelines);
- By definition of the Draft Yukon GUDI Assessment Guideline, the well is potentially under the direct influence of surface water because it does not meet the requirements of the Guidelines for Water Well Construction;
- The hydrogeology of the area also indicates that there are no protective low permeability layers between the surface and the water table, and the well is likely less than 15 m deep and as thus would be considered a shallow well;
- Positive total coliform results;
- Poor surface completion of the wellhead below the basement.

**Photo 0147:** M0064 and M0094 Above Ground Heating Fuel Storage Tank

- Secondary containment should be provided for the two above ground fuel storage tanks that are approximately 18 m from the well. Alternatively, they could be replaced with double walled fuel storage tanks to mitigate any potential contamination of the well;

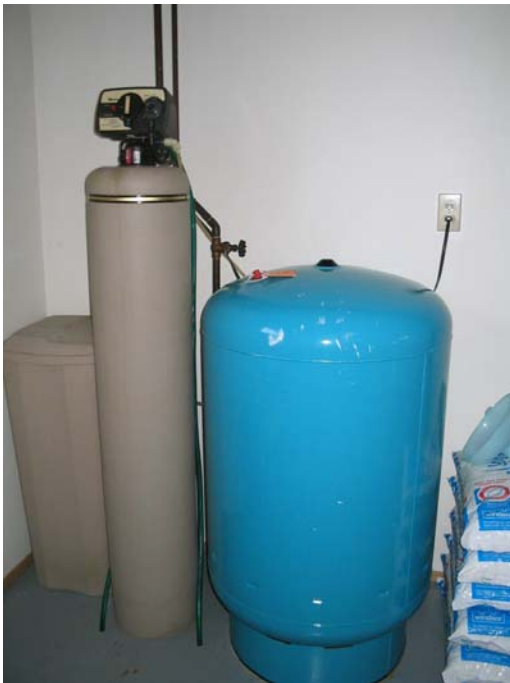
- There are existing water softeners in each residence; however it was found from the water quality results that the softener, as of October 2004, was not functional. It is possible that since that time the softener had been repaired, but it should nevertheless be ensured that both softeners are fully functional and adequate for use as pretreatment for the UV systems. Adjustment should be made to the existing softener to reduce sodium levels. Although sodium concentrations at 80 mg/L are below the CDWQG, they may be elevated for persons on sodium-reduced diets.

**Photo 0011:** M0094 Water Softener (left) and Pressure Tank (right)

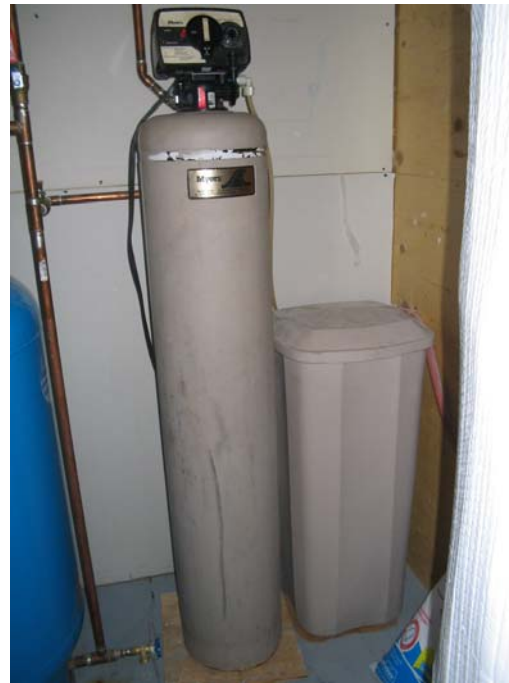
**Photo 0012:** M0064 Water Softener
