19.0 BUILDING M0201: CARMACKS RCMP HOUSING

PROJECT SMALL PUBLIC WATER SYSTEMS ASSESSMENT
WHITEHORSE REGION

| CLIENT | | TITLE WATER SYSTEM DISTRIBUTION/TREATMENT SCHEMATIC SYSTEM ID.: M0201 RCMP HOUSING | |

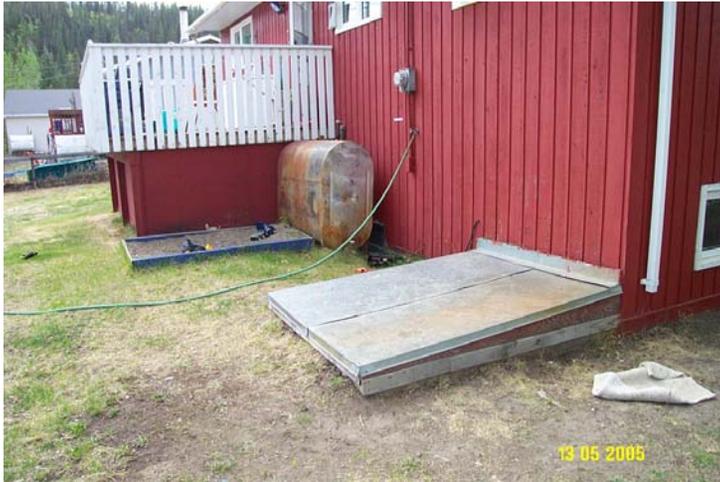
- The wellhead is located within 30 m of potential sources of contamination. There are two above ground fuel storage tanks located 3 m and 24 m from the well. In addition, there is an adjacent well 22 m from the M0201 well;

Photo 0166: M0201 Wellhead (front below paneling), R.C.M.P. Residence (behind) and Above Ground Storage Tank (center)

- A treatment system should be installed consisting of a NSF 61 certified inline filtration system capable of removing particles to 1 micron absolute and a NSF/ANSI 55 certified UV disinfection system, using the existing water softener for pretreatment. This is a conceptual design recommendation based on the information available for planning and budgeting purposes. Engineering input will be required for final system specifications;
- Further sampling will be required to determine if the softener is an adequate pretreatment system for UV disinfection; and,
- Secondary containment should be installed on the two above ground storage tanks, or they should be replaced with double walled fuel storage tanks.

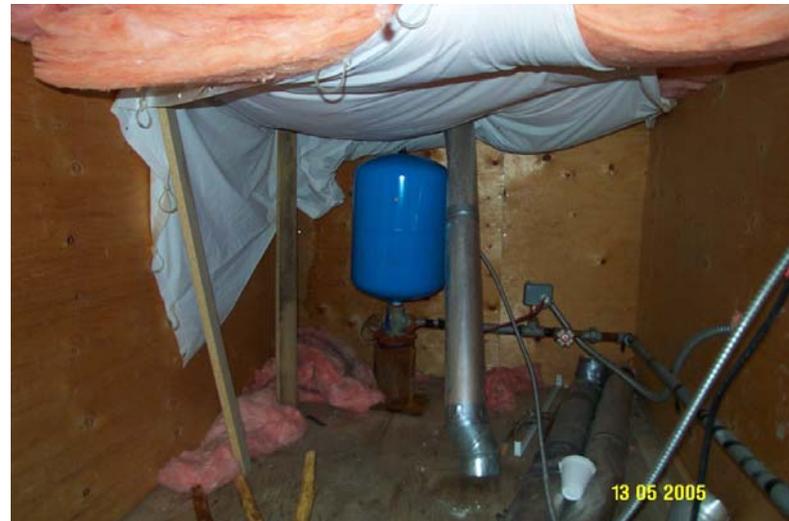
- Poor surface completion of the wellhead below ground (located in an attachment to the basement of the residence);
- There is no surface sanitary seal (grout or bentonite seal as required by the Canadian Groundwater Association's Well Construction Guidelines);

- The pressure tank is located directly on top of the wellhead. This blocks access to the well so that maintenance or proper inspection is difficult. In addition, the pressure tank is likely too small and inefficient for a residence that currently houses a family of four or five.

Photo 0167: M0201 Wellhead and Pressure Tank

- The first option involves upgrading the existing wellhead construction. In order to mitigate the high-risk deficiencies identified in this report, the water system should be upgraded by rehabilitating the wellhead construction to retrofit a surface seal to 3 m in depth (6 m would not be possible), and extend the casing to 500 mm above grade.
- The pressure tank should be relocated to a convenient location and easy access to the wellhead should be available.
