5.0 BUILDINGS M0156, M0226: PELLY CROSSING RCMP DETACHMENT AND RESIDENCE

PROJECT SMALL PUBLIC WATER SYSTEMS ASSESSMENT
WESTERN REGION

SMALL PUBLIC WATER SYSTEM ASSESSMENT

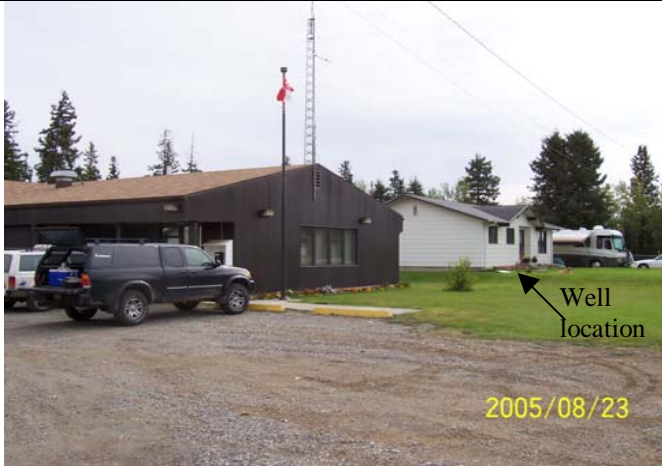
Photo 381: M0156 Pelly Crossing RCMP detachment. (left) Residence M0226 on (right).

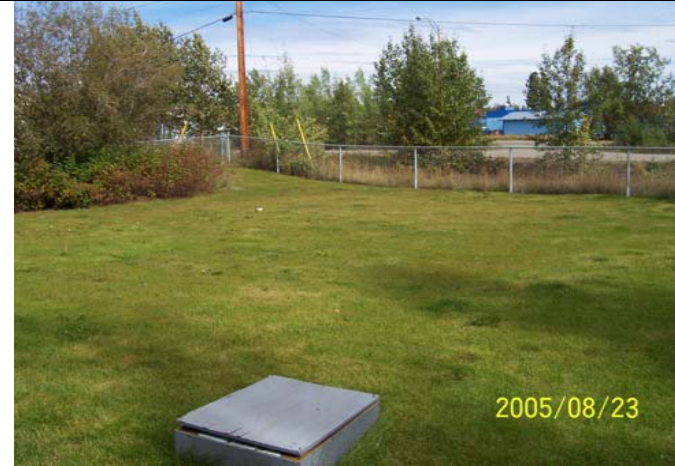
Photo 381: M0156/M0226 Well enclosure.

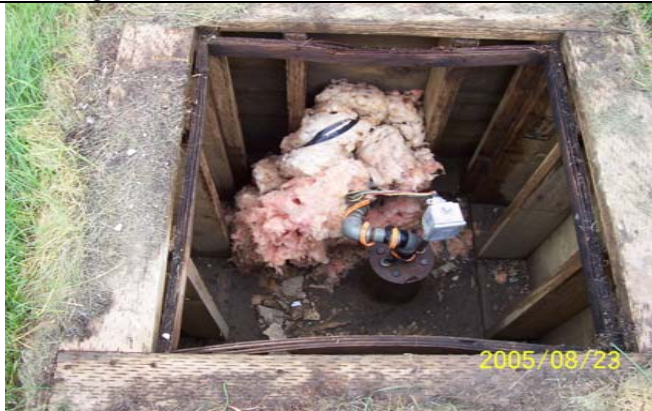
- Poor surface completion of the well (located in well pit below grade);
- There is no surface sanitary seal (grout or bentonite seal as required by the Canadian Groundwater Association's Guidelines for Water Well Construction;
- Completed at a depth of only 12.5 m, this well is considered a shallow well, and is likely completed within an unconfined aquifer;
- Elevated and variable chloride and nitrate concentrations may indicate that the aquifer is being impacted by septic effluent or surfacewater;
- By definition of the Draft Yukon GUDI Assessment Guideline, the well is potentially under the direct influence of surfacewater because it is a vulnerable type (unconfined aquifer), has a production zone less than 15 m below grade, and does not meet the requirements of the Guidelines for Water Well Construction; and,
- There is no treatment or disinfection for this water system.

Photo 379: M0156/M0226 Well enclosure and wellhead.

- The casing should be extended to at least 500 mm above the base of the well pit, and a localized near surface bentonite seal installed immediately around the wellhead;
- The well and water system should be super-chlorinated (disinfected with a 200 mg/L chlorine solution); and,
- Disinfection treatment consisting of filtration to 1 micron (absolute), and a UV system that is NSF/ANSI certified (or equivalent) should be installed within the M0226 to ensure disinfection of the water supplied to this residence and the detachment. Pretreatment consisting of a water softener would likely be necessary for optimum UV performance; the existing softener system should be serviced and brought back into operation. These are conceptual design recommendations based on the information available for planning and budgeting purposes. Engineering input will be required for final system specifications.

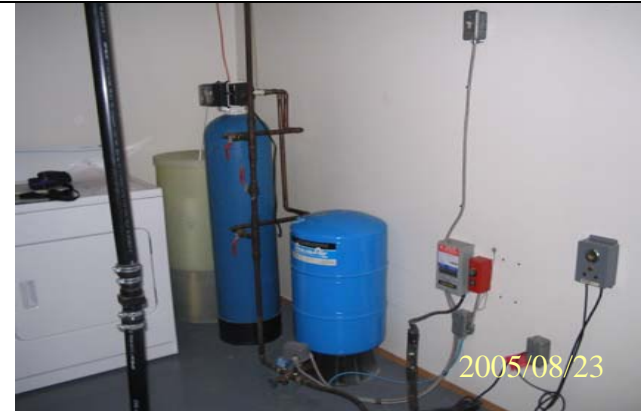
- The well is located within 30 m of an indoor fuel storage tank;
- There was a previous CDWQG MAC exceedence of copper, however two subsequent sampling events had copper below CDWQG concentrations; and,
- The water softener was not functioning at the time of the water system assessment.

Photo 199: M0156/M0226 Water System (pressure tank, pump controls, softener).
