4.0 BUILDINGS M0026, M0227: PELLY CROSSING RCMP RESIDENCES

4.1 Description of Existing Water Supply System

SMALL PUBLIC WATER SYSTEMS ASSESSMENT
 NORTHERN REGION

PELLY RCMP
 BUILDING # M0227 & M0026
 SITE LOCATION DIAGRAM
 WELL ID: M0026/M0227

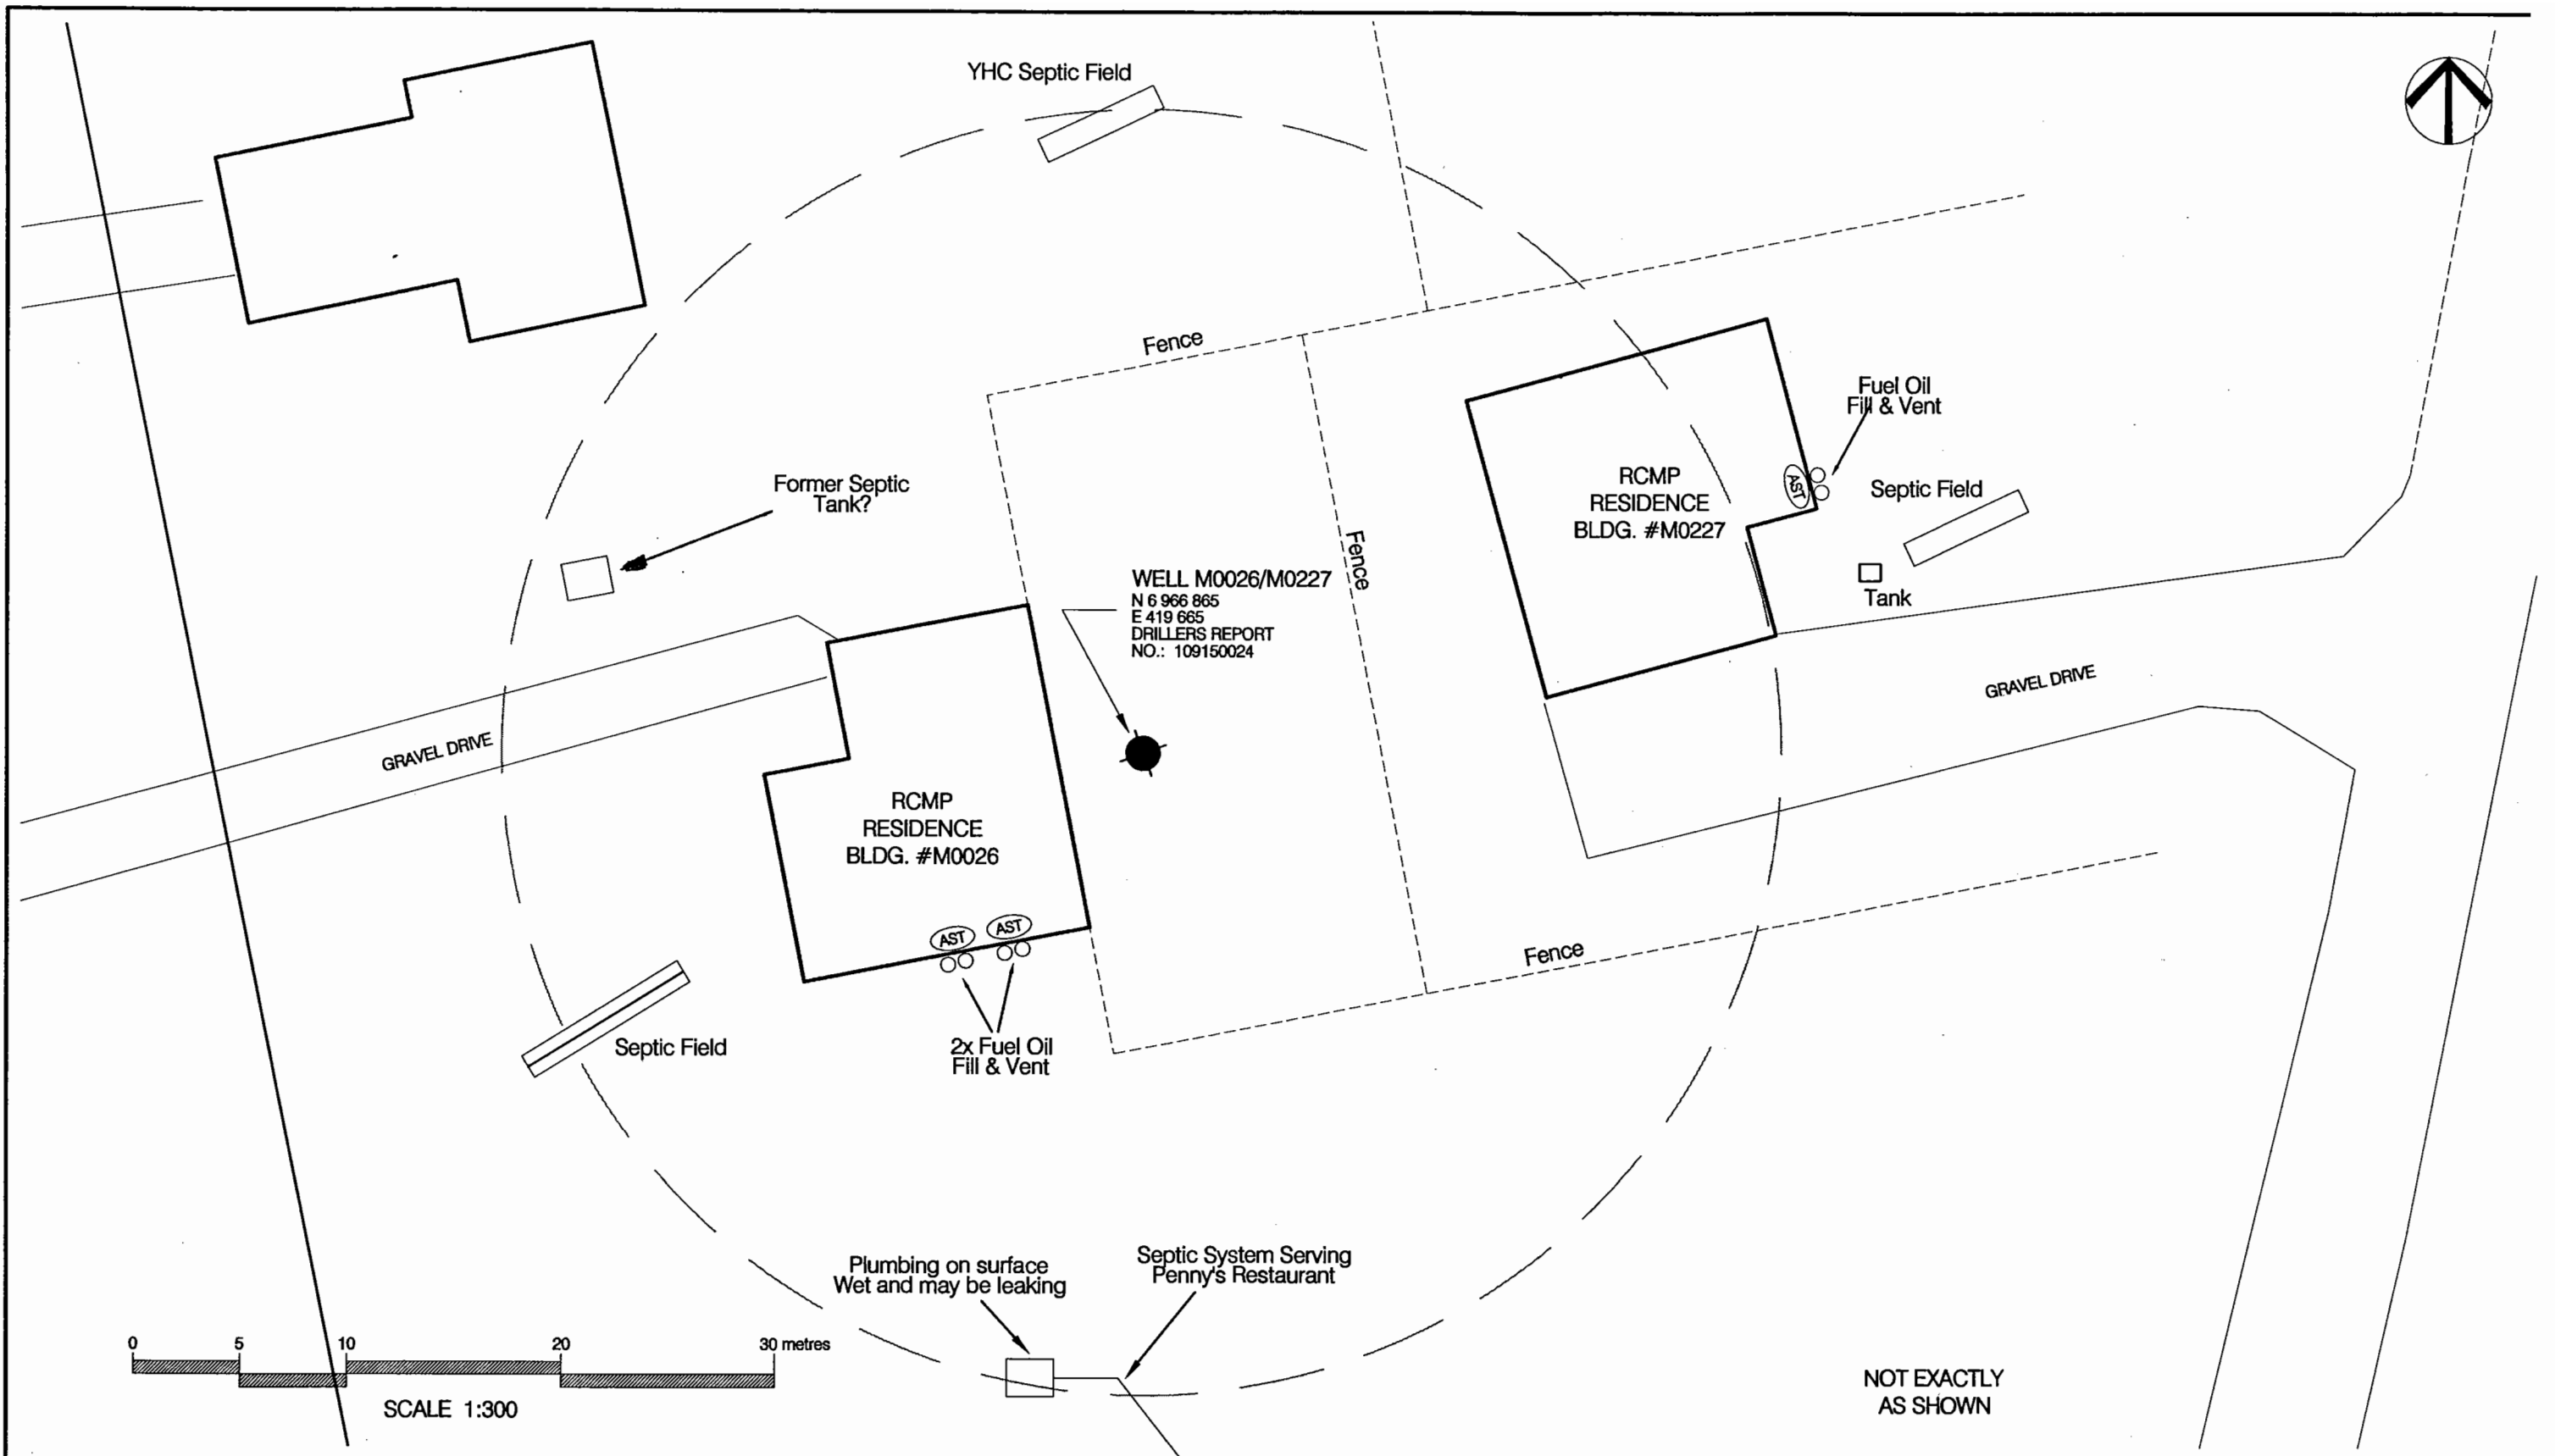
FIGURE No.
 FIGURE M0026
 /M0227-A

Each residence is served by in-ground septic disposal systems. As shown on Figure M0026-A, the septic system for residence M0227 is located greater than 30 m east of the building and likely crossgradient from the well. The septic system for residence M0026 is located on the west side of the building and septic effluent discharge likely begins approximately 25 m away and crossgradient from the well.

- On-site sewage disposal system (septic field) for the M0026 residence at 25 m;
- On-site sewage disposal system (septic field) for a neighboring house at 27 m;
- A possible former septic tank at 28 m; and
- Indoor heating oil fuel storage tanks within 30 m.

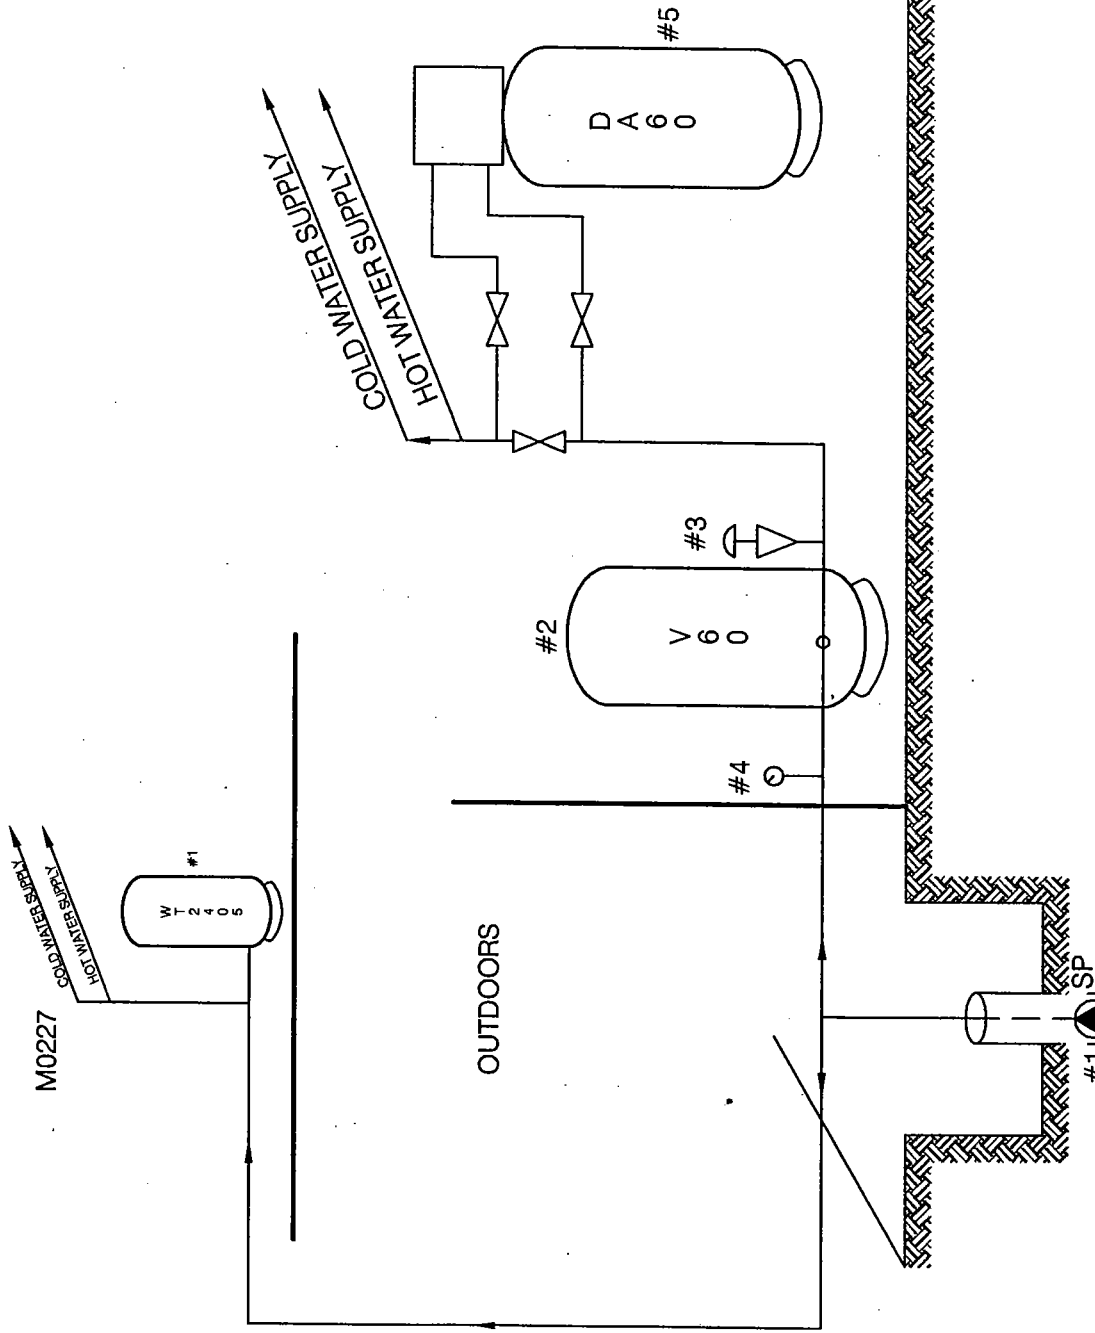
FIGURE M0026-B

Water from the well is split at the wellhead and provided to each residence through underground freeze-protected piping. There is a water softener in residence M0026, however, it was not functioning at the time of the water system assessment. Schematics detailing the water supply systems are provided as Figures M0026-B and M0227-B in Appendix A4.

RETURN SOFTNER TO OPERATION, INSTALL
FILTRATION & UV (NSF 55) 10 GPM.

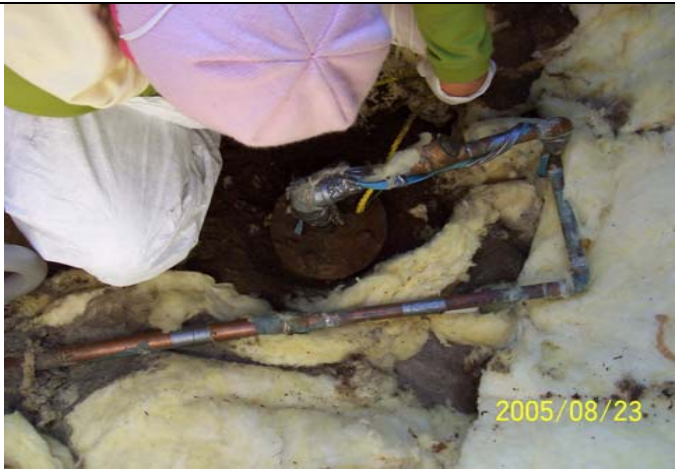
- Poor surface completion of the wellhead (located in a pit below grade);
- There is no surface sanitary seal (grout or bentonite seal as required by the Canadian Groundwater Association's Guidelines for Water Well Construction);

- The wellhead enclosure is subject to flooding (there was sediment covering the wellhead at time of water system assessment);
- The well is within 30 m of potential contaminant sources including on-site sewage disposal systems (septic fields);

Photo 385: M0026 Wellhead.

- The casing should be extended to at least 500 mm above the base of the well pit, and a localized near surface bentonite seal installed immediately around the wellhead.
- The well and water system should be super-chlorinated (disinfected with a high concentration of chlorine solution).
- Disinfection treatment consisting of filtration to 1 micron (absolute), and a UV system that is NSF/ANSI-certified (or equivalent) should be installed at each residence. Pretreatment consisting of a water softener would likely decrease the maintenance requirements for UV performance; however, it is not considered imperative, for a Priority 1 mitigation. These are conceptual design recommendations based on the information available for planning and budgeting purposes. Engineering input will be required for final system specifications.

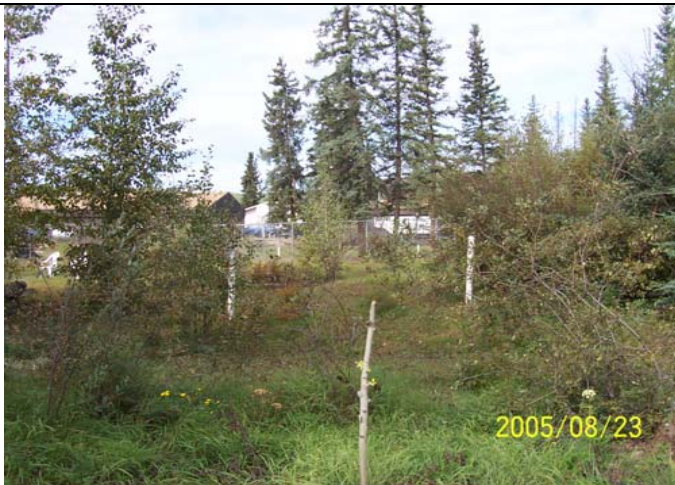
Photo 390: M0227 Septic system.
