## **10.0 BUILDING 5681: STEWART CROSSING GRADER STATION**

SMALL PUBLIC WATER SYSTEMS ASSESSMENT  
NORTHERN REGION

STEWART X-ING GRADER STATION  
BUILDING # 5681  
SITE LOCATION DIAGRAM  
WELL ID: 5681

## SMALL PUBLIC WATER SYSTEM ASSESSMENT

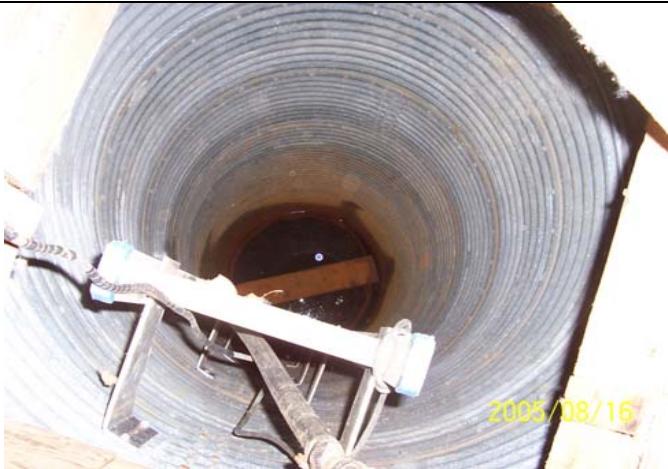
Additionally, there is an abandoned dug well on site located in a pumphouse just outside from the southeast corner of the property and approximately 110 m south of the deep well. This well has not been properly decommissioned, and could pose a safety risk in its current condition. The dug well enclosure, although it has a ladder, is not locked, and could be easily accessed by children.

**Photo 003:** Looking down abandoned dug well.

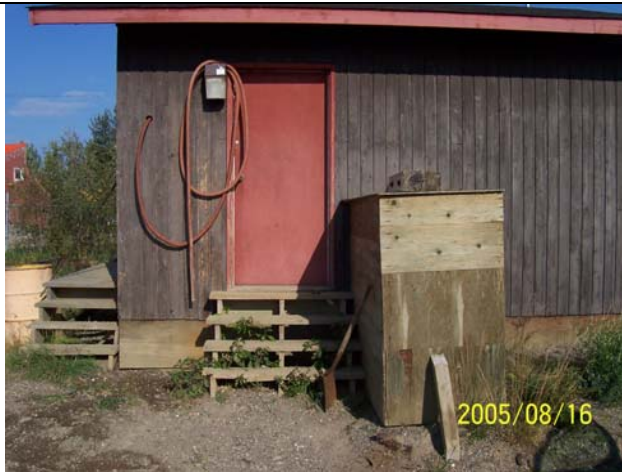
- Poor surface completion of the well. Due to insulation surrounding the wellhead it was not possible to determine the exact stick up of the well casing, however it is unlikely that the casing extends the required 500 mm above grade, and as such, could potentially be subjected to flooding and is in contravention of the regulation;
- The well is located within 30 m of potential contaminant sources including various chemical storage drums, creosote timbers, and industrial activities;
- Turbidity has been in exceedence of the both the CDWQG MAC and AO;
- The chlorine disinfection system was not in operation at the time of water system assessment;
- There is no backflow prevention between the system and on the public fill station; and,
- The pumphouse door is normally left unlocked which could pose a security issue.

**Photo 009:** 5690 Existing deep well enclosure and well house storage building.

- Standard wellhead including installation of a pitless unit and near surface sanitary seal should be completed. With a near surface sanitary seal, this well would considered to be non-GUDI.
- A chlorine tap should be installed on the wellhead and the well and water system should be super-chlorinated.

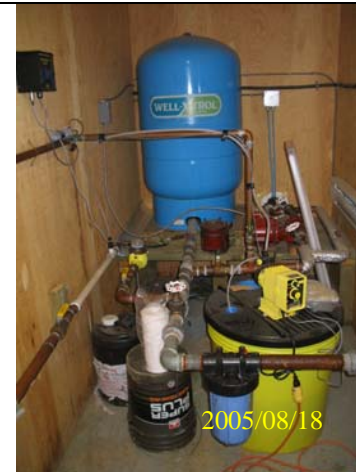
**Photo 174:** 5690 water system that serves 5681 & 5682. (pressure tank, filter, pump controls, LMI proportion feed chlorination system).

- Primary disinfection treatment consisting of a duplex commercial filtration system to filter to 1 micron (absolute) should be considered and the proportional feed chlorination system should be upgraded to ensure disinfection of the water supplied to this building. It is recommended that a digital dosing proportional feed chlorination system (or equivalent) be installed to replace the existing LMI system, as it would be more reliable and require less maintenance. The LMI system could be maintained as a back-up chlorination system (a back-up chlorination system was recommended by Niels Jacobsen in February 2003). The digital dosing type of chlorine injection system has recently been installed in most other community wells in the Yukon and would lend itself to better preparedness for equipment maintenance and replacement as well as operator training. These are conceptual design recommendations based on the information available for planning and budgeting purposes. Engineering input will be required for final system specifications.

INSTALL PROPER DRAIN FACILITY FOR  
TREATMENT SYSTEM.  
RETURN SOFTNER TO SERVICE AND  
TRAIN PERSONNEL TO OPERATE THE  
SYSTEM AND INSTITUTE CHLORINE  
RESIDUAL TESTING AT SCHEDULED  
INTERVALS. DAILY RESIDUAL TESTING  
IS RECOMMENDED.

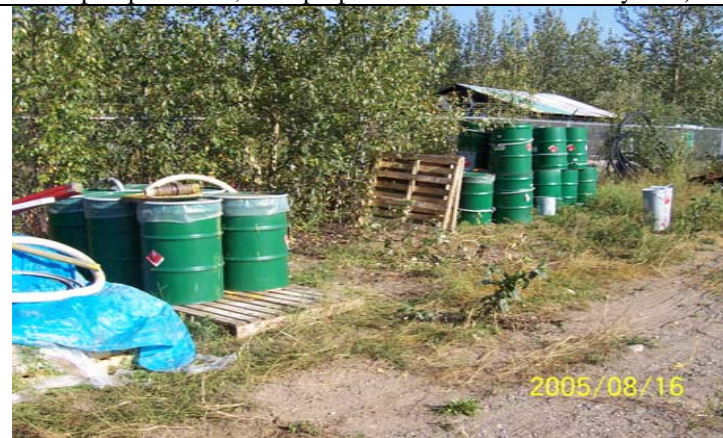
- Various drums containing paint, toluene, and other unknown chemicals within 15 m of the well;
- Creosote treated timbers at 15 m; and
- Various industrial activities occurring around the well.

**Photo 012:** Paint and toluene drum storage.

- All chemical storage and creosoted timber piles should be relocated to at least 30 m from the wellhead. Activities within 30 m of the wellhead should be regulated to ensure that hazardous chemicals are not handled or stored in proximity to the wellhead.
