9.0 BUILDING 3100: NELNAH BESSIE JOHN SCHOOL

SMALL PUBLIC WATER SYSTEMS ASSESSMENT
 WESTERN REGION

NELNAH BESSIE JOHN SCHOOL
 BUILDING # 3100
 SITE LOCATION DIAGRAM
 WELL ID: 3100A

SMALL PUBLIC WATER SYSTEM ASSESSMENT

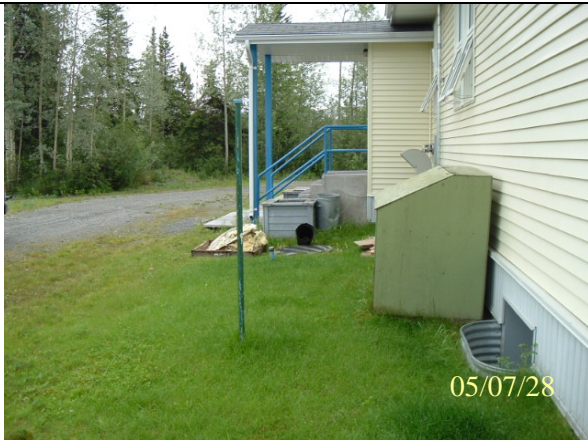
- An underground fuel storage tank (UST) at approximately 1 m; and
- A septic field potentially within 30 m (exact location unknown).

- Poor surface completion of the wellhead (located in a pit below grade);
- There is no surface sanitary seal (grout or bentonite seal as required by the Canadian Groundwater Association's Guidelines for Water Well Construction);
- By definition of the Draft Yukon GUDI Assessment Guideline, the well is potentially under the direct influence of surface water because it does not meet the requirements of the Guidelines for Water Well Construction;
- The well is located within 30 m of potential sources of contamination including an underground fuel storage tank located 1 m from the well;

Photo 0567: 3100 Wellhead in pit (back centre), underground fuel storage tank (front centre), school (right)

Priority 2 recommended upgrades include the removal of the UST located adjacent to the well. The UST should be replaced with a double walled above ground storage tank (AST) located at a safe distance from the well. Observations should be made and confirmatory sampling completed to confirm whether the existence of the UST has impacted soils in the vicinity of the tank, which could ultimately impact on the groundwater and water quality.

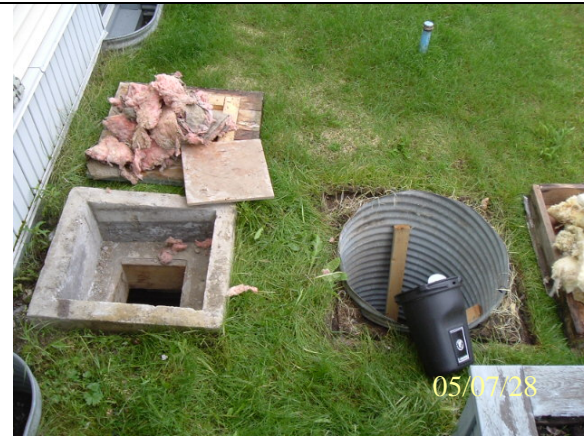
Photo 0570: 3100 Wellhead in pit (right), access enclosure (left)

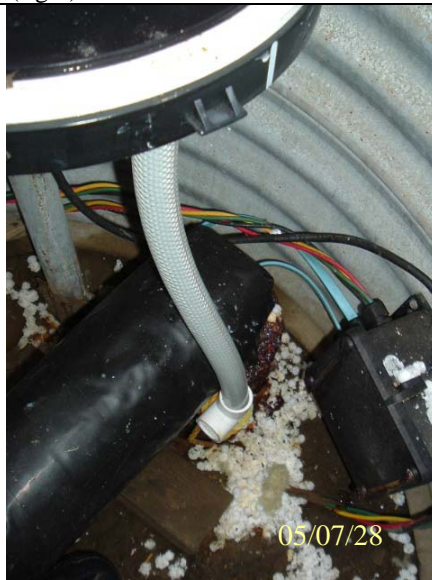
The water system is equipped with a pellet chlorinator that is installed on the wellhead, however, at the time of the assessment, it was not functioning properly as it was discharging some pellets into the wellhead enclosure (some appeared to be discharging into the well as designed). This water system is also equipped with a water softener and an activated carbon filter for treatment. Field chemistry completed during the water system assessment indicated that the residual chlorine concentration was approximately 0.07 mg/L.

THIS IS A REASONABLY GOOD INSTALLATION.
HOWEVER THE CONFIGURATION DOES NOT
MEET THE NEW REGULATION AND THE
PELLET CHLORINATORS HAVE PROVEN
TROUBLESOME FOR MAINTENANCE AND RUSTING
OUT THE CASING.

Photo 0572: 3100 Wellhead and pellet chlorinator. Note pellets in bottom of pit.

REPLACE THE PELLET CHLORINATOR WITH
PROPORTIONAL FEED CHLORINATION AND
CHANGE CHARCOAL FILTER TO MULTI-MEDIA
CONFIGURATION.

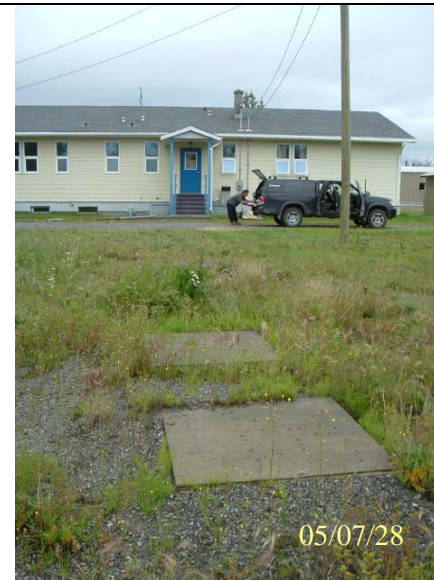
The school's septic tank is located approximately 22 m north of the well on the north side of the school as indicated in Figure 3440-A. The location of the septic effluent discharge field is unknown but it is likely located north of the tank. The location of the septic disposal system should be confirmed prior to making final decisions regarding water supply system upgrades.

Photo 0569: 3100 Septic tank (front), school (rear)

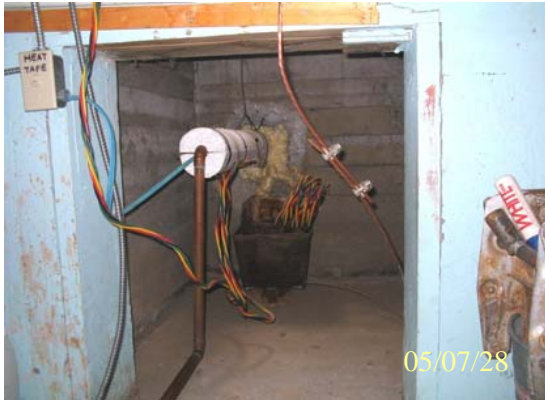
There is an abandoned well located approximately 1 m from the current well. The abandoned well did not have a proper cap.

An additional source of contamination is an abandoned and uncapped well that is located approximately 1 m from the existing well.

There is also an abandoned well in an enclosure off from
the basement of the school. Drilled April 1961, depth: 48 ft.
Abandoned well is open w/ no cap. Static water level
(measured) 13.22 m below grade.

Photo 0101: 3100 Point of entry from well (top), abandoned well under box (bottom)

- Properly decommissioning the abandoned well adjacent to the well that currently serves the building;
- Priority 1 upgrades to eliminate immediate risk would also involve upgrading the existing disinfection system to ensure that adequate disinfection is provided. Two options are presented below:
 - The first option would involve the installation of retention tanks and a proportional feed chlorine injection system with a flow meter, a chemical feeding pump, day tank, injection piping, spill containment deck and appurtenances.
 - The second option presented for Priority 1 upgrades would involve the installation of a UV disinfection system with NSF/ANSI 55 certification.

- The cost to decommission the abandoned well is estimated to be approximately **\$1,000** for materials and labour, and should be completed regardless of which disinfection treatment system is chosen.
- The estimated cost for a proportional feed chlorine injection system with appurtenances, and included disinfection of the well and water system is in the order of **\$7,000**.
- The estimated cost for an NSF/ANSI 55 certified UV disinfection system including disinfection of the well and water system by superchlorination would cost approximately **\$2,500**.
