7.0 BUILDING M0133: BEAVER CREEK RCMP RESIDENCE

SMALL PUBLIC WATER SYSTEMS ASSESSMENT
WESTERN REGION

BEAVER CREEK RCMP
RESIDENCE BUILDING # M0133
SITE LOCATION DIAGRAM
WELL ID: M0133

SMALL PUBLIC WATER SYSTEM ASSESSMENT

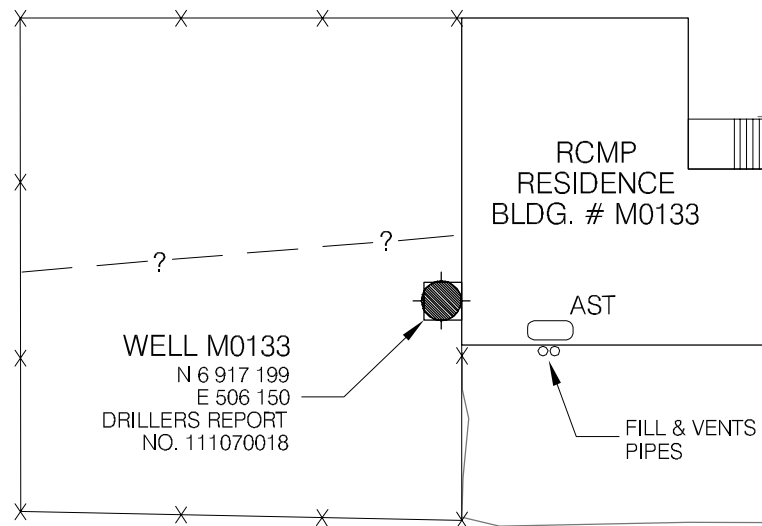
FIGURE No.
FIGURE M0133-A

The septic tank that serves the residence is located approximately 20 m west of the well, and the septic effluent discharge field is located approximately 40 m down slope from the well. Although the effluent field is downslope from the well, conceptual hydrogeology (outlined in a following section) indicates that it may be hydraulically upgradient. A site plan showing the septic system is given by Figure M0133-A in Appendix A7.

- An indoor fuel storage tank (AST) at 3 m;
- An abandoned well approximately 1 m from the well that is currently not in use; and
- A septic Tank at 20 m (note that sewage regulation allows tank to be within 15 m).

In addition, the septic field is located 40 m away from the well.

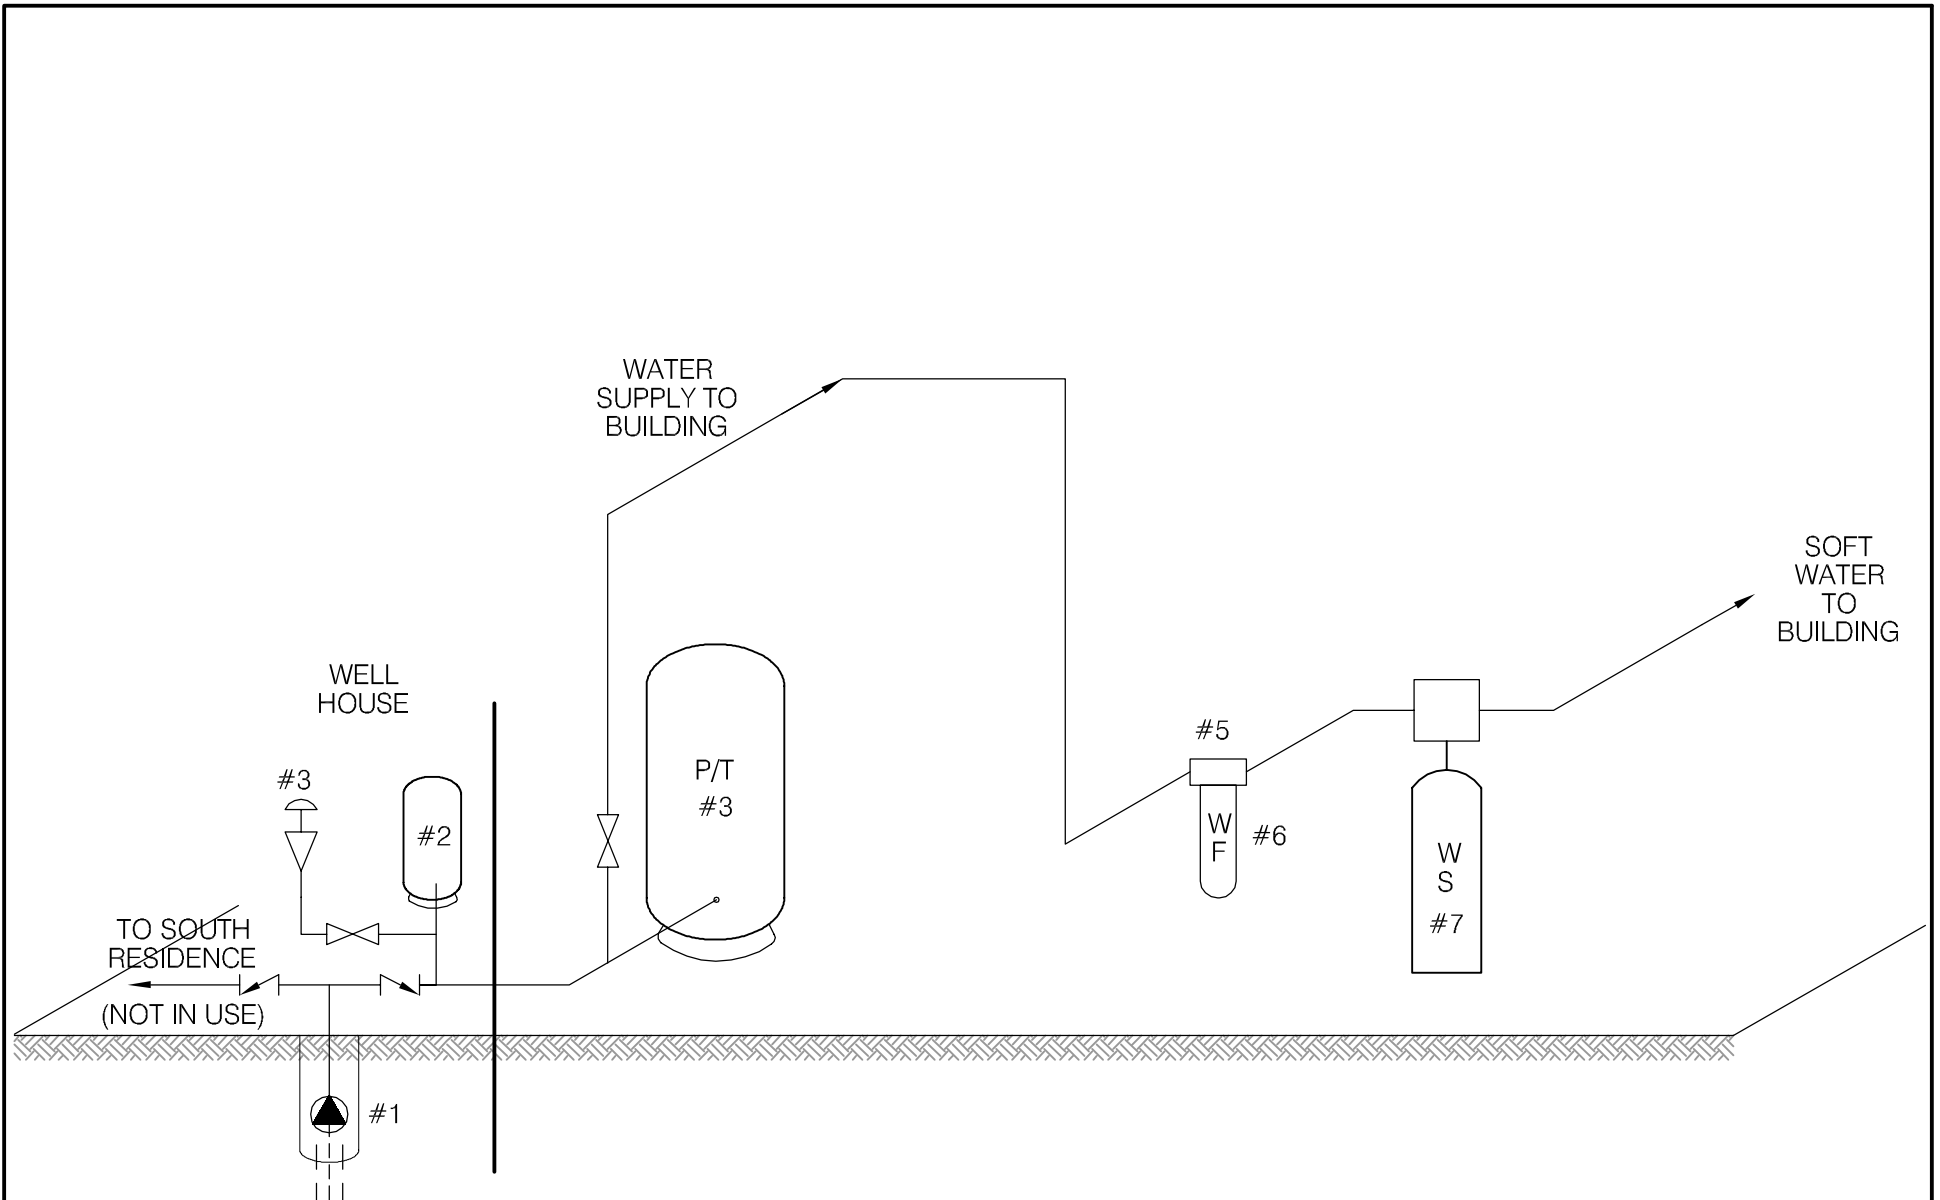
TITLE WATER SYSTEM DISTRIBUTION/TREATMENT SCHEMATIC SYSTEM ID.: M0133 BEAVER CREEK RCMP RESIDENCE	
DATE	SEPT. 2005	DWN.	JSB
CHKD.	FMM	FILE NO.	1260002.003
		DWG.:	FIGURE M0133-B

The water system is equipped with an in-line filter and a water softener, however, at the time of the assessment, the softener was being bypassed and was not functioning. The system is not equipped with a disinfection system. A schematic detailing the well supply system is provided as Figure M0133-B in Appendix A7.

- The plumbing installation was observed to be unprofessional, and the softener discharge is not to code;
- The water softener was not functioning at the time of the water system assessment;
- The in-line filter was observed to need replacing; and,
- There is an indoor fuel storage tank located in the basement of the residence, however, because the floor is concrete the potential risk of impact to the well from a spill or leak event is considered minimal.

- Upgrade plumbing to meet code;
- Repair water softener, and replace filter; and,
- Install secondary containment tray around AST.

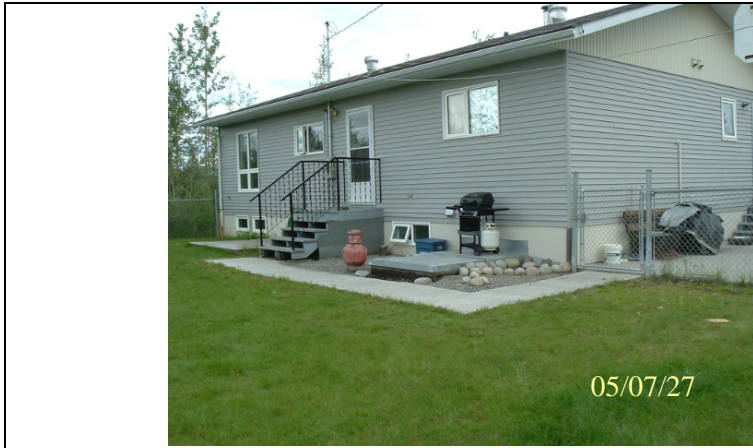
- Poor surface completion of the wellhead (located in an enclosure below grade);
- There is no surface sanitary seal (grout or bentonite seal as required by the Canadian Groundwater Association's Guidelines for Water Well Construction);
- By definition of the Draft Yukon GUDI Assessment Guideline, the well is potentially under the direct influence of surface water because does not meet the requirements of the Guidelines for Water Well Construction.
- The well is located within 30 m of potential sources of contamination including: an abandoned well that is not equipped with a proper cap and is located within 1 m of the current well, and an AST located in the basement of the building; and,
- There is no disinfection system.

Photo 0545: M0133 Beaver Creek RCMP Residence from rear, wellhead enclosure (front centre)

- The wellhead at M0131 should be extended to a minimum of 500 mm above the surrounding grade, and the well pit should be backfilled with a low-permeability material to provide a surface seal around the well casing. A surface sanitary seal (grout or bentonite) should be installed as deep as possible during wellhead improvements.

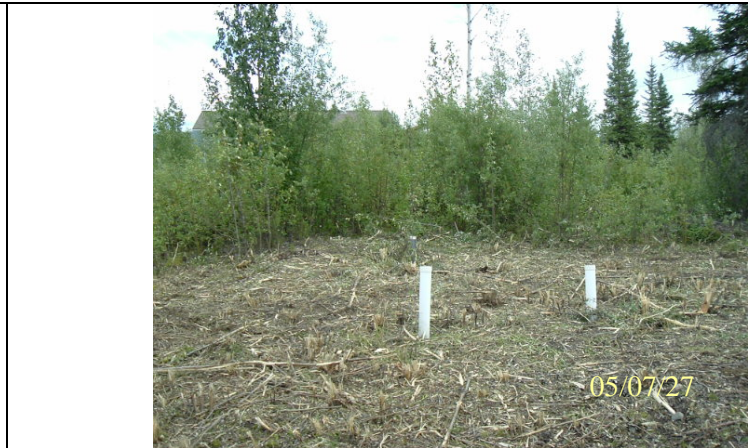
Photo 0544: M0133 Septic field

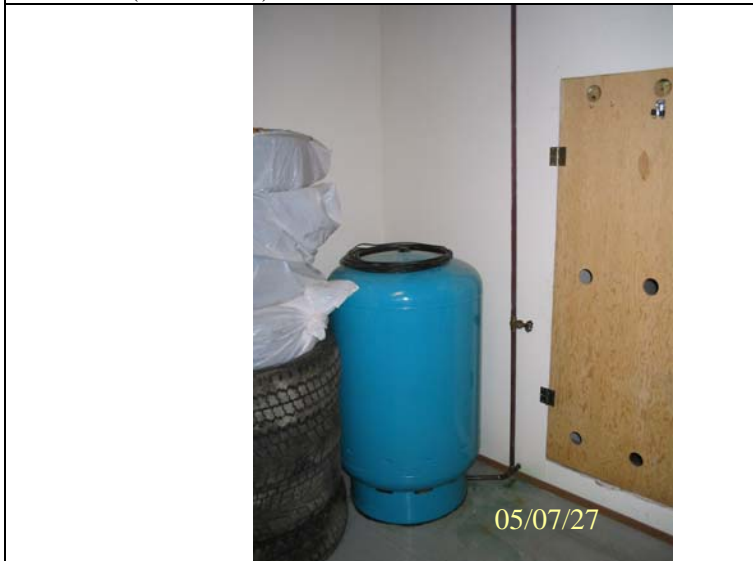
Photo 0089: M0133 Pressure tank

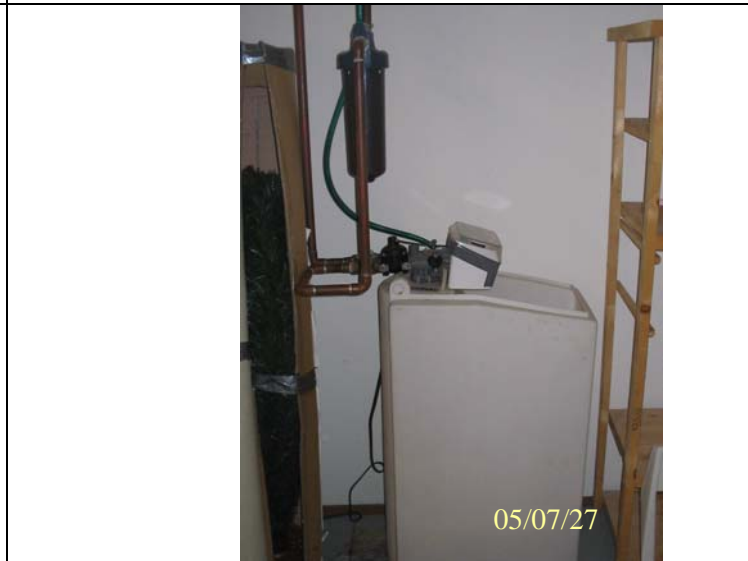
THE PIPING AT WELL HEAD IS UNPROFESSIONAL.
THE WATER SOFTENER IS NOT OPERATIONAL
AND THE INLINE FILTER IS IN NEED OF
CHANGING.
THE SOFTNER DRAIN IS NOT TO CODE.

Photo 0090: M0133 In-line filter and water softener

REPAIR WATER SOFTENER AS NECESSARY IN
PUT BACK INTO SERVICE. CHANGE INLINE
FILTER. REPIPE SOFTNER DRAIN TO CODE.
BRING WELL HEAD PIPING TO CODE.
