### **13.0 BUILDING 3123: BEAVER CREEK GRADER STATION**

SMALL PUBLIC WATER SYSTEMS ASSESSMENT  
WESTERN REGION

## SMALL PUBLIC WATER SYSTEM ASSESSMENT

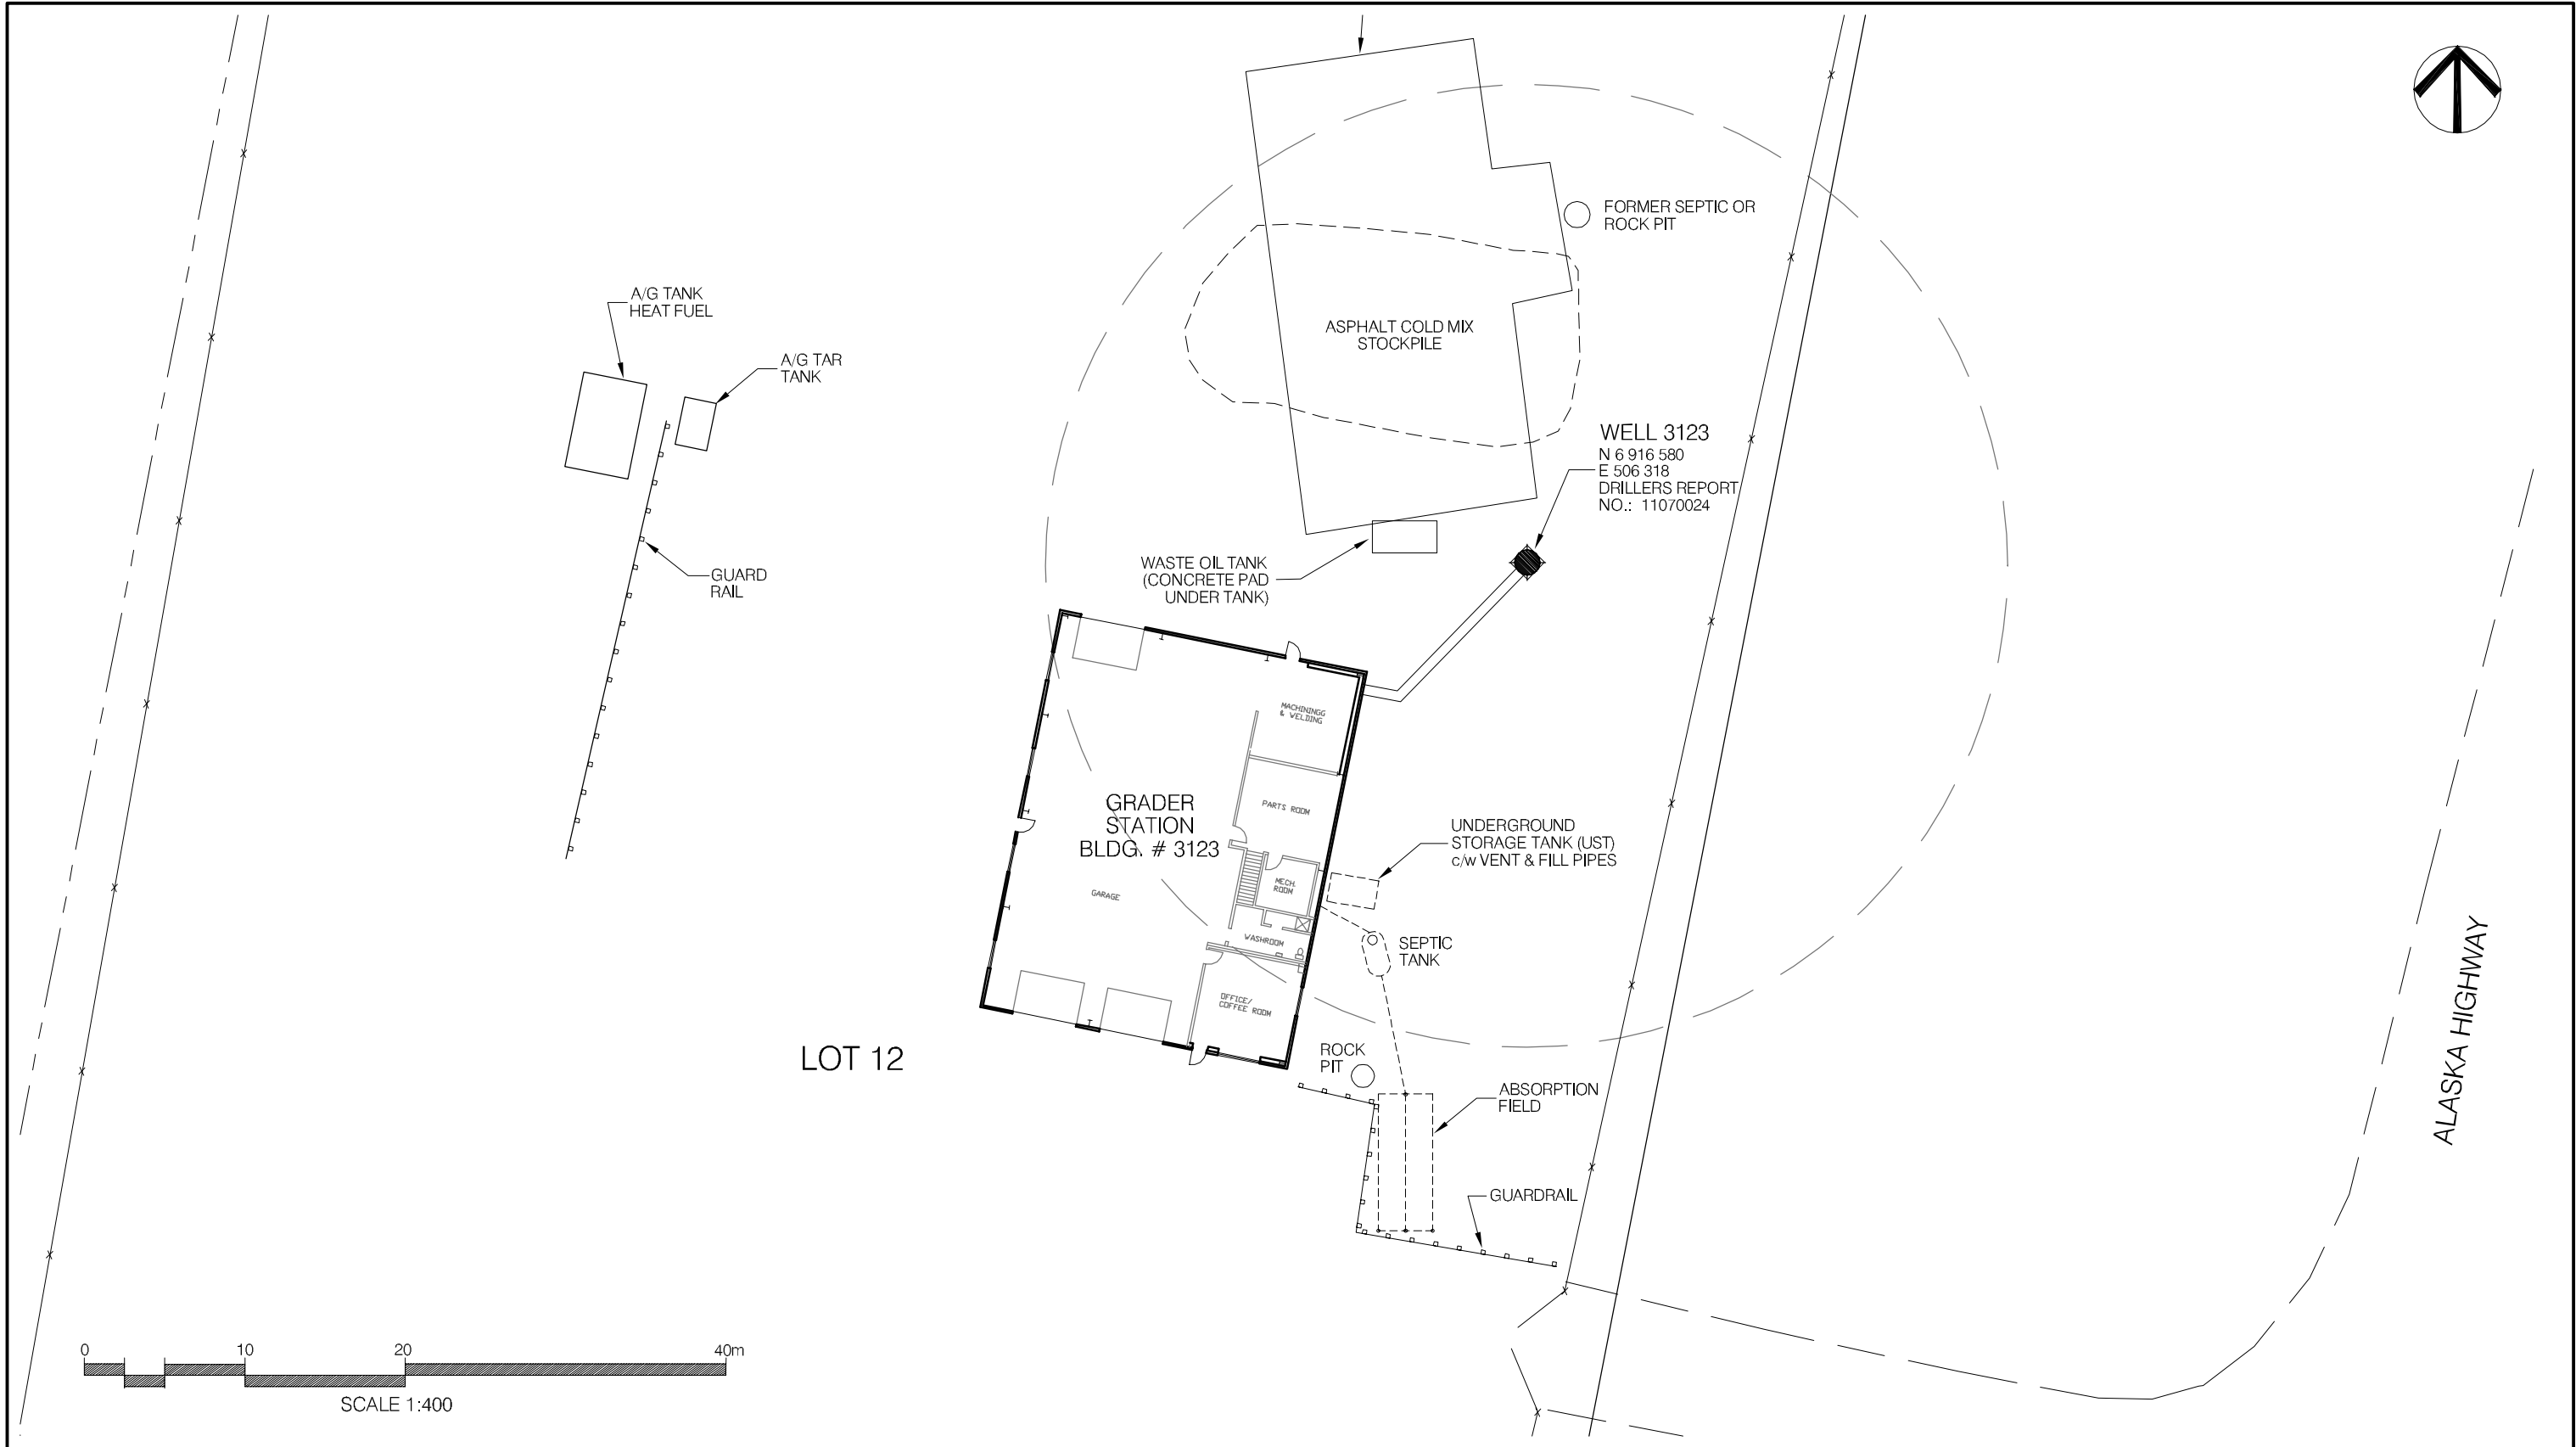
REVISION ISSUE  
0  
FIGURE No.  
FIGURE 3123-A

There is a septic tank present at the southeast corner of the building approximately 20 m from the well. Septic effluent is discharged to an in ground disposal field south of the tank approximately 34 m from the well and potentially upgradient of the well. There is a rock pit that is used to drain the garage sumps located approximately 34 m south that is also potentially up gradient from the well. There is also an old abandoned septic tank and field approximately 22 m north and likely downgradient from the well. A site plan showing the septic system is provided as Figure 3123-A in Appendix A13.

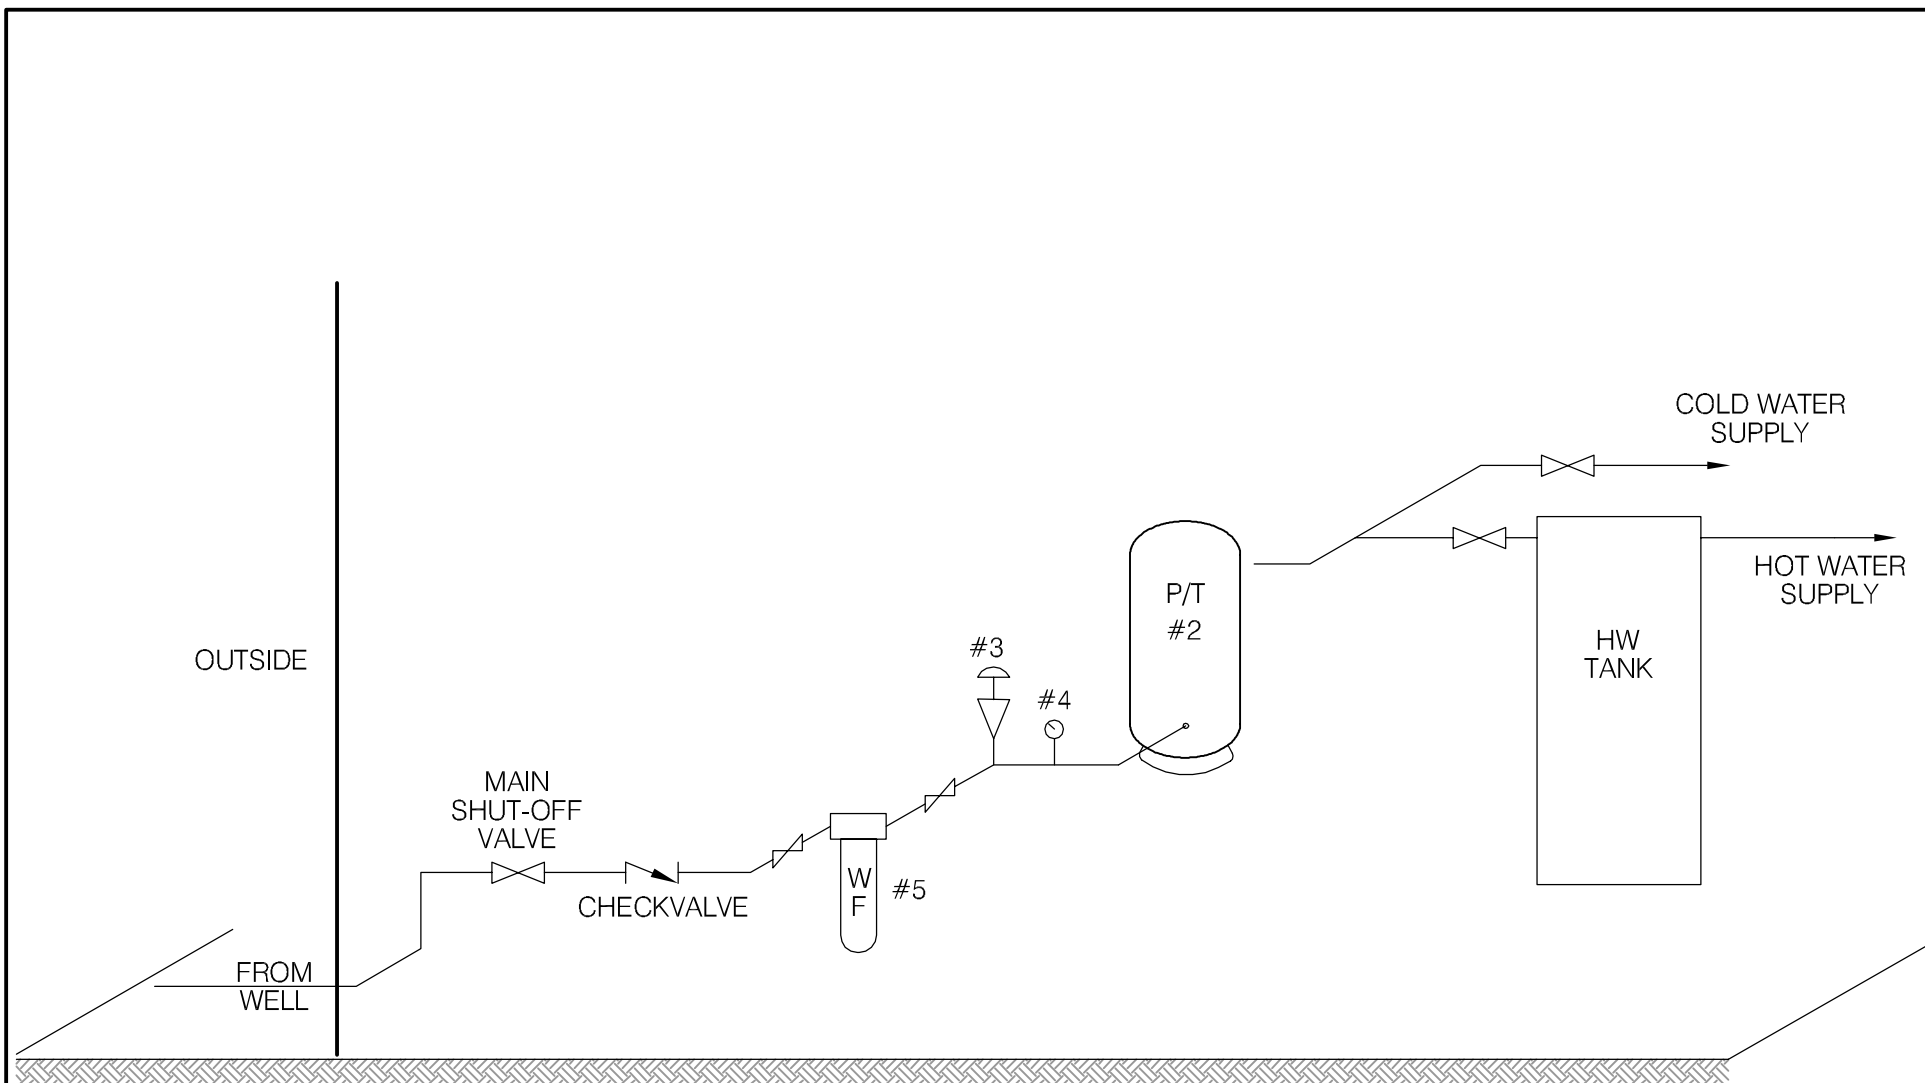
<div>Yukon Highways and Public Works Property Management Branch</div>			TITLE WATER SYSTEM DISTRIBUTION/TREATMENT SCHEMATIC SYSTEM ID.: 3123 BEAVER CREEK GRADER STATION						
DATE	SEPT. 2005	DWN.	JSB	CHKD.	RMM	FILE NO.	1260002.003	DWG.:	FIGURE 3123-B

There is an inline filter (5 micron cartridge) present, but there is otherwise no treatment or disinfection system for the water supplying the grader station maintenance garage. A schematic detailing the well supply system is provided as Figure 3123-B in Appendix A13.

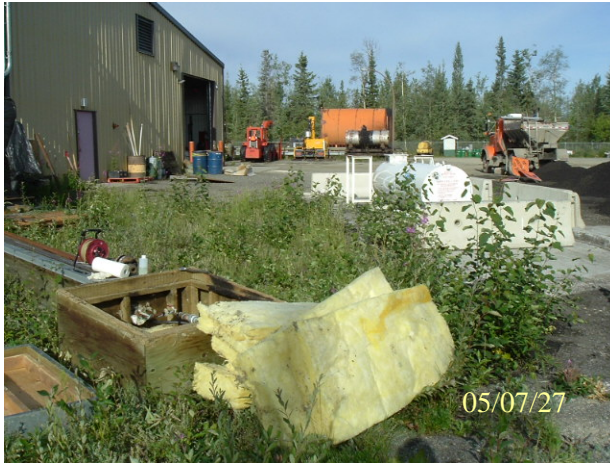
- The well is located within 30 m of potential sources of contamination, including an above ground used oil storage tank at 7 m and an asphalt cold mix pile at 8 m;

**Photo 0518:** 3123 Beaver Creek Grader Station maintenance garage (back left), wellhead (front left), above ground used oil storage tank (back right)

- Standard wellhead upgrades to raise casing to at least 500 mm above grade and retrofit a surface sanitary seal (grout or bentonite as deep as possible);
- Relocate AST;
- Relocate UST;
- Relocate cold mix asphalt pile; and,
- Decommission former leach pit.

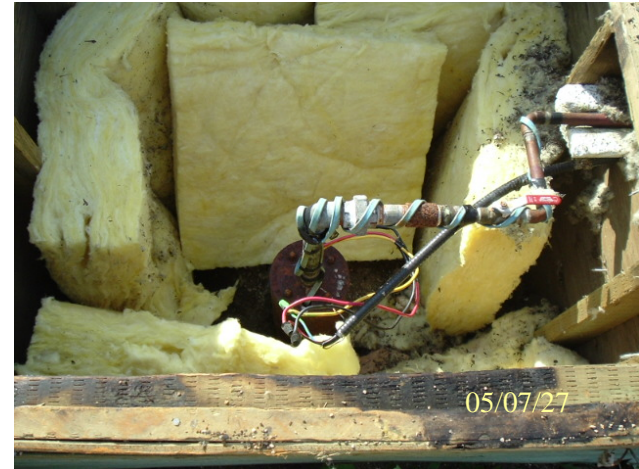
- Poor surface completion of the well (located in a PWF wooden enclosure and casing only extends 100 mm above grade);
- There is no surface sanitary seal (grout or bentonite seal as required by the Canadian Groundwater Association's Guidelines for Water Well Construction);

**Photo 0516:** 3123 Wellhead in enclosure

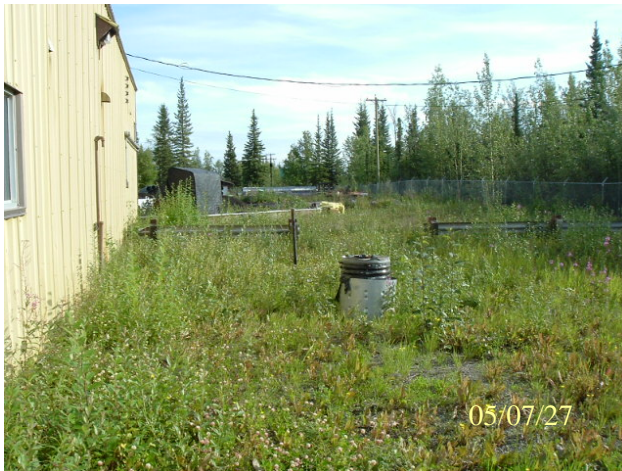
- There is a former rock pit or septic leach pit located 22 m upgradient from the well;
- It was reported by grader station employees that there had previously been a break in the septic line or discharge line to the rock pit (they were unsure which) within 30 m of the well; and,

**Photo 0520:** 3123 Leach pit (centre), maintenance garage (left), wellhead enclosure (back centre)

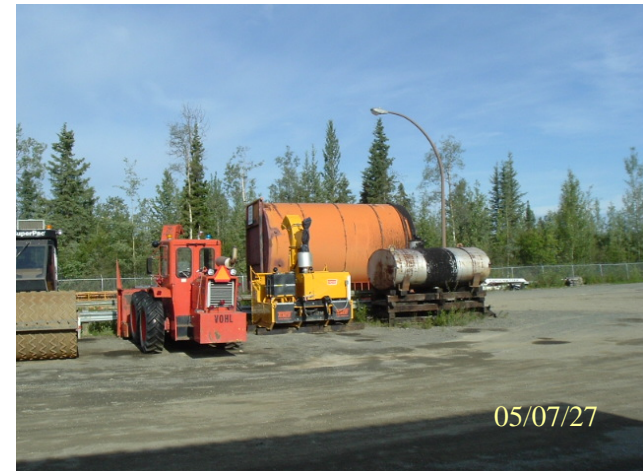
**Photo 0515:** 3123 Heating fuel and tar above ground storage tank

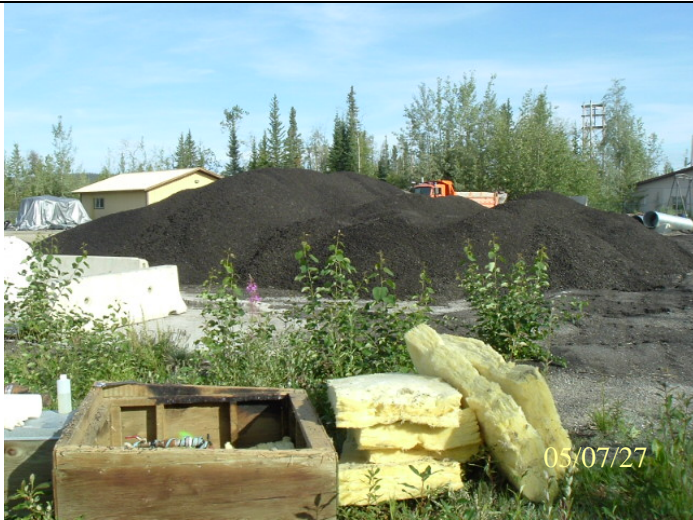
**Photo 0519:** 3123 Cold mix asphalt pile (rear), wellhead enclosure (front left)

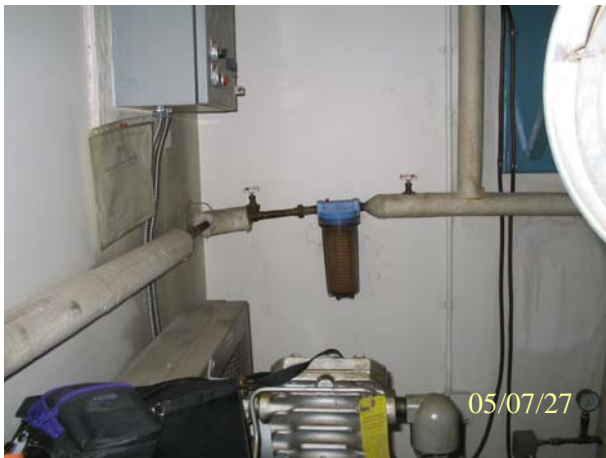
**Photo 0073:** 3123 In-line filter

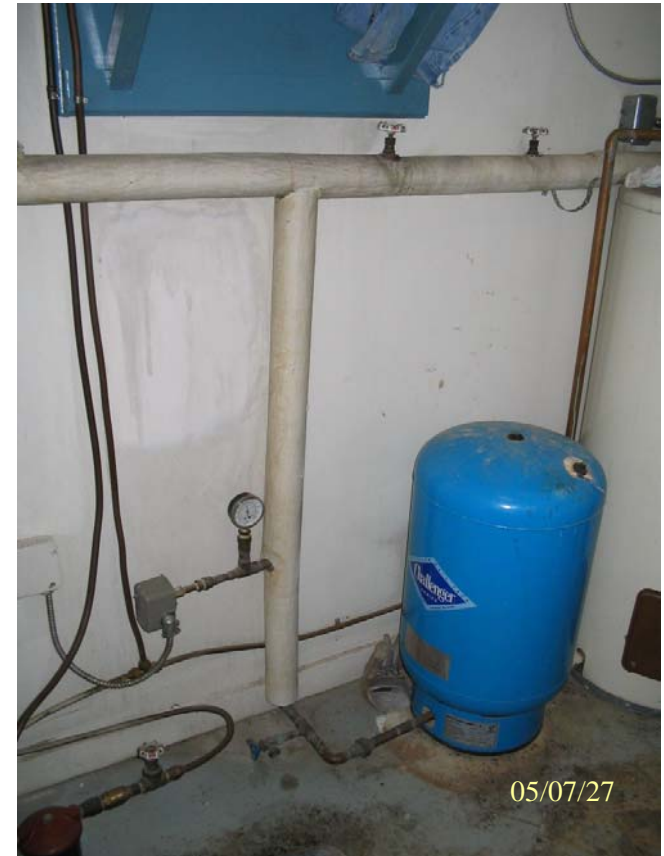
**Photo 0074:** 3123 Pressure tank and pump controls
