8.0 BUILDING M0134: BEAVER CREEK RCMP RESIDENCE

SMALL PUBLIC WATER SYSTEMS ASSESSMENT
WESTERN REGION

BEAVER CREEK RCMP
RESIDENCE BUILDING # M0134
SITE LOCATION DIAGRAM
WELL ID: M0134

SMALL PUBLIC WATER SYSTEM ASSESSMENT

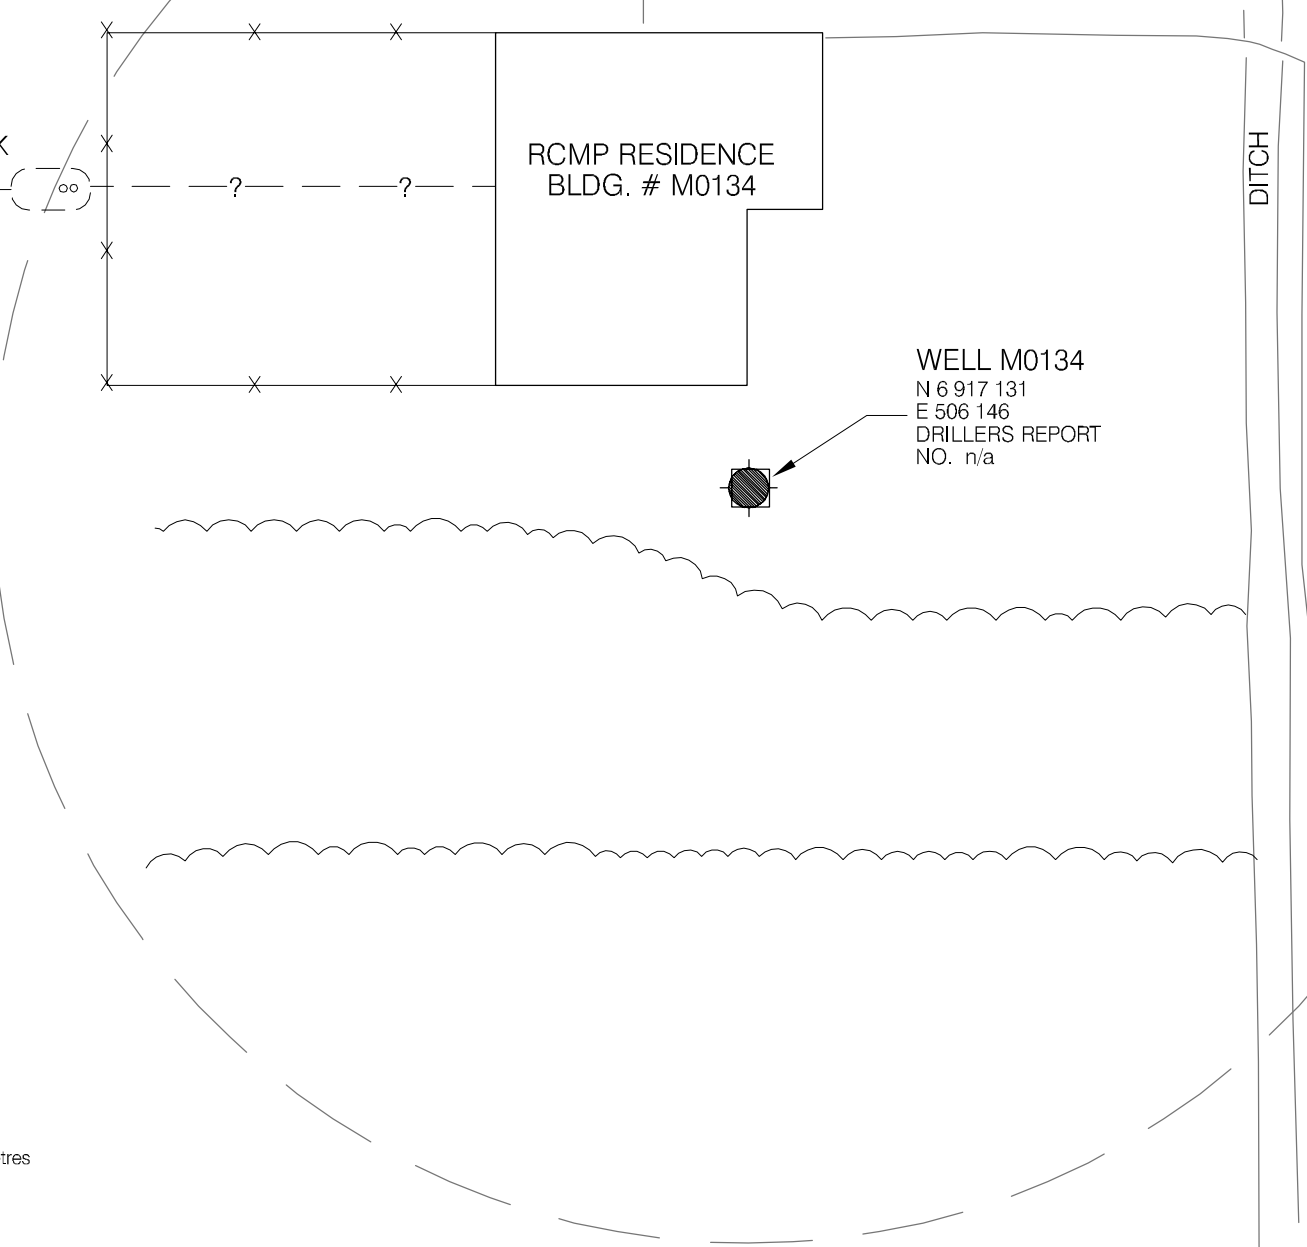
FIGURE No.
FIGURE M0134-A

There is a septic tank located west of the residence approximately 28 m northwest of the well. Septic effluent is discharged to the west of the tank in a septic field beginning at approximately 34 m from the well. Figure M0134-A in Appendix A8 gives a site plan showing the septic system.

In addition, a septic tank is located 28 m away from the wellhead, and a septic field is located 34 m away.

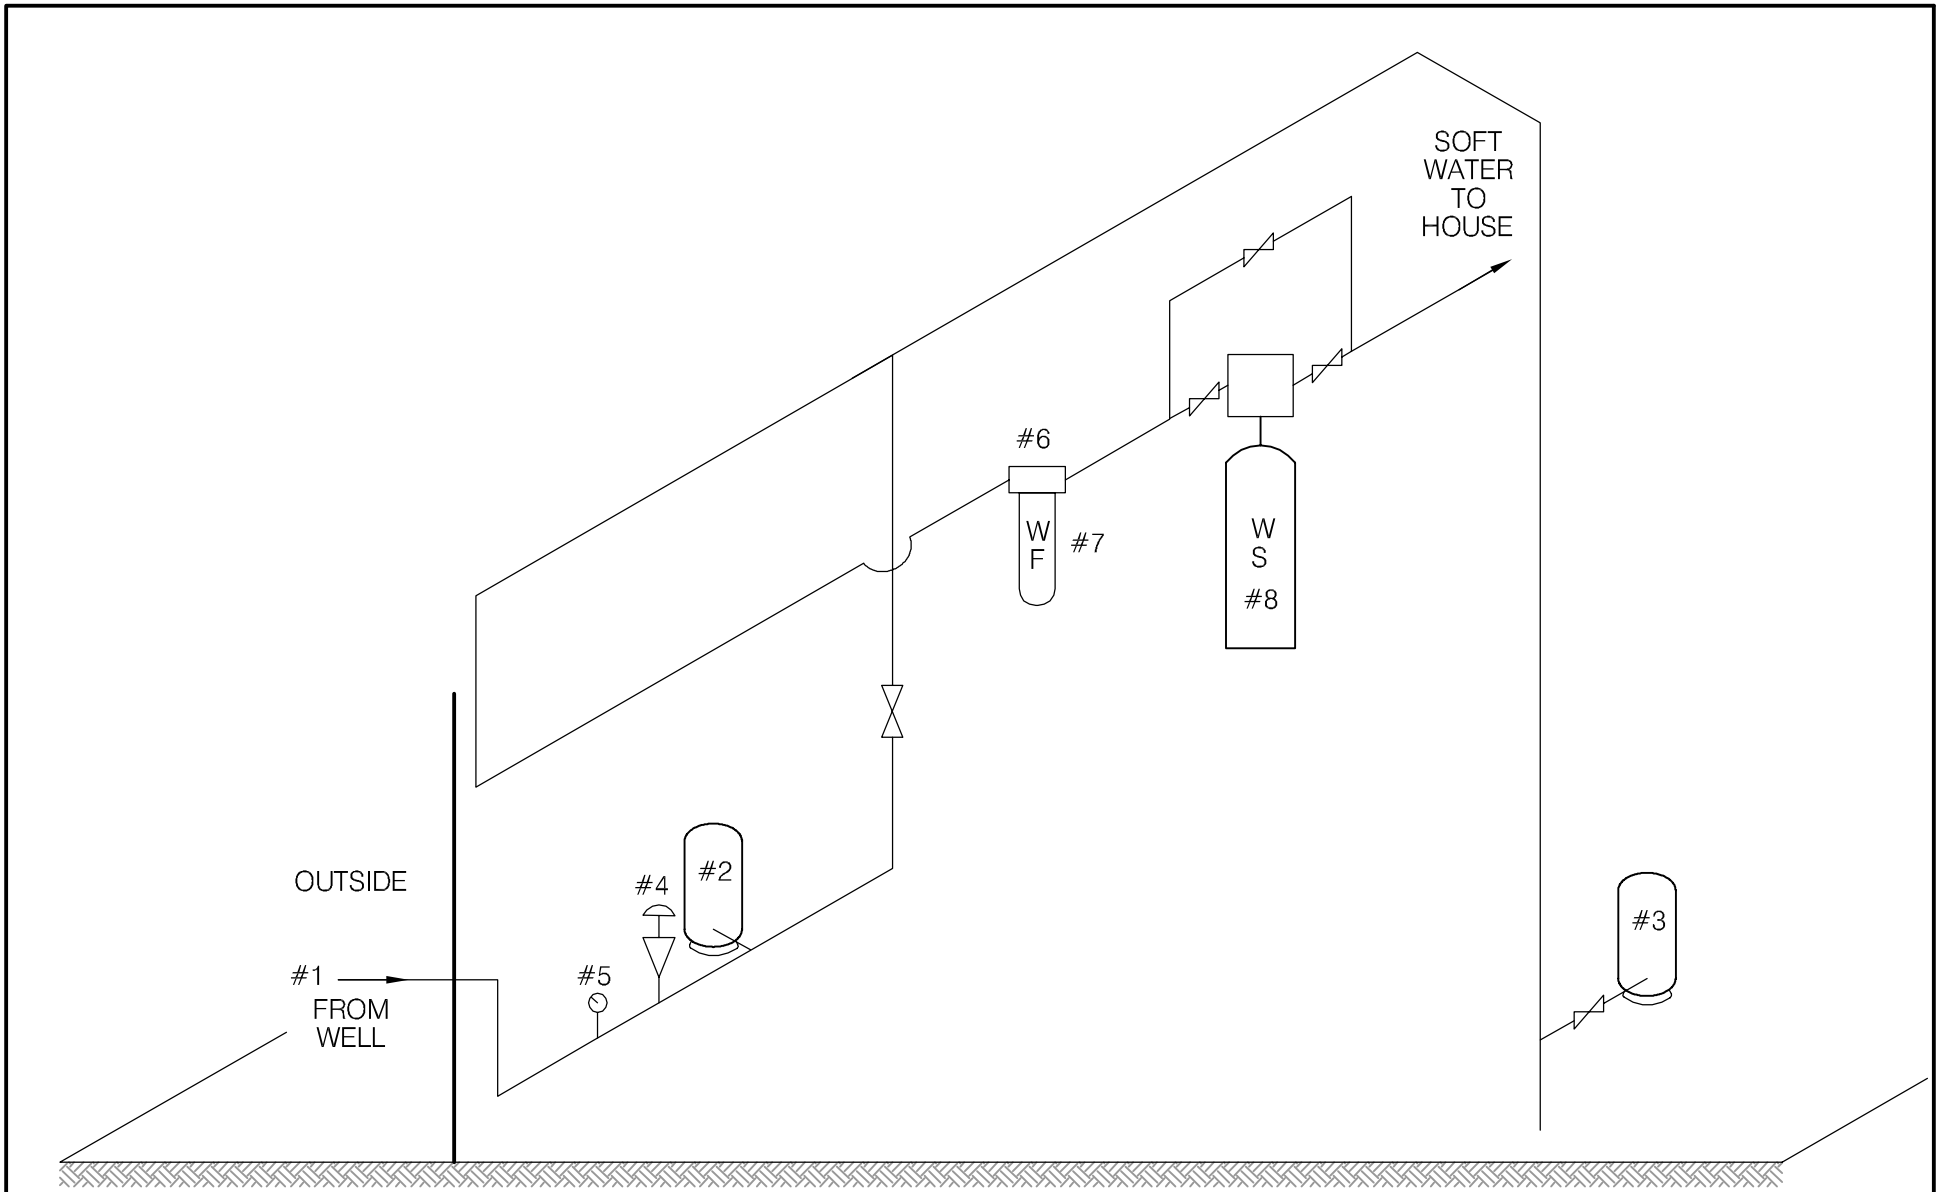
TITLE WATER SYSTEM DISTRIBUTION/TREATMENT SCHEMATIC SYSTEM ID.: M0134 BEAVER CREEK RCMP RESIDENCE							
DATE	SEPT. 2005	DWN.	JSB	CHKD.	FMM	FILE NO.	1260002.003	DWG.:	FIGURE M0134-B

The water system is equipped with a water softener and an in-line filter, but both were reportedly not functioning properly at the time of the water system assessment. There is no disinfection system present. A schematic detailing the water supply system is provided as Figure M0134-B in Appendix A8.

- The in-line filter and water softener are both in poor condition. Water quality results and observations made during the water system assessment conclude that the water softener is not functioning properly; and,
- The softener drain is not installed to code.

INSIDE INSTALLATION IS OF GOOD QUALITY.
INLINE FILTER AND WATER SOFTENER IS IN
VERY BAD CONDITION.
SOFTENER DRAIN NOT TO CODE.

- Upgrade plumbing to meet code;
- Repair water softener, and replace filter; and,
- Install secondary containment tray around AST.

REPAIR SOFTENER & INLINE FILTER AS
NECESSARY TO PROVIDE PRETREAT FOR UV
SYSTEM. INSTALL UV SYSTEM FOR
APPROPRIATE FLOW.
INSTITUTE BI-ANNUAL WELL MAINTENANCE
PROGRAM. MAINTAIN TREATMENT SYSTEM
IN WORKING ORDER.

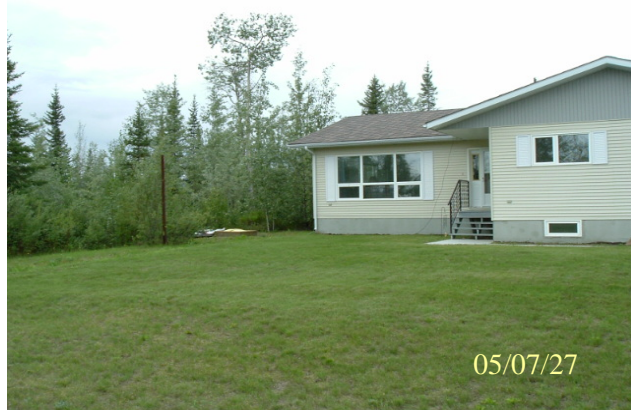
Photo 0549: M0134 Beaver Creek RCMP Residence (right), wellhead enclosure (left)

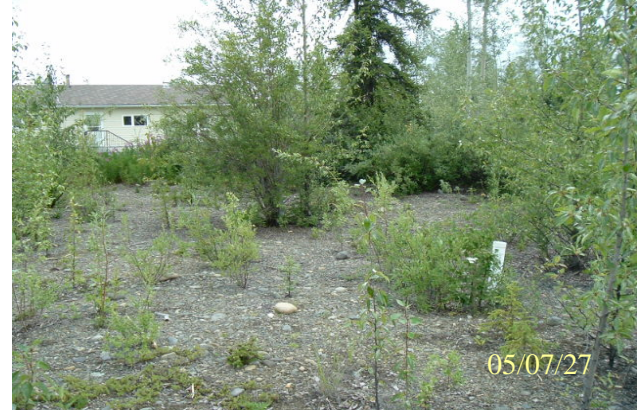
Photo 0547: M0134 Septic field looking east towards residence

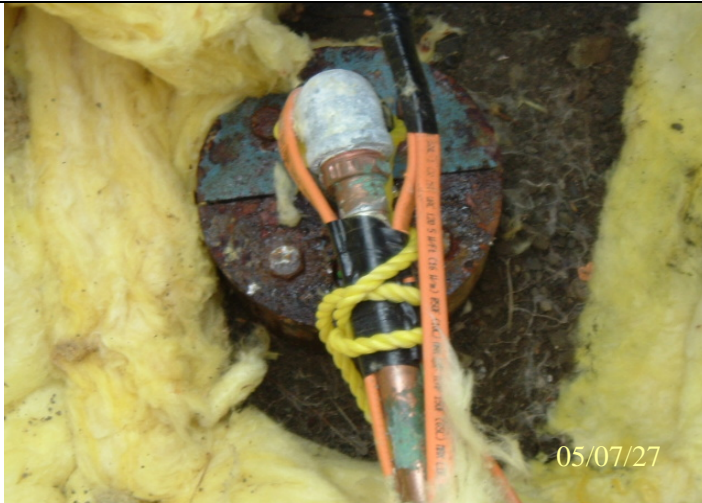
- Poor surface completion of the wellhead (located in a pit below grade);
- There is no surface sanitary seal (grout or bentonite seal as required by the Canadian Groundwater Association's Guidelines for Water Well Construction; There is no well log available to review well construction and/or lithology;
- By definition of the Draft Yukon GUDI Assessment Guideline, the well is potentially under the direct influence because the well depth is unknown and the well construction does not meet the requirements of the Guidelines for Water Well Construction; and,
- There is no disinfection system.

- i. Is the well head below grade? describe in detail ~ 1.05 m below grade
- ii. Are there signs of ponding on the enclosure(e.g. water stains, etc.)? Yes No
- iii. Is the wellhead enclosed by fiberglass insulations? Yes No
- iv. Any evidence of rodents? Specify Yes,
- v. Does the well casing have a proper seal cap? Yes No
If no, describe condition split gasket cap

Photo 0550: M0134 Wellhead in pit

- The wellhead at M0134 should be extended to a minimum of 500 mm above the surrounding grade, and the well pit should be backfilled with a low-permeability material to provide a surface seal around the well casing. A surface sanitary seal (grout or bentonite) should be installed as deep as possible during wellhead improvements.

- Standard wellhead upgrades (casing extension, sanitary seal, plumbing and electrical extensions, and insulation and heat trace as necessary) would cost approximately **\$4,000**.
- Installation of NSF 61 NSF 61 filtration system (to 1 micron absolute) would cost in the order of **\$500**.

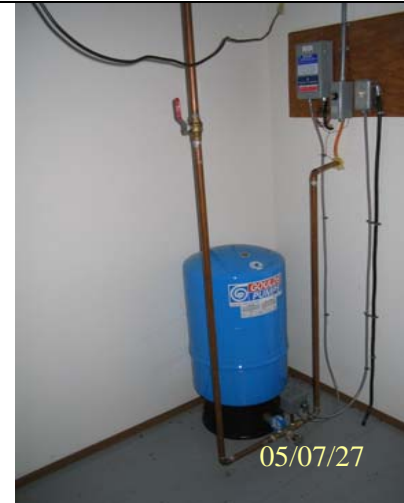
Photo 0094: M0134 pressure tank and pump controls
