15.0 BUILDING 3964: BEAVER CREEK HEALTH CENTRE

SMALL PUBLIC WATER SYSTEMS ASSESSMENT
WESTERN REGION

BEAVER CREEK HEALTH CENTRE
BUILDING # 3964
SITE LOCATION DIAGRAM
WELL ID: 3964

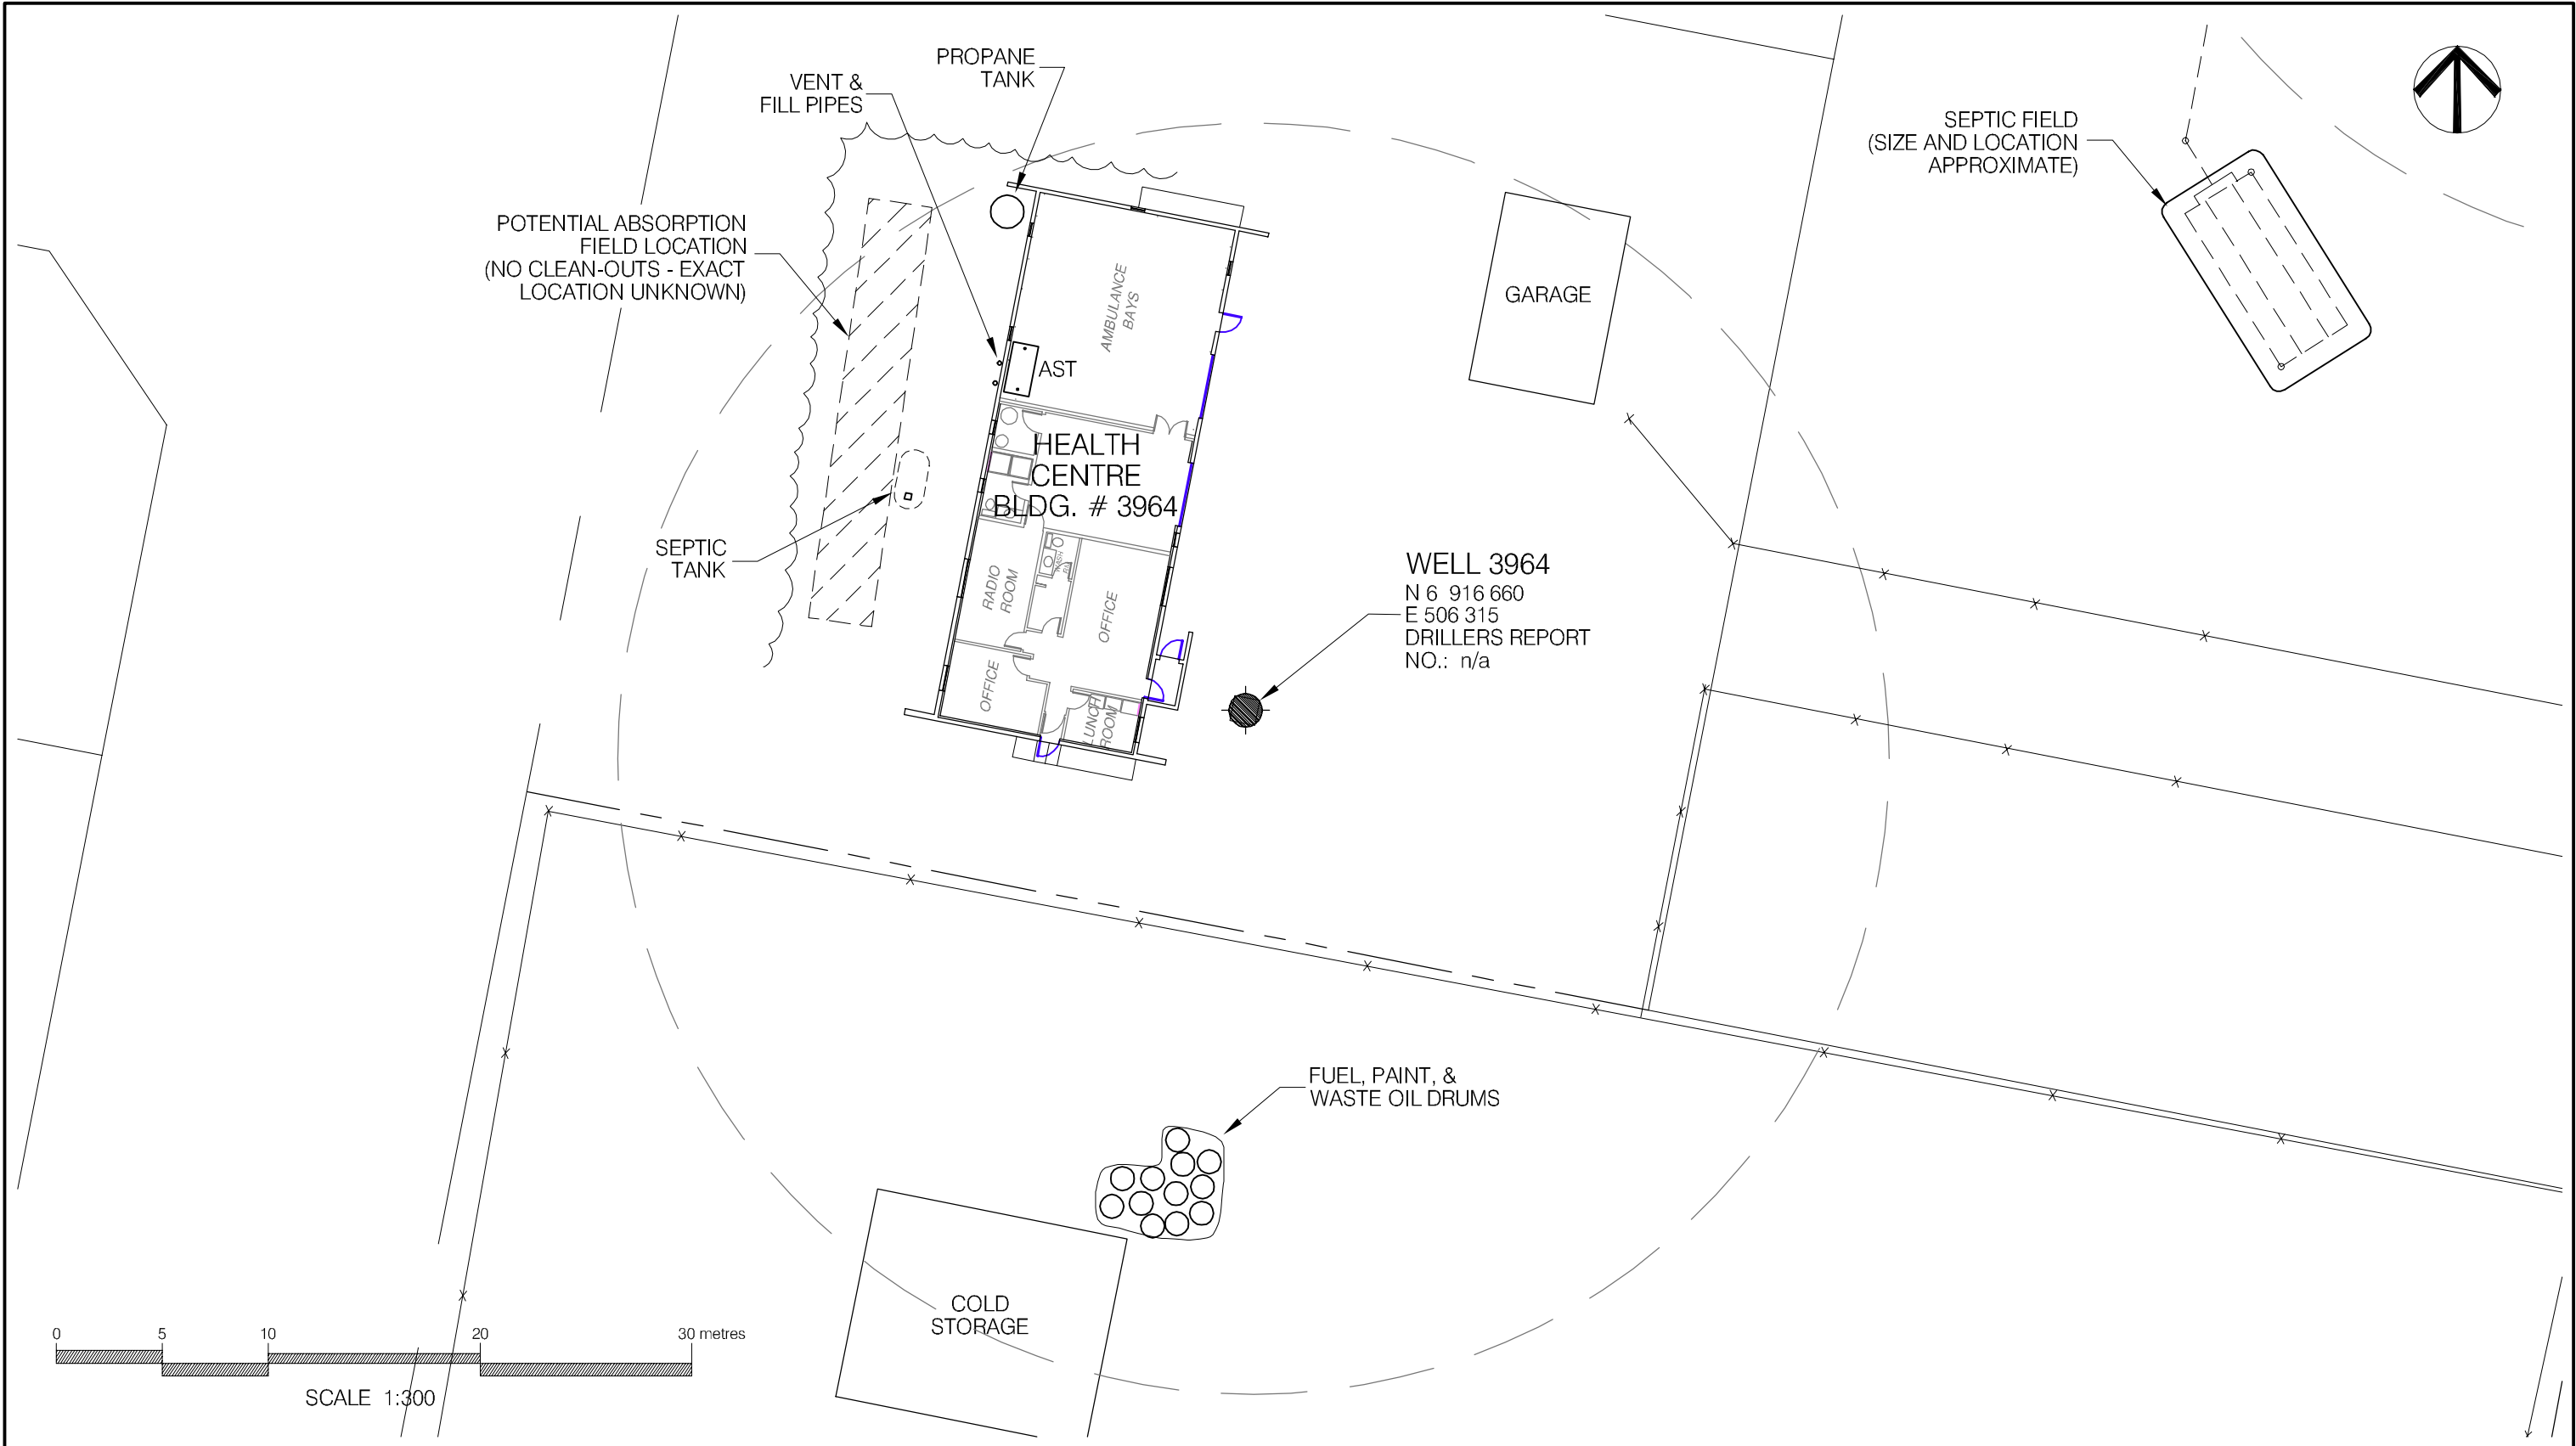
FIGURE No.
FIGURE 3964-A

Septic effluent is discharged to a septic system on the west side of the health centre. The septic tank is located approximately 20 m northwest of the well. The exact location of the septic field is unknown, however, it is likely that it is within 30 m of the well. Conceptual hydrogeology indicates that the septic system is likely cross-gradient from this well. There is also an abandoned septic tank or rock pit approximately 45 m south of the well on the Beaver Creek Grader Station property, and a septic field serving the Visitor Reception Centre approximately 42 m northeast and downgradient from the well. A site plan showing the existing wastewater system is given by Figure 3964-A in Appendix A15.

30 m RADIUS FROM WATER WELL FOR CONSIDERATION OF PROXIMITY TO POTENTIAL CONTAMINANT SOURCES.

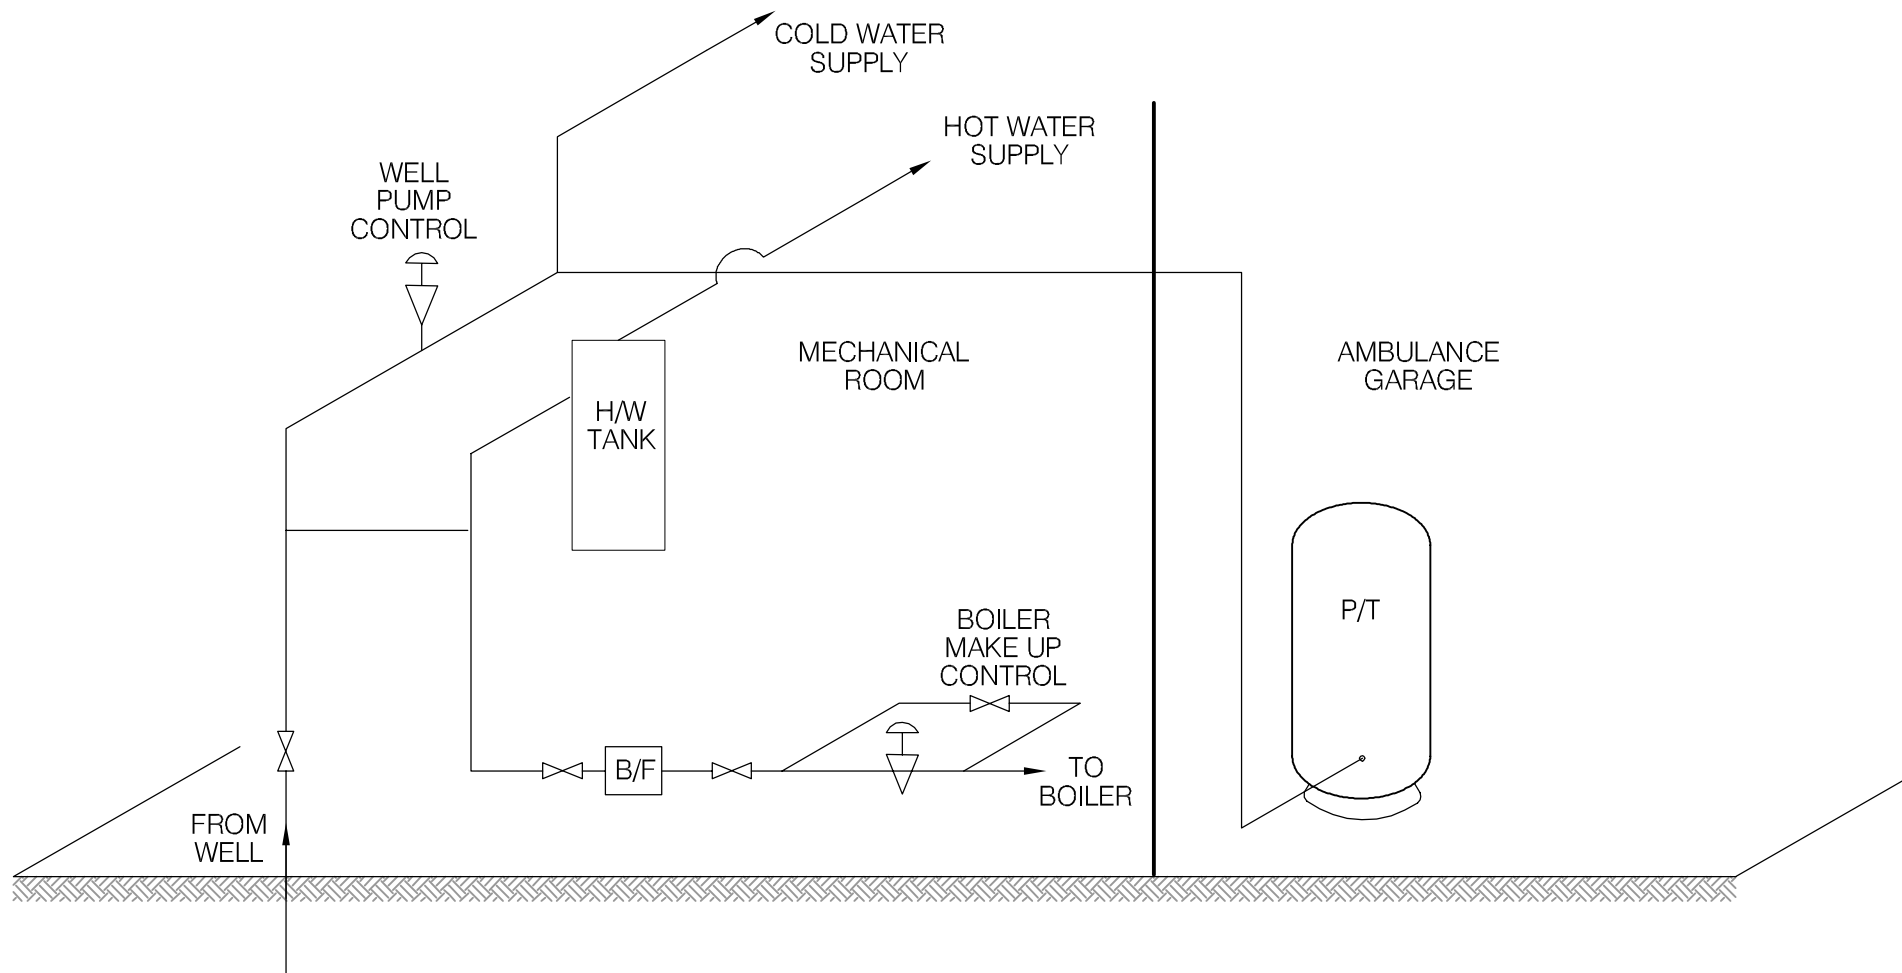
TITLE WATER SYSTEM DISTRIBUTION/TREATMENT SCHEMATIC SYSTEM ID.: 3964 BEAVER CREEK HEALTH CENTRE			
DATE	SEPT. 2005	DWN. JSB	CHKD.	RMM	FILE NO. 1260002.003	DWG.: FIGURE 3964-B

There is no treatment or disinfection system for the water supplying this site. A schematic detailing the well supply system is provided as Figure 3964-B in Appendix A15.

HEAT TRACE NO THERMOSTAT, NO GFI PROTECTION, THE
HEAT TRACE STAT IN PLACE DOES NOT APPEAR
TO BE WORKING. NO PRESSURE GAUGE ON
SYSTEM.

BRING HEAT TRACE INSTALLATION TO CODE.
INSTALL PRESSURE GAUGE. THIS BEING
A HEALTH CENTRE - INSTALL PROPORTIONAL
CHLORINATOR IN LINE AT POINT OF ENTRY
WITH PROPER RETENTION TANKS, INSTITUTE
PROPER FREE CHLORINE RESIDUAL TESTING.
INSTITUTE BI-ANNUAL WELL MAINTENANCE
PROGRAM.

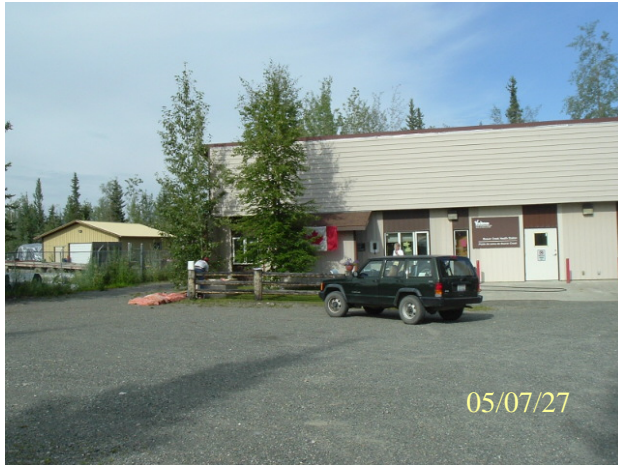
**Photo 0526:** 3964 Beaver Creek Health Centre

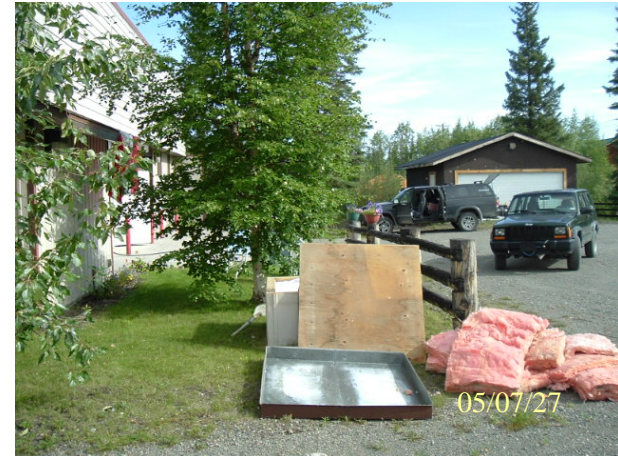
Unauthorized access by humans? ☐ Yes ☒ No Entrance by animals? ☐ Yes ☒ No
Enclosure unlocked Access possible

**Photo 0522:** 3964 Wellhead enclosure (centre), health centre (left)

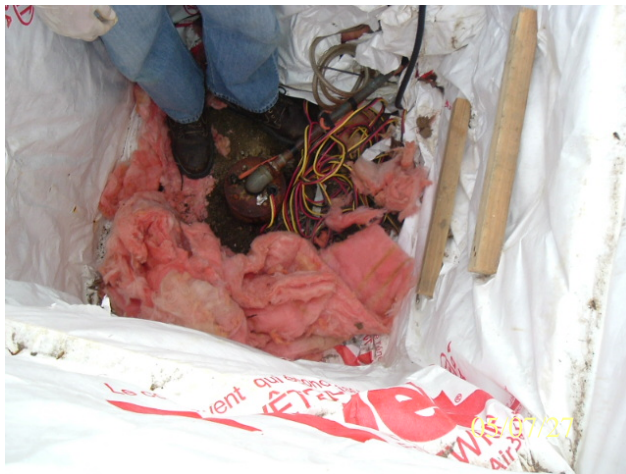
- Poor surface completion of the wellhead (located in a pit below grade);
- There is no surface sanitary seal (grout or bentonite seal as required by the Canadian Groundwater Association's Guidelines for Water Well Construction);

- i. Is the well head below grade? describe in detail ~ 1.15 m below grade
- ii. Are there signs of ponding on the enclosure(e.g. water stains, etc.)? ☐ Yes ☒ No
- iii. Is the wellhead enclosed by fiberglass insulations? ☒ Yes ☐ No
- iv. Any evidence of rodents? Specify Access possible. Some evidence
- v. Does the well casing have a proper seal cap? ☒ Yes ☐ No
- If no, describe condition Solid plate cap

**Photo 0521:** 3964 Wellhead in pit

- The casing should be extended to at least 500 mm above the base of the well pit, and a localized near surface bentonite seal installed immediately around the wellhead, while leaving the remainder of the base of the well pit for drainage.
- The well and water system should be superchlorinated.
- Disinfection treatment consisting of filtration to 1 micron absolute, and a UV system that is NSF/ANSI certified should be installed. Pretreatment will likely be required for proper UV performance. Alternatively, a proportional feed chlorination system with retention tanks and appurtenances could be installed. These are conceptual design recommendations based on the information available for planning and budgeting purposes. Engineering input will be required for final system specifications.

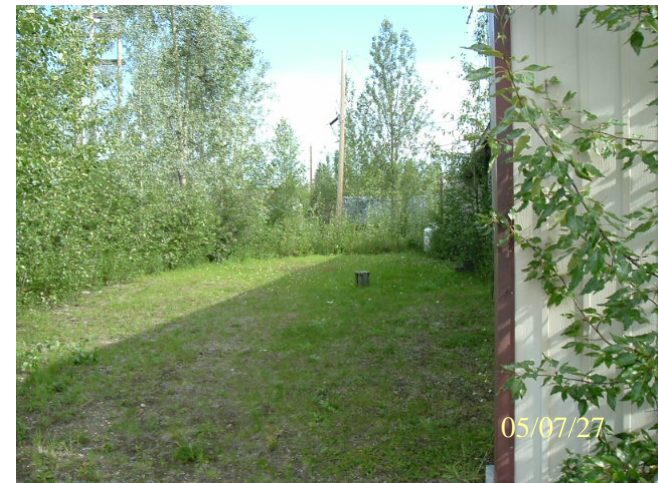
- The closest point of the effluent discharge field for the health centre is likely 18 m cross gradient from the well;
- Water quality reported chloride above normal background concentrations for the area, and suggest that the well may potentially be under the influence of surfacewater or septic sources; and,

septic tank @ ~20m, Visitor Reception Centre septic @ 42m

**Photo 0524:** 3964 Septic tank and field at rear of health centre building

The exact location of the septic field should be confirmed.

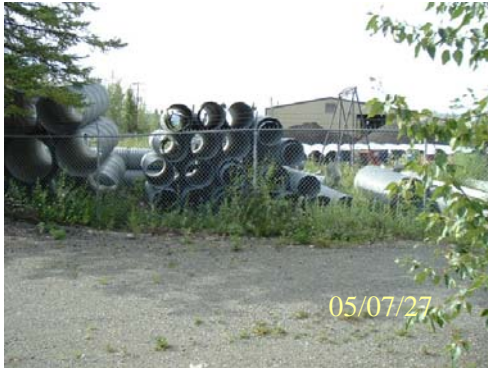
In addition, an asphalt mix pile is located approximately 40 m south from the wellhead on the Grader Station property.

- The well is located within 30 m of potential sources of contamination, including a fuel storage tank at approximately 20 m and fuel, oil, and paint drums at 20 m;

Photo 0525: 3964 Looking south at Beaver Creek Grader Station (site 3123) as seen from wellhead

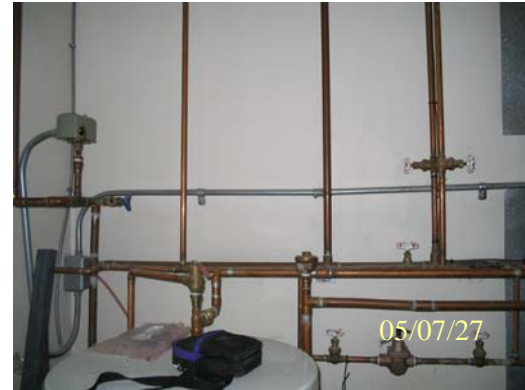
Photo 0076: 3964 Piping and water heater in mechanical room

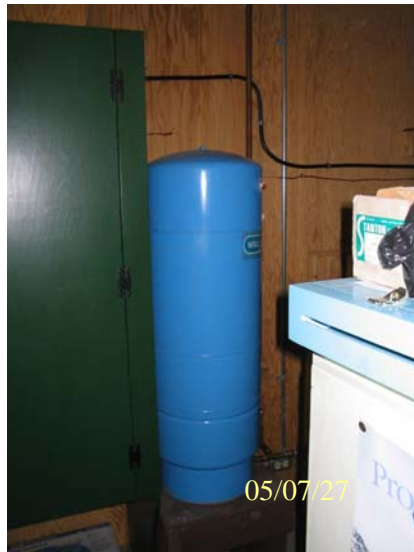
Photo 0077: 3964 Pressure tank

- Install pressure guage on system if option 1 of Priority 2 is chosen. Consider completing this at the same time as Priority 2 upgrades.

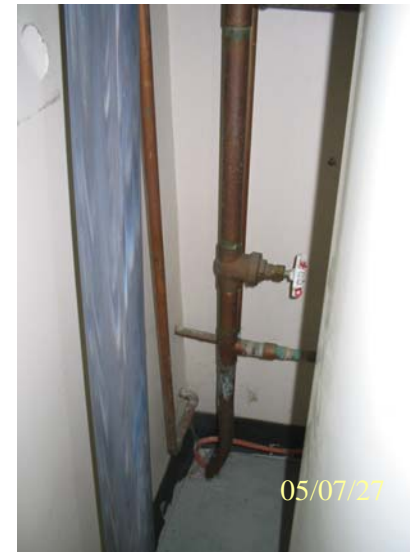
- There is no treatment or disinfection system.

Photo 0079: 3964 Point of entry
