14.0 BUILDINGS M0092: WATSON LAKE RCMP DETACHMENT

SMALL PUBLIC WATER SYSTEMS ASSESSMENT
 EASTERN REGION

WATSON LAKE RCMP HOUSE
 BUILDING # M0092
 SITE LOCATION DIAGRAM
 WELL ID: M0092-A

PART A: EBA Site Inspection

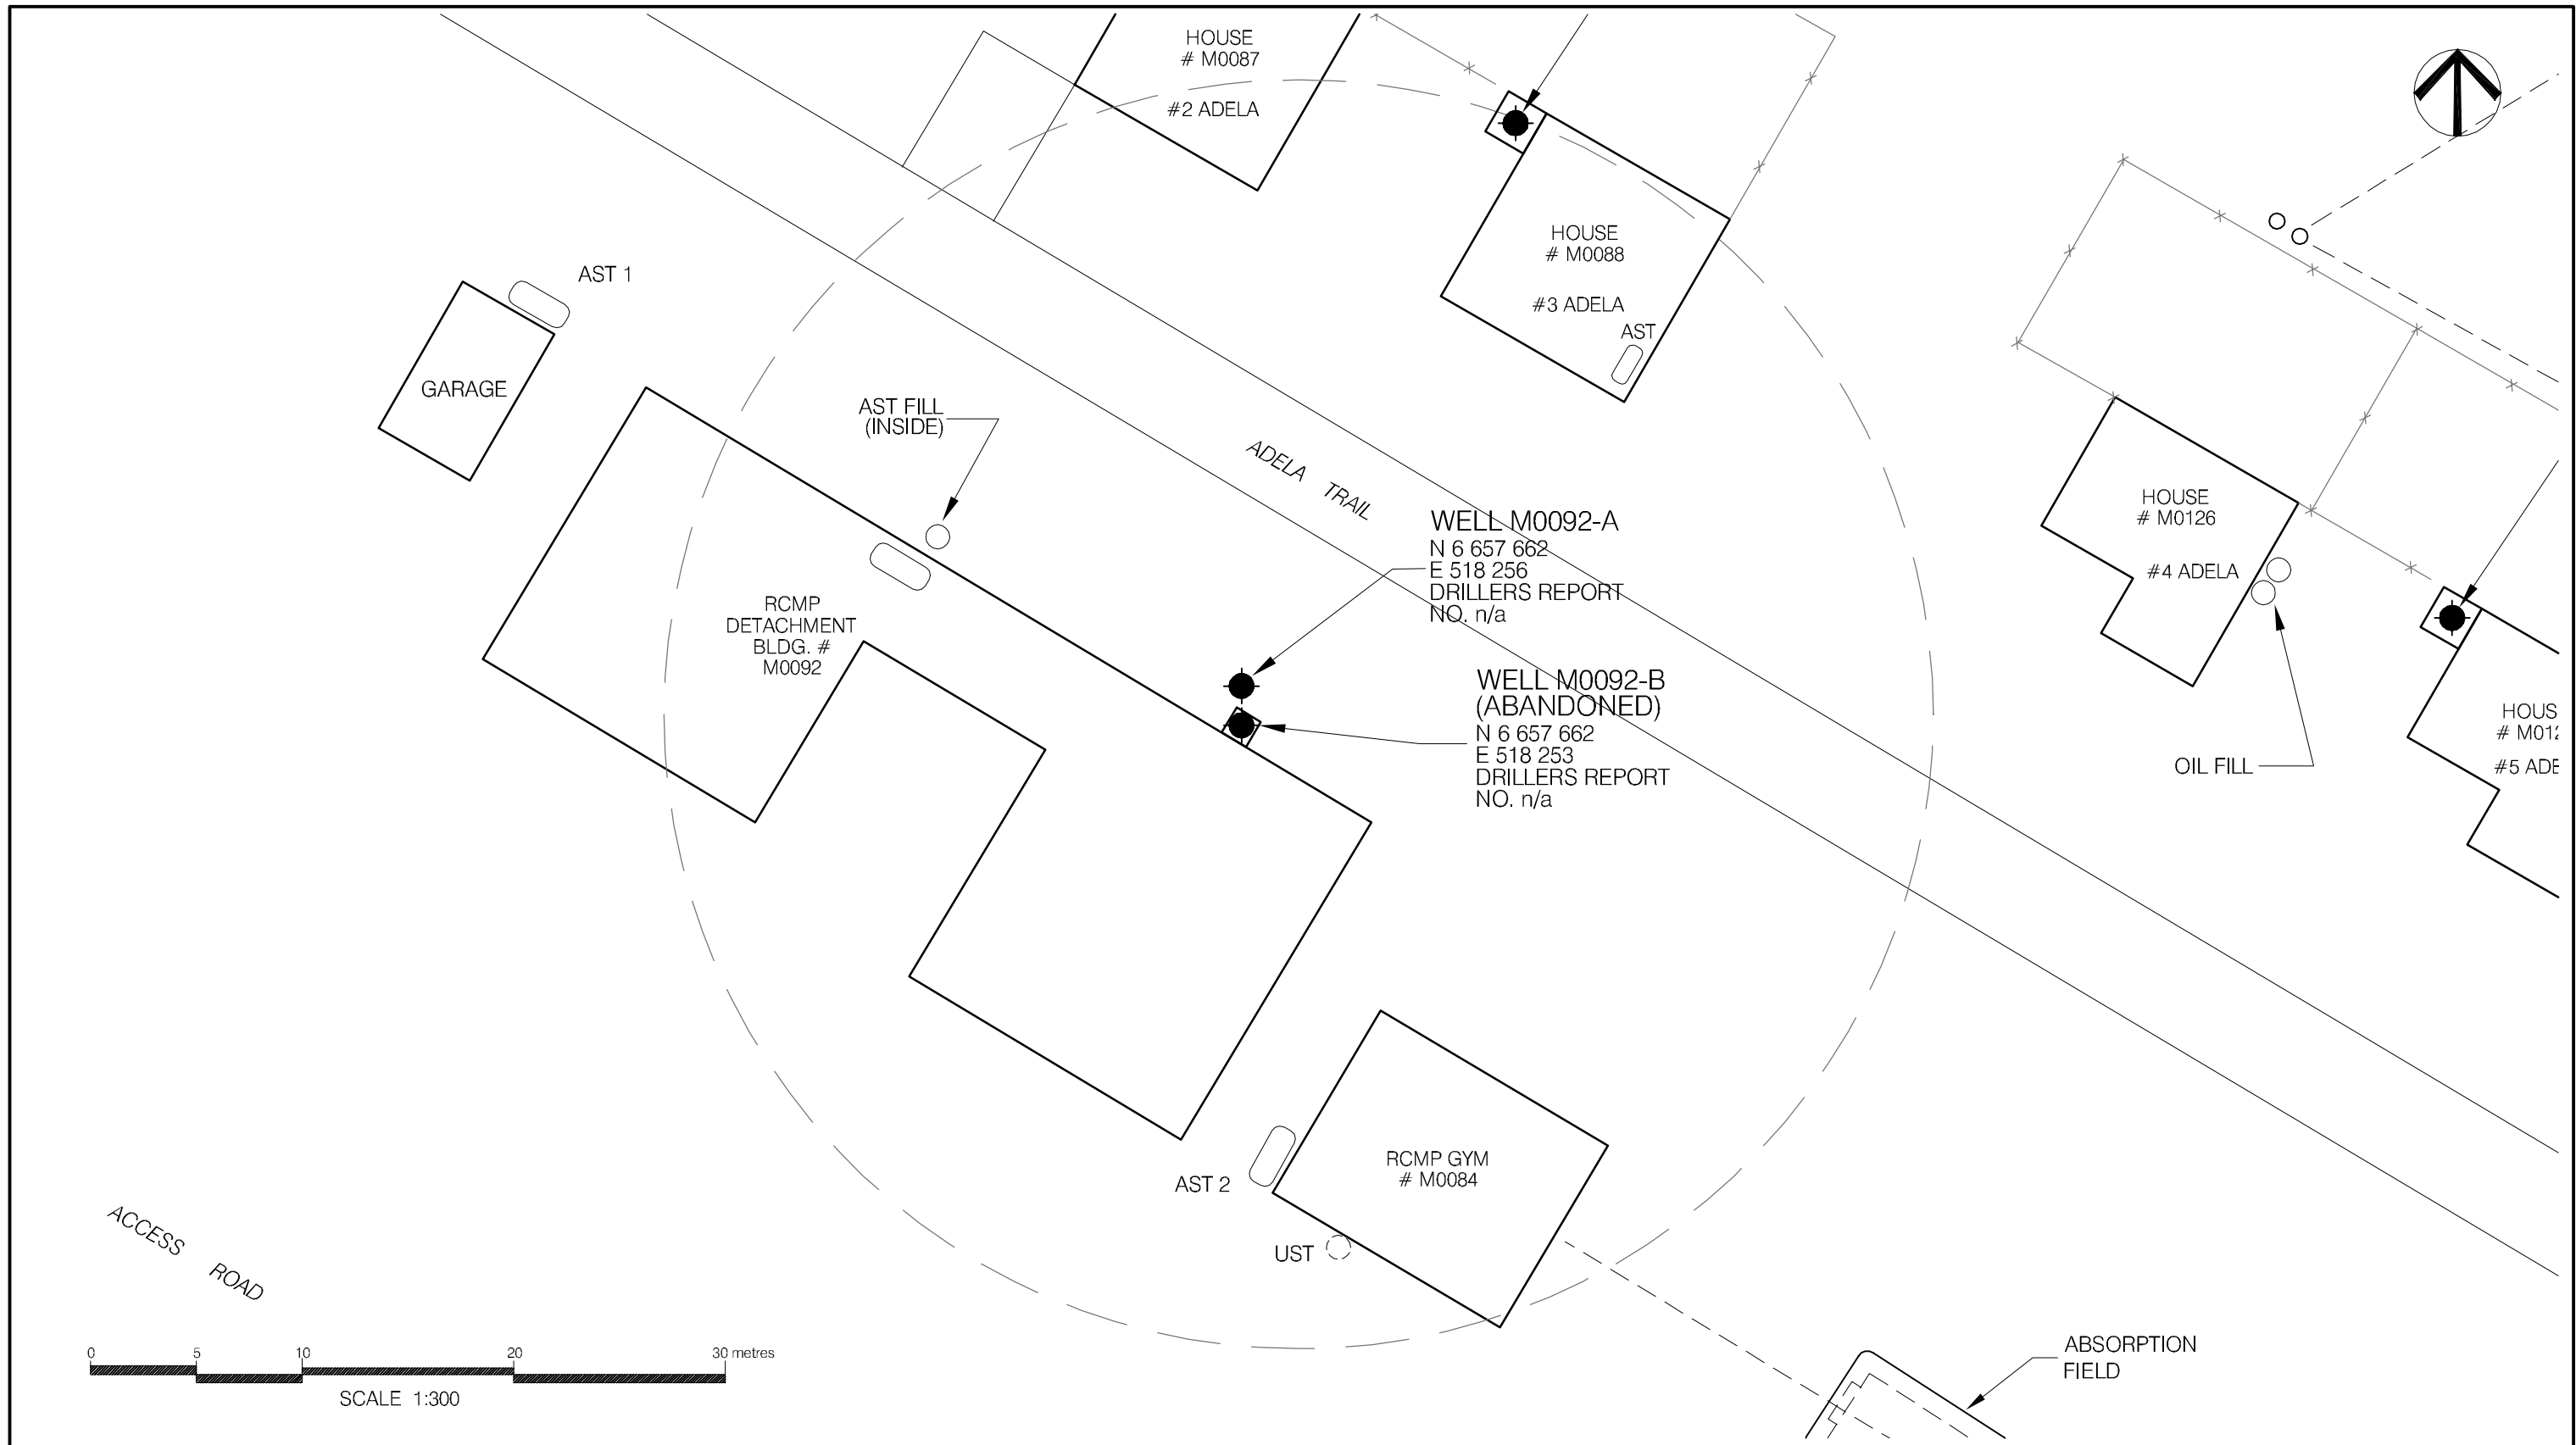
FIGURE No.
 M0092-A

There is a septic field that is used commonly by both the RCMP detachment and the RCMP gym. This field is located approximately 35 m east of the main well. Figure M0092-A, provided in Appendix A14, shows the location of the septic system.

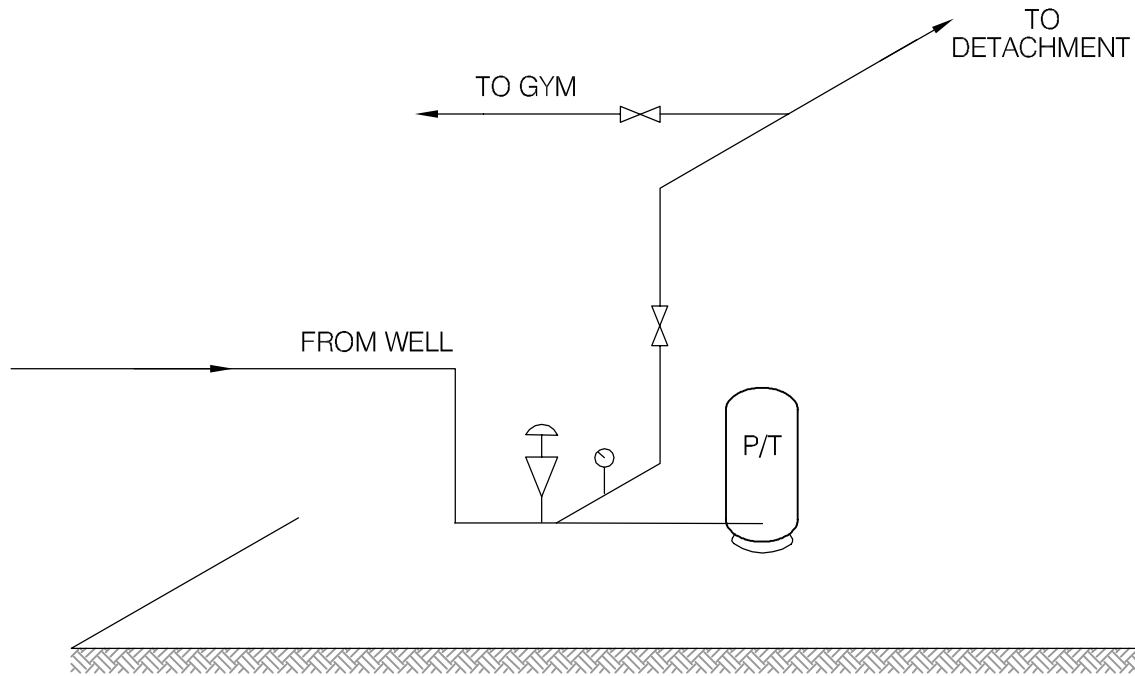
DWG.: FIGURE M0092-B

There is no treatment or disinfection system present on the water system. In addition to serving the detachment, this well also serves the RCMP Gym (building M0084). A schematic detailing the water system is provided as Figure M0092-B in Appendix A14.

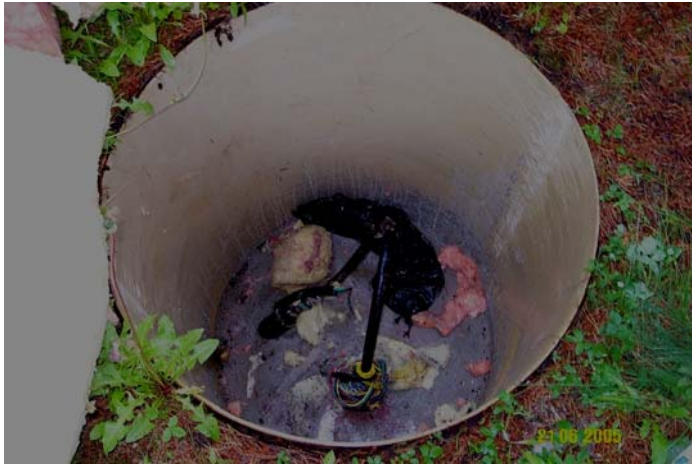
Well Construction Details					
Wellhead Above ground (m)	Well Cap	Well Screen	Surface Seal	Apron Grading	Comments
1.15 below grade	Split seal gasket cap		Unlikely	Slight slope away from well	Well services both the M0092 RCMP detachment and the M0084 RCMP gym

Photo 0281: M0092-A Wellhead in pit

- The well should be superchlorinated;
- Additional assessment, including a pumping test, should be done on the detachment well to determine its yield and other construction details. Although this is not considered a high risk issue, this information will be necessary to determine the course of action for other Priority 1 upgrades (e.g. to determine sizing for disinfection system);
- There are two options available for the type of disinfection system to be installed for the proposed water distribution system, and are outlined below:

- The wellhead construction should be improved, including extending the well to at least 500 mm above grade and installing a commercial pitless unit. A surface sanitary seal (grout or bentonite) to at least 3 m below grade should be retrofitted around the well and the ground surface should be graded to promote surface drainage away from the wellhead;

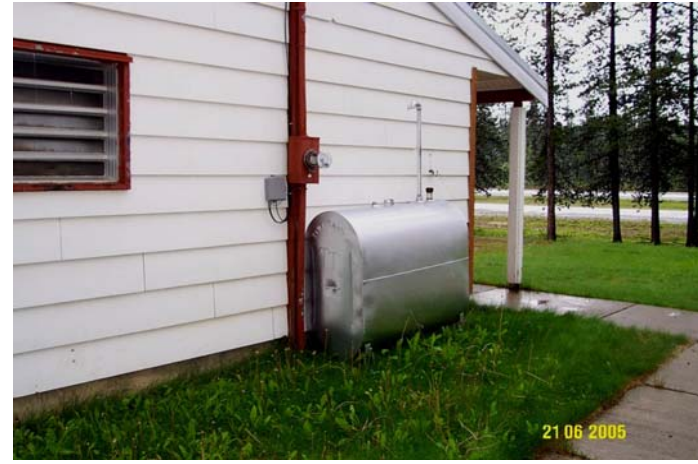
- An adjacent abandoned well at approximately 1 m;
- Underground fuel storage tank at approximately 17 m; and,
- Two above ground fuel storage tanks at approximately 17 m and 27 m.

Photo 0282: M0092 Above ground fuel storage tank

- The existing above ground fuel storage tanks should be removed and replaced with double walled EnviroTanks with secondary containment.

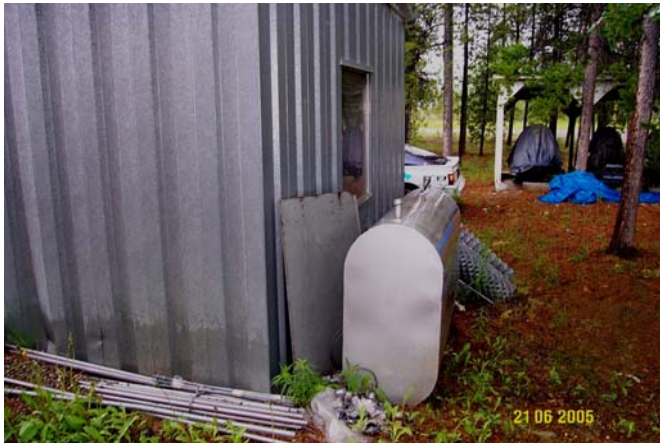
Photo 0285: M0084 (RCMP gym, left) Above ground fuel storage tank (centre)

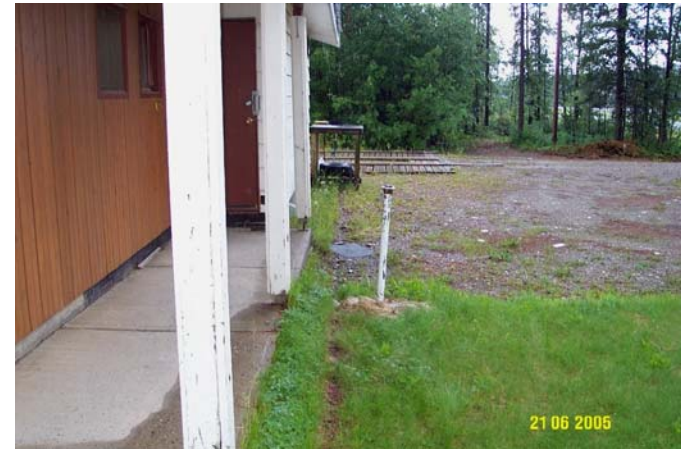
Photo 0283: M0092 Potential underground fuel storage tank (centre), RCMP detachment building (left)

-
- The existing underground fuel storage tank should be removed and all contaminated soil (if any) should be removed and properly disposed of.

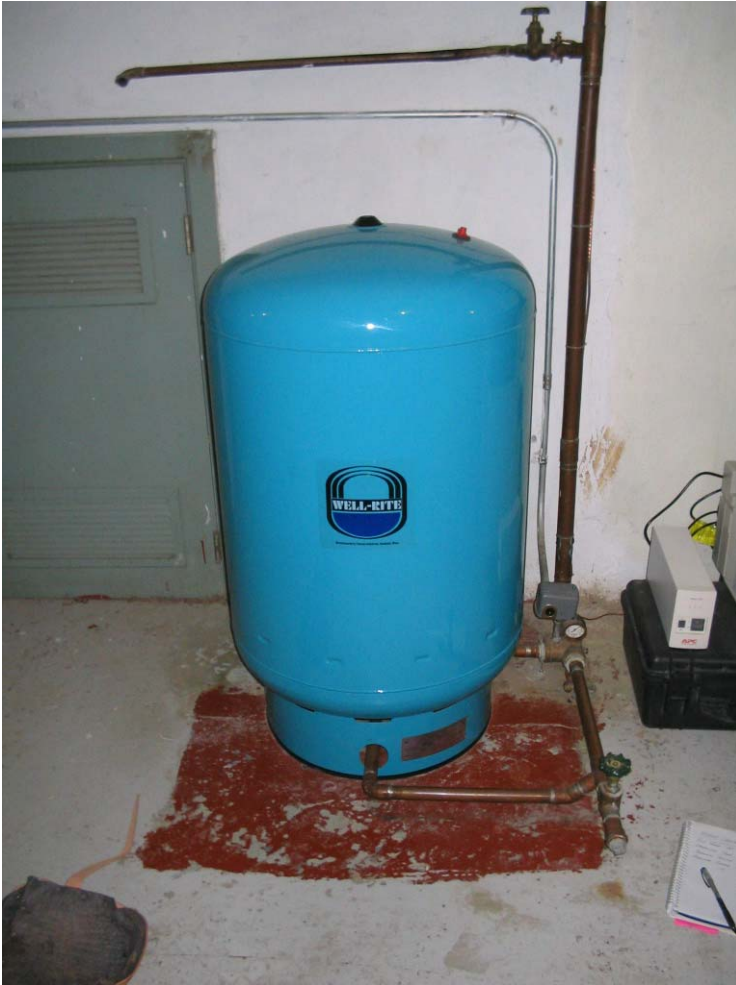
Photo 0022: M0092 Pressure tank

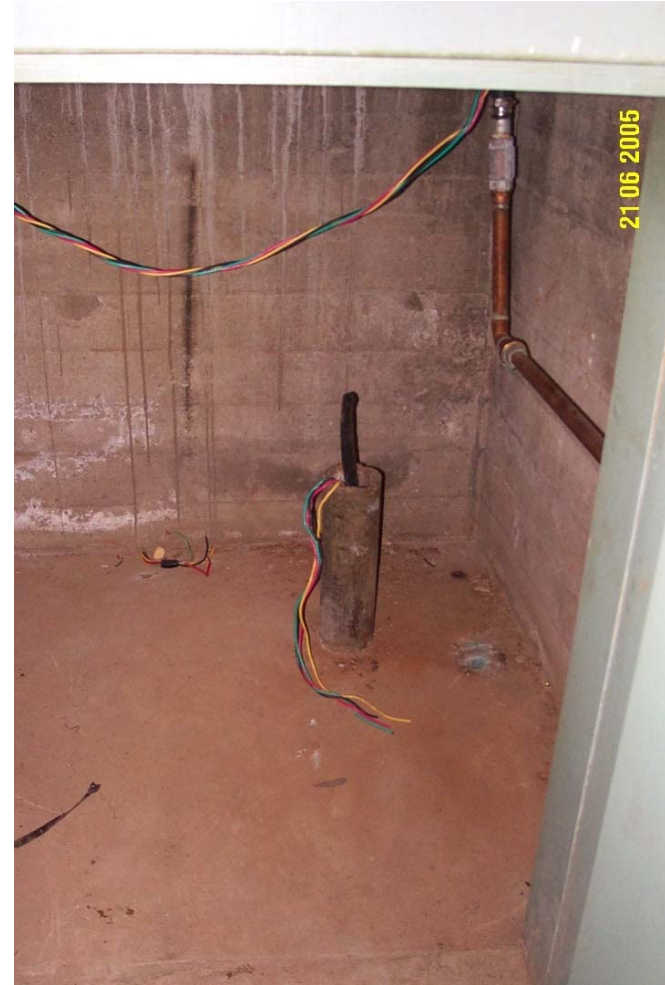
- The well is located within 30 m of potential sources of contamination, including an abandoned well that has not been properly decommissioned and is not equipped with a proper cap;
- The well is located 17 m from an underground fuel storage tank, as well as 17 m and 27 m from two above ground fuel storage tanks;
- Poor surface completion of the well (located in a pit below grade);
- The well is not equipped with a surface sanitary seal as required by the Canadian Groundwater Association's Well Construction Guidelines;
- By definition of the Draft Yukon GUDI Assessment Guideline, the well is potentially under the direct influence of surface water because it is a vulnerable type (unconfined aquifer), and does not meet the requirements of the Guidelines for Water Well Construction; and,
- There is no treatment or disinfection system present.

Well Construction Details					
Wellhead Above ground (m)	Well Cap	Well Screen	Surface Seal	Apron Grading	Comments
Approximately 1.6 m below grade	No		Unlikely	Slight slope away from well	Well is no longer in use.

- i. Is the well head below grade? describe in detail ~ 1.6 m below grade
- ii. Are there signs of ponding on the enclosure(e.g. water stains, etc.)? Yes No
- iii. Is the wellhead enclosed by fiberglass insulations? Yes No
- iv. Any evidence of rodents? Specify No
- v. Does the well casing have a proper seal cap? Yes No
If no, describe condition No, no seal cap.

Photo 0277: M0092-B Wellhead in enclosure off from basement of RCMP detachment

- A chlorine disinfection system with suitable retention should be installed at a centralized location on the water system in the basement on the RCMP detachment.
- The abandoned well in the basement of the detachment should be properly decommissioned in accordance with Guidelines on Water Well Construction; and,
