## **16.0 BUILDING 4821: WATSON LAKE WEIGH SCALES**

SMALL PUBLIC WATER SYSTEMS ASSESSMENT  
 EASTERN REGION

WATSON LAKE WEIGH SCALE  
 BUILDING # 4821  
 SITE LOCATION DIAGRAM  
 WELL ID: 4821-A

### PART A: EBA Site Inspection

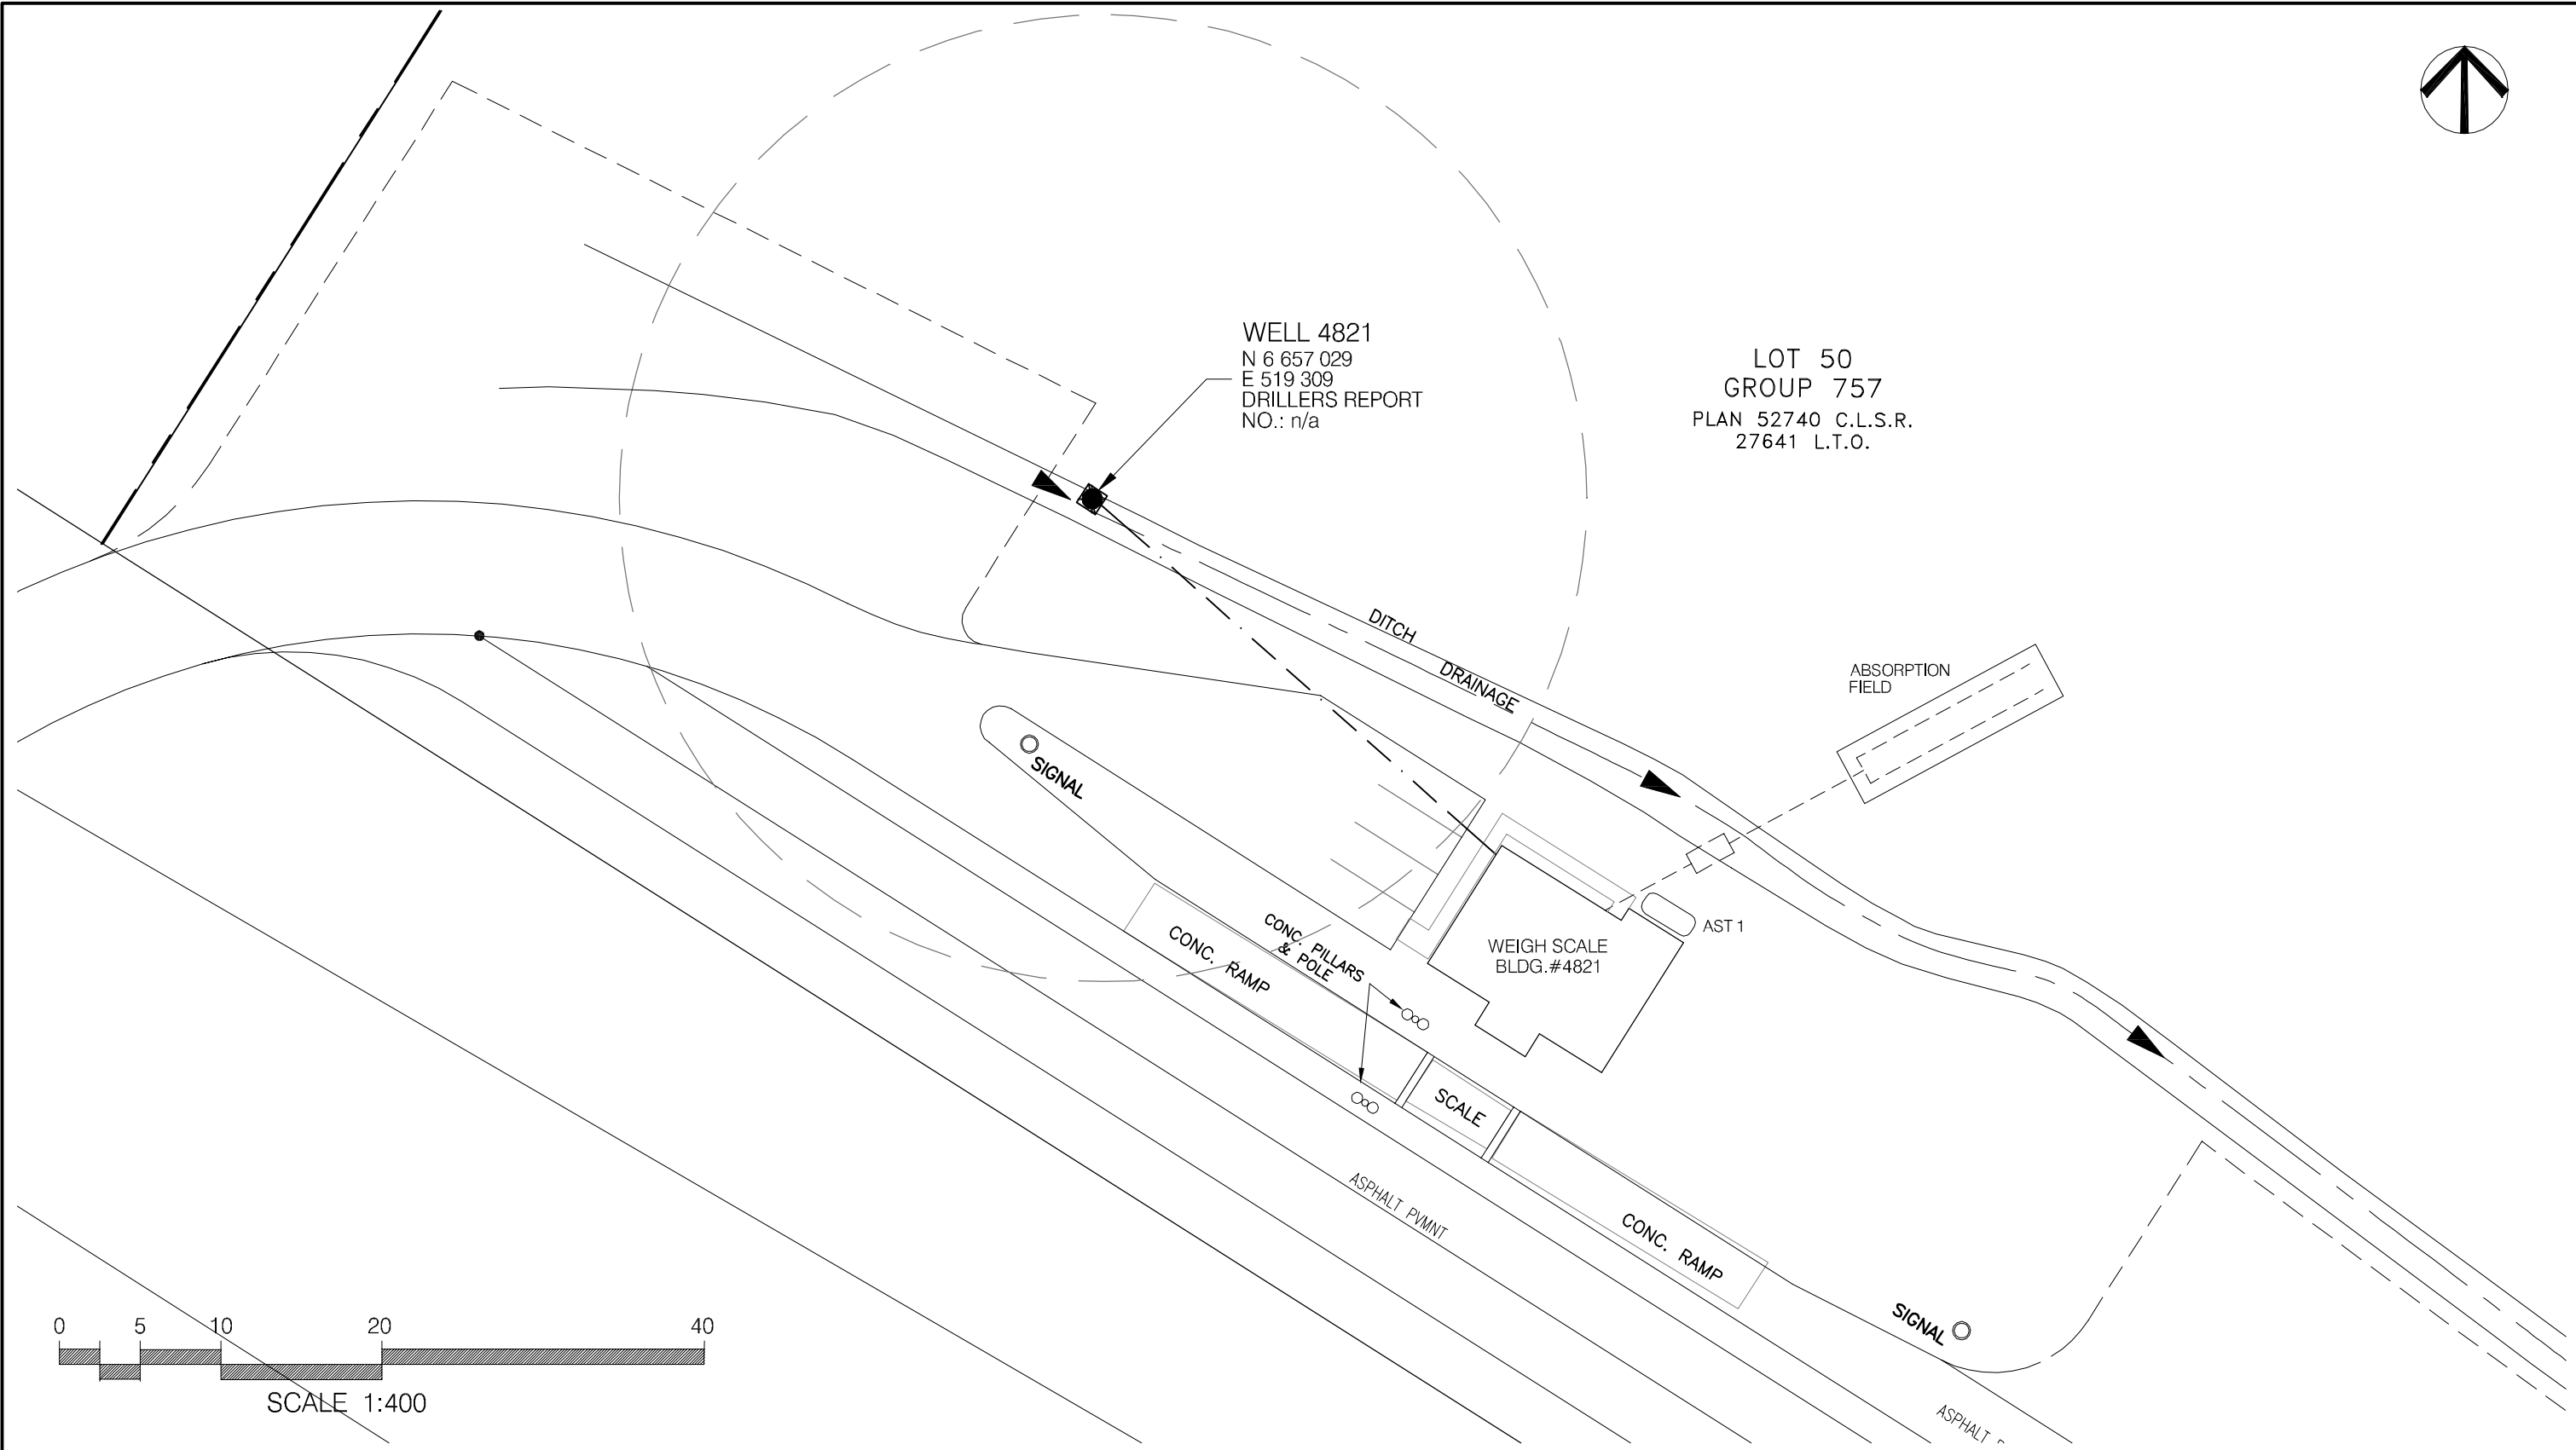
FIGURE No.  
 4821-A

The septic tank is located north of the weigh scales office approximately 52 m east from the wellhead. The septic tank discharges effluent to a field located north of the tank. A site plan showing the septic system is given by Figure 4821-A in Appendix A16.

30 m RADIUS FROM WATER WELL FOR CONSIDERATION OF PROXIMITY TO POTENTIAL CONTAMINANT SOURCES.

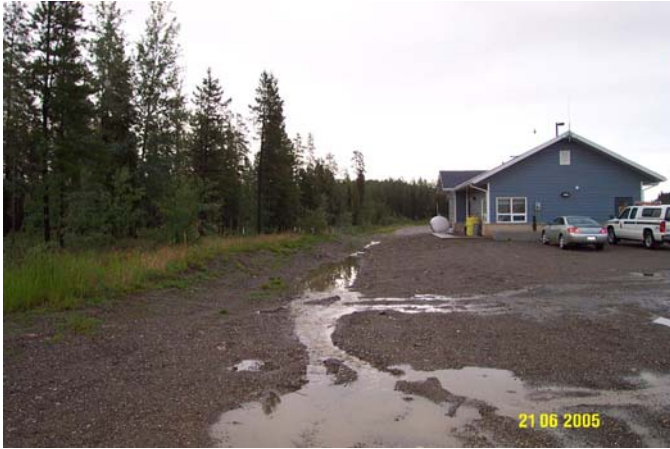
Potential contaminant sources observed during the site investigation are presented in field notes in Appendix A16. Photos of potential contaminant sources are also provided in Appendix A16. A drainage feature runs directly around the well and during rainy periods surface water flows within 1 m of the wellhead. The drillers log indicates that this is an item of concern and that the sanitary surface seal is not sufficient to protect the aquifer from this surface water feature.

The well is apparently built in a natural drainage flow ditch in parking lot. There is a small stream - with evidence of hydrocarbons in it - that runs around well

**Photo 0291:** 4821 Weigh scale office (back right, as seen from wellhead), drainage stream (centre), and septic field (back left)

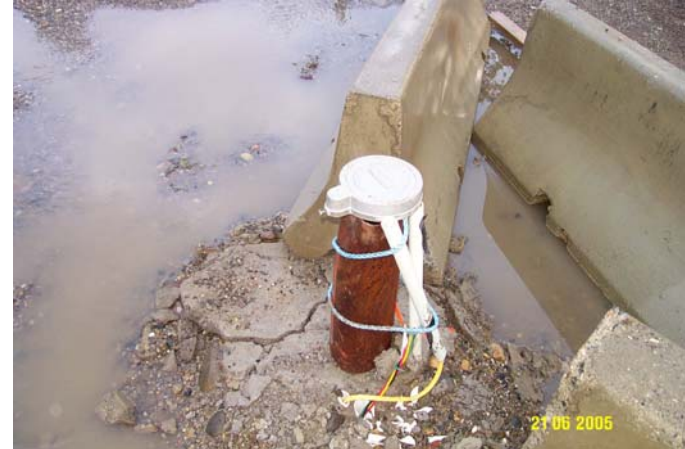
**Photo 0290:** 4821 Wellhead – pitless adapter

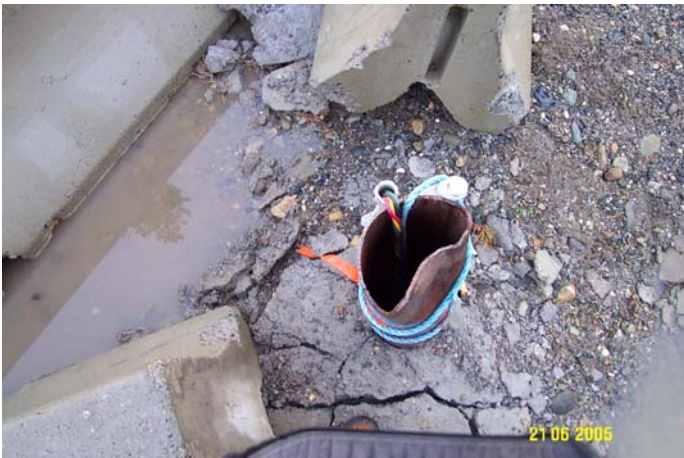
- Poor location of the well in the weigh scales parking lot. There is a drainage feature that runs directly around the wellhead. The wellhead is susceptible to damage from vehicle impact. A truck has reportedly already hit the well casing, and the damage prevents the cap from being properly fastened to the top of the casing;

Cap on top of casing is unfastened due to damage to well casing

- a. Comments on overall installation:  
The wellhead was damaged - is currently open as the cap cannot properly seal the top of the casing  
\_\_\_\_\_  
\_\_\_\_\_  
\_\_\_\_\_  
\_\_\_\_\_
- b. Recommendations: \_\_\_\_\_  
\_\_\_\_\_  
\_\_\_\_\_  
\_\_\_\_\_  
\_\_\_\_\_

**Photo 0288:** 4821 Wellhead – notice damage due to impact with truck

- The well and water system should be superchlorinated and the well casing should be repaired. The casing should extend at least 500 mm above grade and be equipped with a proper locking and vented cap;
- A surface-seal to at least 3 m below grade should be installed;
- The ground surface around the wellhead should be graded to promote surface drainage away from the well;
- A proper reinforced barricade and chain-link fence should be placed around the wellhead to prevent damage by vehicles; and,
- An NSF-61 certified filtration system (to 1 micron absolute) followed by a UV disinfection system (or equivalent) should be installed. Pretreatment consisting of a softener may be required to ensure that the UV system operates properly.

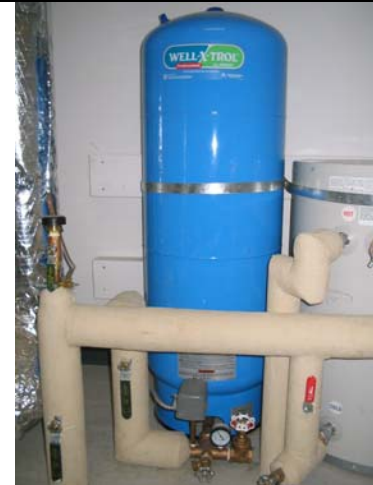
**Photo 0023:** 4821 Pressure tank and controls
