12.0 BUILDING M0086: WATSON LAKE RCMP RESIDENCE

SMALL PUBLIC WATER SYSTEMS ASSESSMENT
EASTERN REGION

SMALL PUBLIC WATER SYSTEM ASSESSMENT

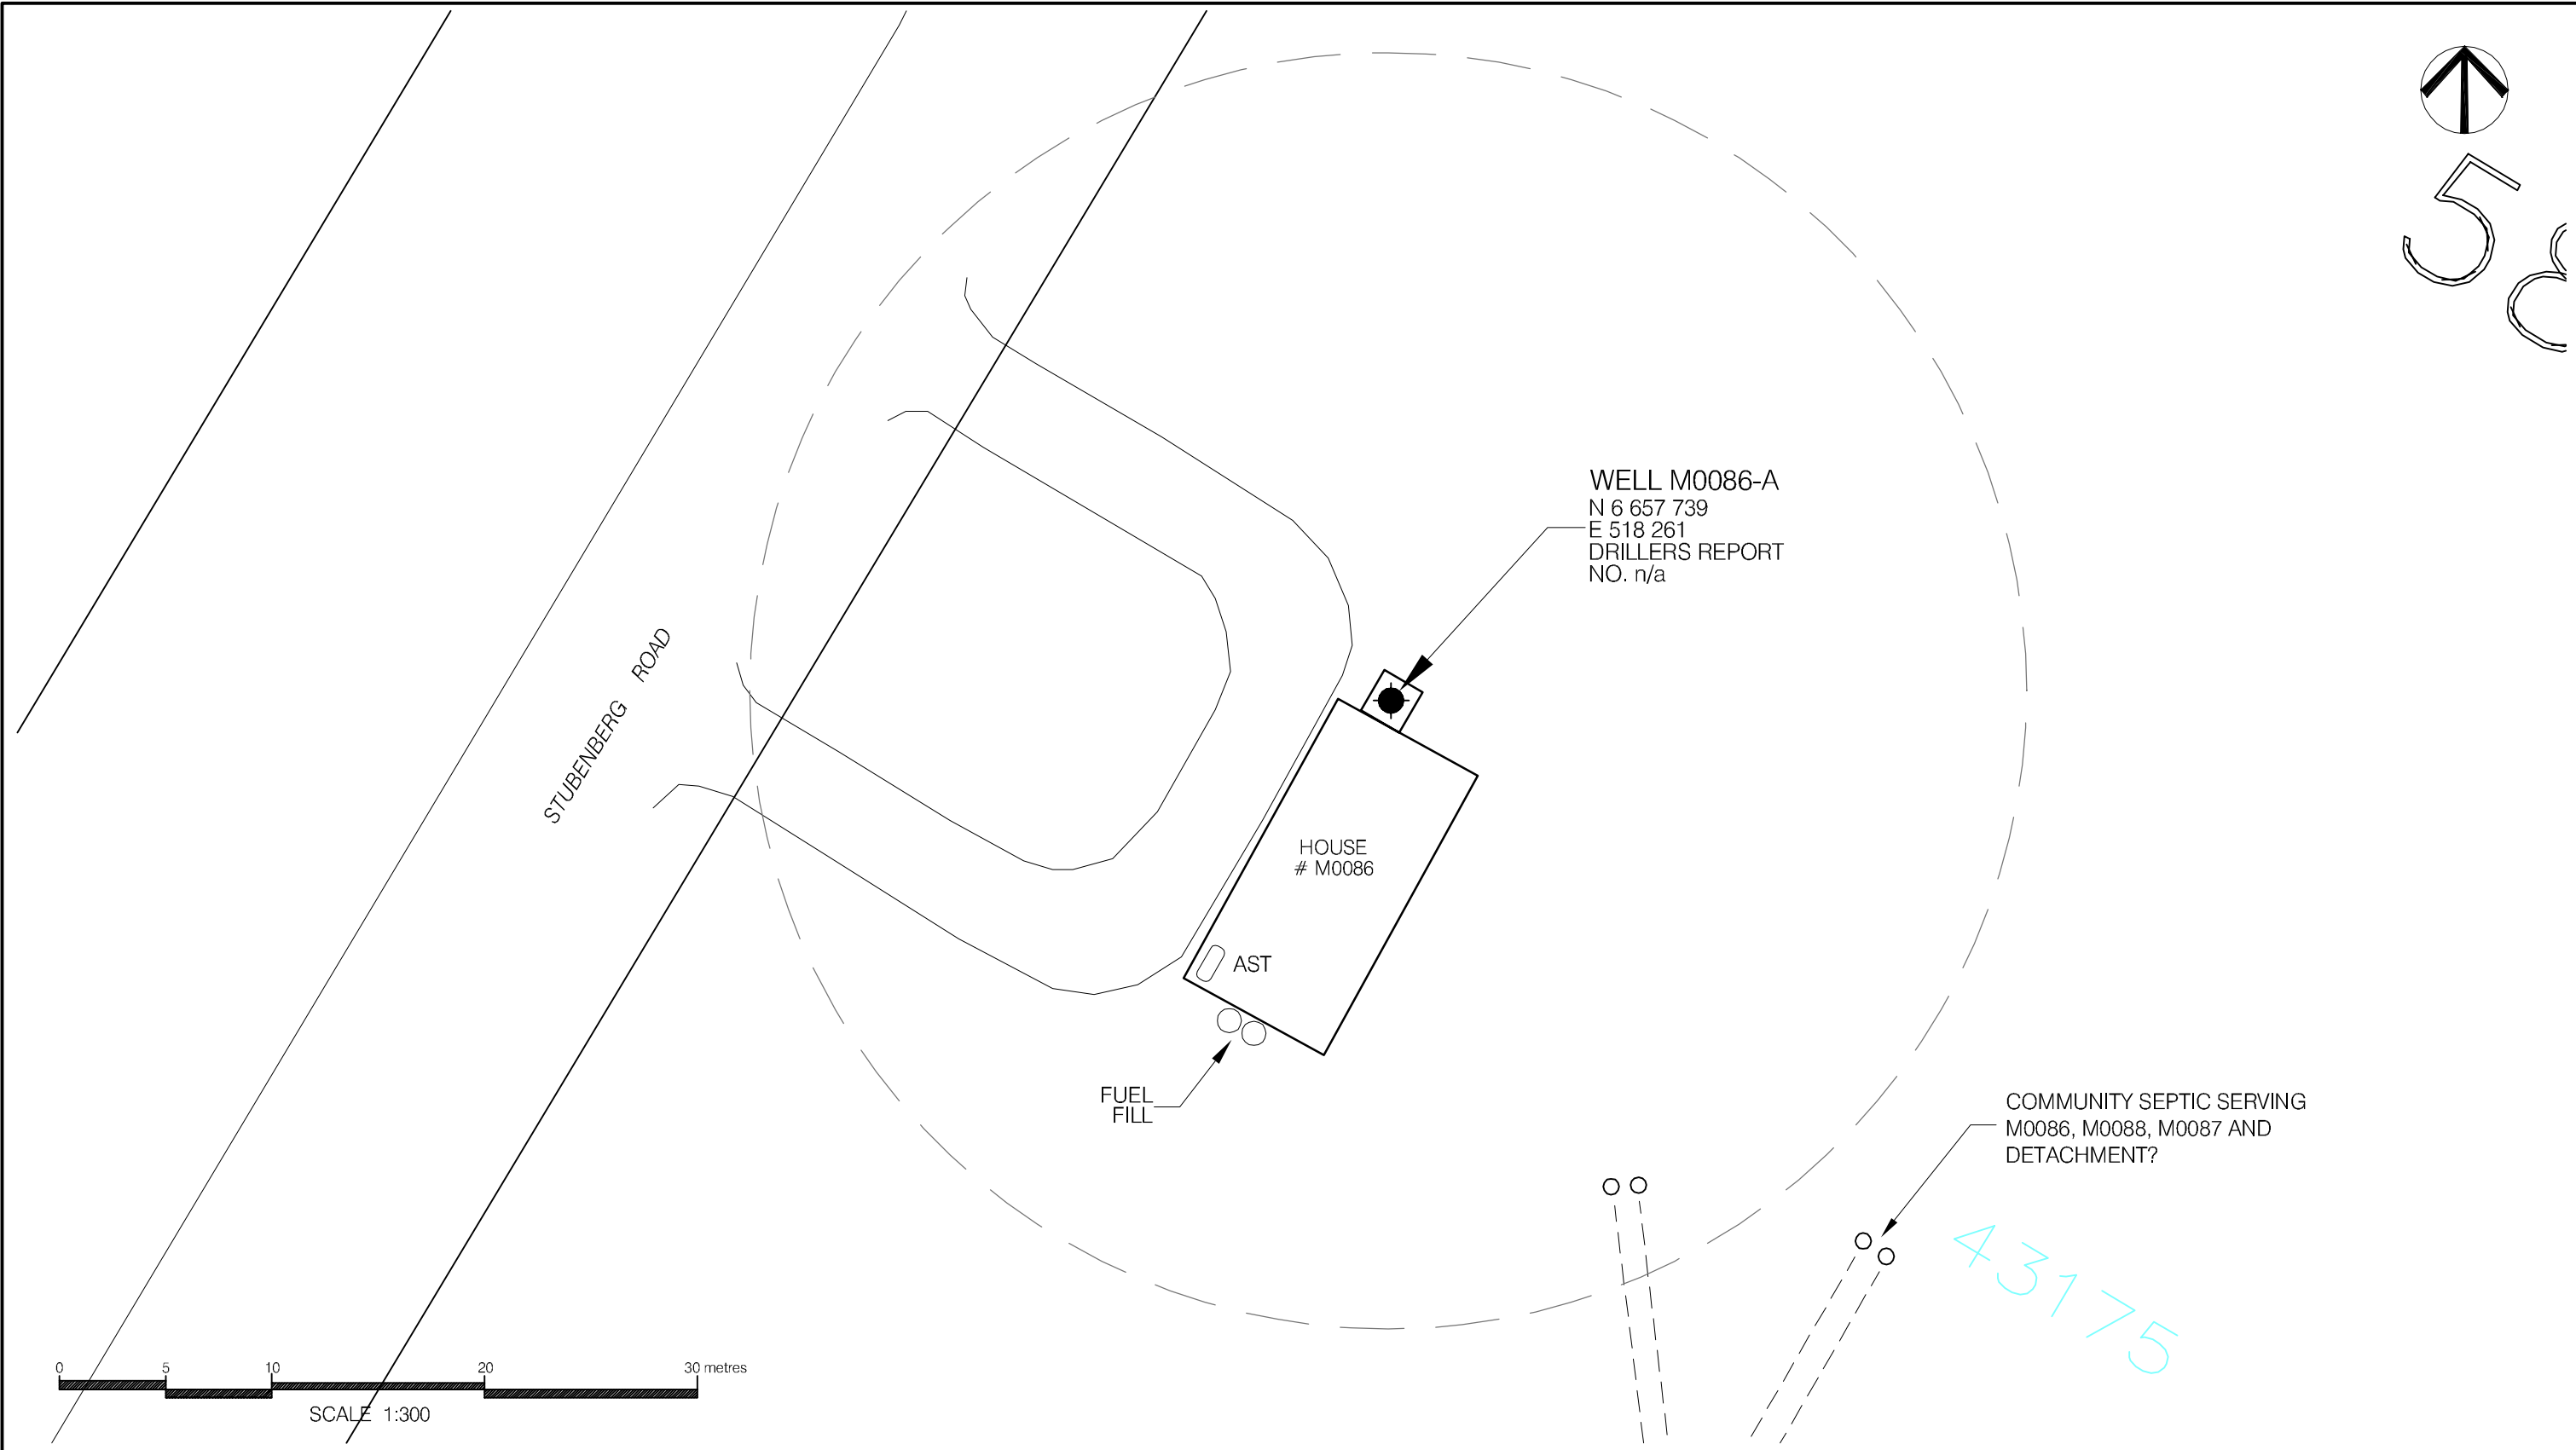
FIGURE No.
M0086-A

There is a communal in ground septic disposal system that is used for this residence as well as the M0087 and M0088 RCMP Residences. This field is located approximately 20 m east of the M0086 well. Figure M0086-A, provided in Appendix A12, shows the location of the septic system.

- Septic field approximately 25 m from well;
- Fuel storage tank located in the basement of residence at 15 m (approx.).

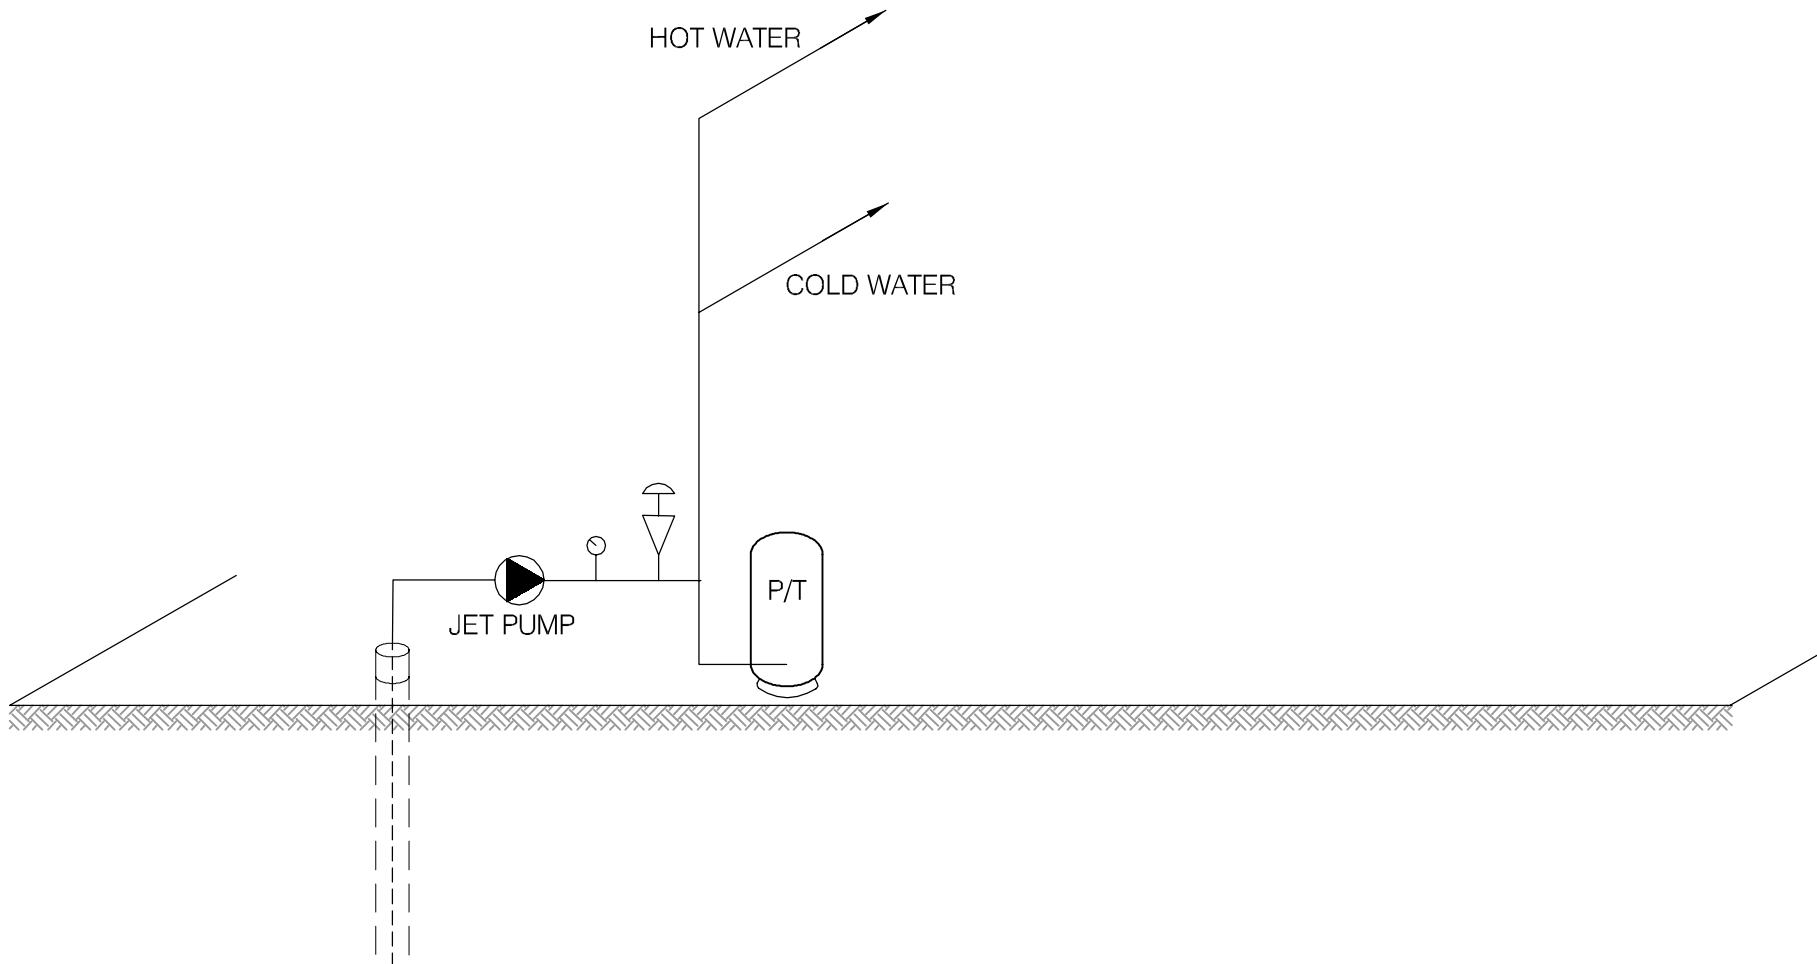
TITLE WATER SYSTEM DISTRIBUTION/TREATMENT SCHEMATIC SYSTEM ID.: M0086 WATSON LAKE RCMP HOUSING	
DATE	JULY 2005	DWN.	JSB
CHKD.	FMM	FILE NO.	1260002.002
		DWG.:	FIGURE M0086-B

There is no treatment present on the water system from this well and it serves the M0086 RCMP Residence only. A schematic detailing the water system is provided as Figure M0086-B in Appendix A12.

- There is a fuel storage tank located inside the basement of the residence. This is not a high-risk deficiency because the resident would likely notice fuel leak or spill before well contamination could occur.
- The pressure tank, jet pump and plumbing are in disrepair.

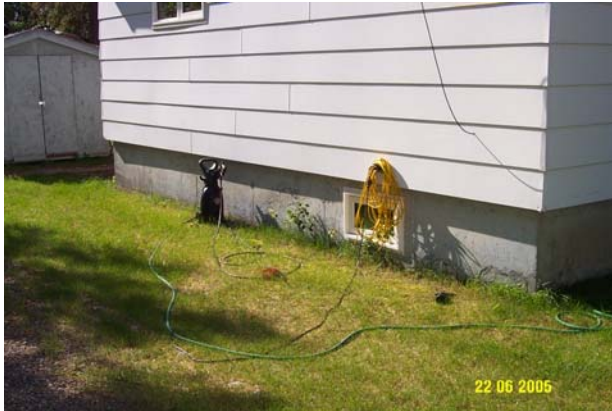
Building M0086, a Watson Lake RCMP Residence at 111 Stubenburg, is supplied water from a 14.3 m deep well. The well is located in a concrete enclosure adjacent to the basement. At the time of inspection the well was open. The well location and other site details are provided on Figure M0086-A in Appendix A12. The coordinates of the wellhead measured by a GPS device were:

Photo 0306: M0086 Watson Lake RCMP Residence – location of well off of basement

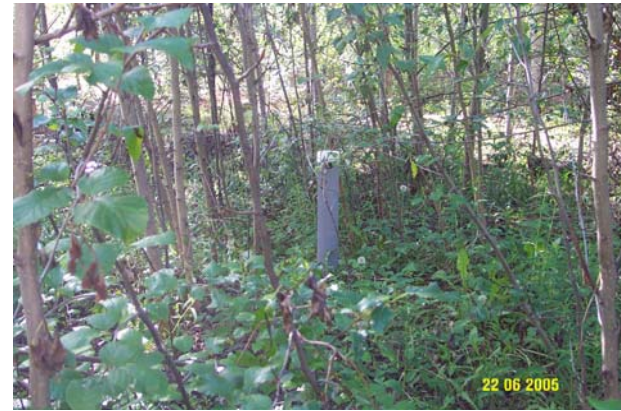
- The well is located within 30 m of potential sources of contamination, including the communal septic system;
- Poor surface completion of the well (located below grade in an enclosure off from basement, wellhead had no cap at time of inspection);
- The well is not equipped with a surface sanitary seal as required by the Canadian Groundwater Association's Well Construction Guidelines;
- At 14.3 m in depth, this well is considered a shallow well;
- By definition of the Draft Yukon GUDI Assessment Guideline, the well is potentially under the direct influence of surface water because it has a production zone less than 15 m below grade, and does not meet the requirements of the Guidelines for Water Well Construction; and,
- There is no disinfection system present, and the only treatment present is a water softener.

Photo 0304: M0086 Septic field

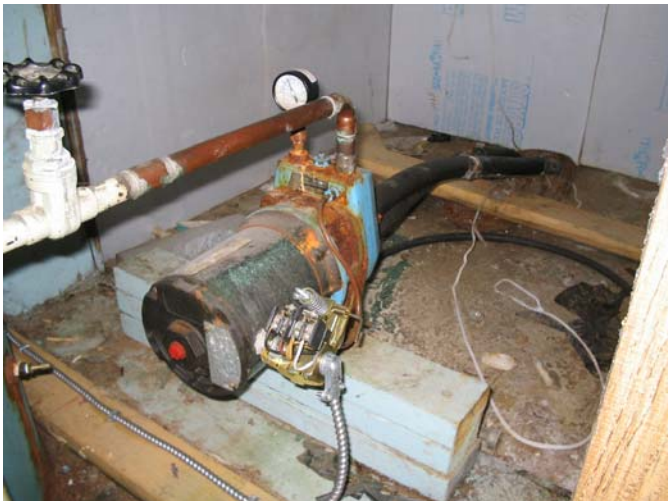
No seal cap - access into well directly is possible

THIS IS A OLD (1989) TOTALLY INADEQUATE INSTALLATION. THE WELL HEAD IS WIDE OPEN, NO SEAL OF ANY KIND. THE PUMP & TANK ARE BOTH AT THE END OF THEIR LIFE CYCLE. PRESSURE TANK IS SHOWING SIGNS OF LEAKAGE AS THE BOTTOM IS NEARLY RUSTED OUT COMPLETELY.

Photo 0043: M0086 Wellhead (back right), and jet pump (front centre)

- If not already completed, the well should be superchlorinated and a cap should be installed on the well casing; and,
- A point of use NSF-55 certified disinfection system with adequate pre-treatment should be installed.

CLEAN THE WELL MECHANICALLY, AFTER EXTENDING THE WELL CASING TO THE REQUIRED HEIGHT ABOVE GRADE. INSTALL A NEW PUMP SYSTEM. INSTALL ON PILGESS ADAPTER.

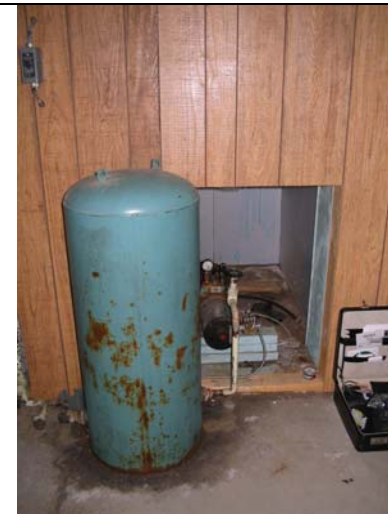
Photo 0044: M0086 Pressure tank (left) and wellhead enclosure off of basement of residence
