13.0 BUILDINGS M0087 AND M0088: WATSON LAKE RCMP RESIDENCES

SMALL PUBLIC WATER SYSTEMS ASSESSMENT
EASTERN REGION

SMALL PUBLIC WATER SYSTEM ASSESSMENT

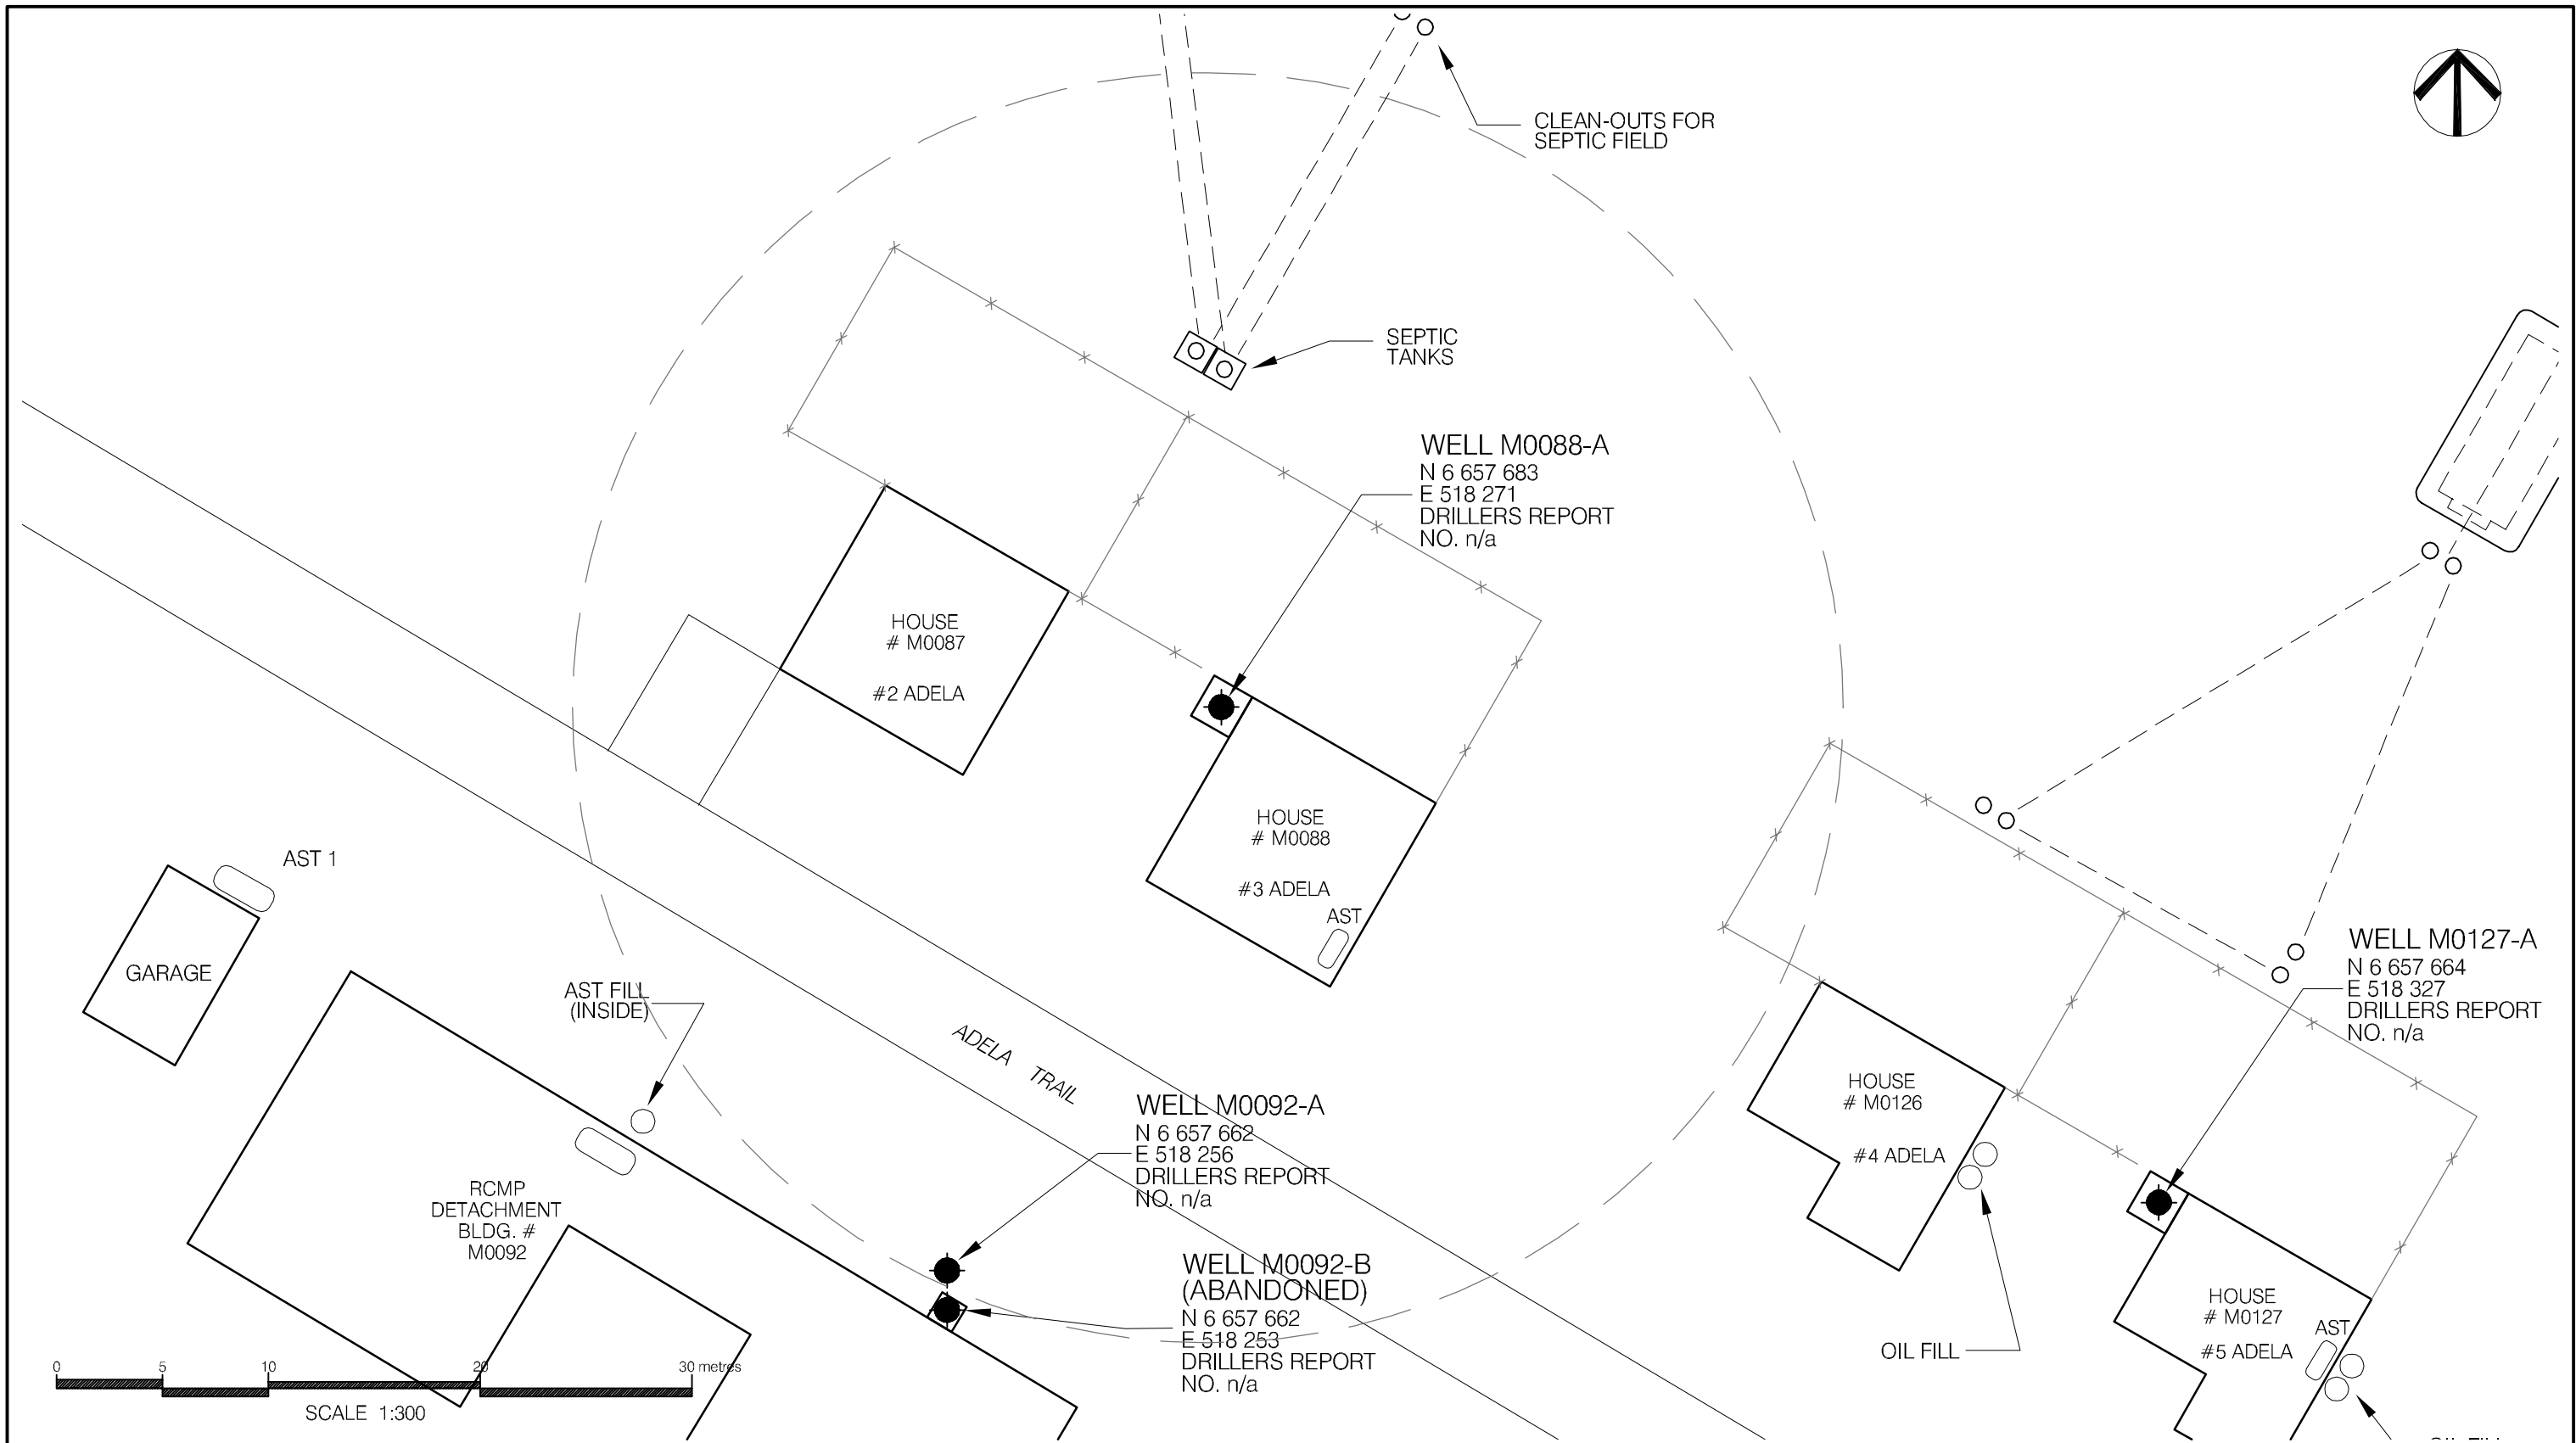
FIGURE No.
M0088-A

A shared septic tank and effluent field that is used for these two residences as well as the M0086 RCMP Residence is located approximately 20 m northwest of the M0088 well. Figure M0088-A, provided in Appendix A13, shows the location of the septic system.

- Septic field at 20 m;
- Fuel storage tank located in the basement of residence at 15 m (approx.).

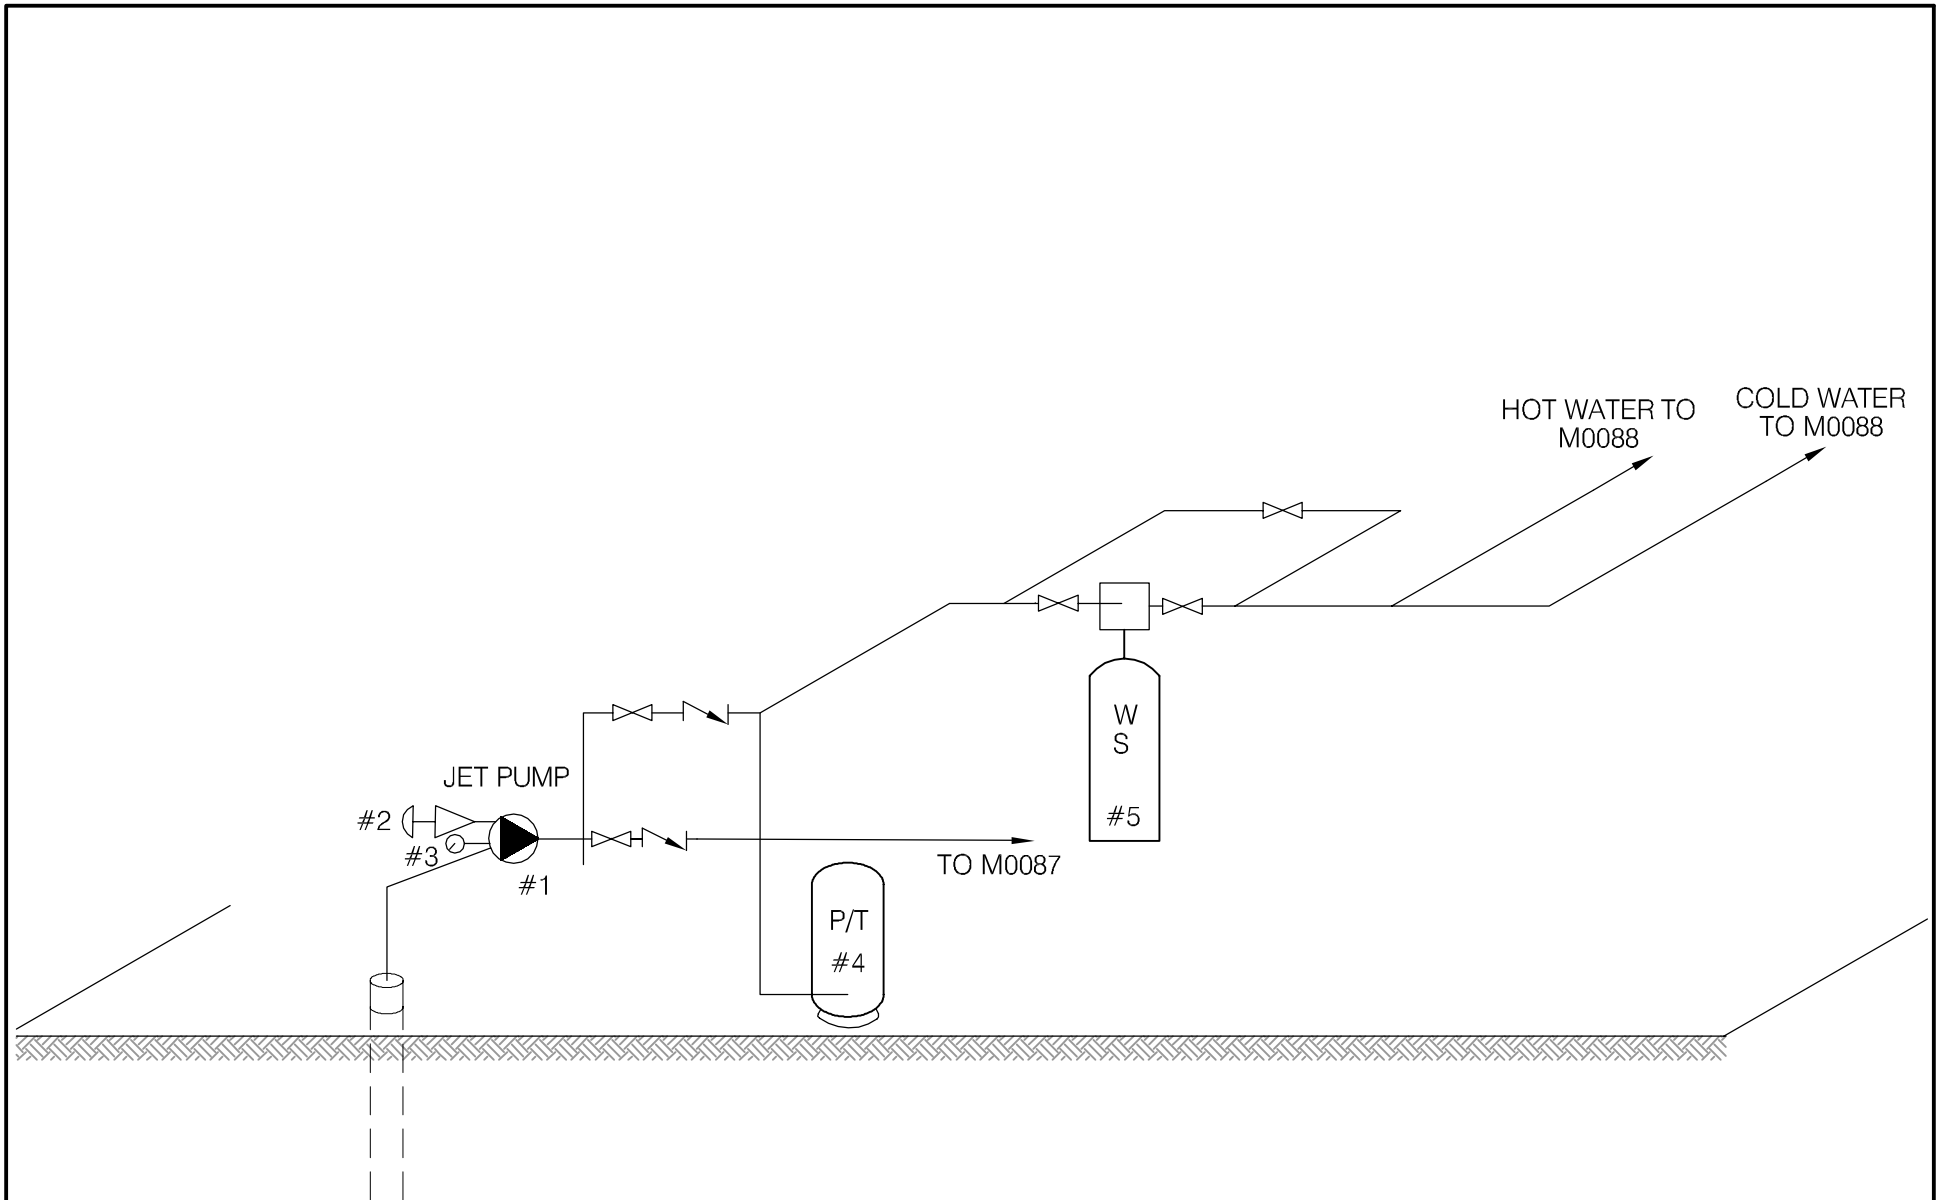
TITLE WATER SYSTEM DISTRIBUTION/TREATMENT SCHEMATIC SYSTEM ID.: M0088 WATSON LAKE RCMP RESIDENCE	
DATE	JULY 2005	DWN.	JSB
CHKD.	FMM	FILE NO.	1260002.002
		DWG.:	FIGURE M0088-B

The water system is equipped with a water softener, but not disinfection. A schematic detailing the water system is provided as Figure M0088-B in Appendix A13.

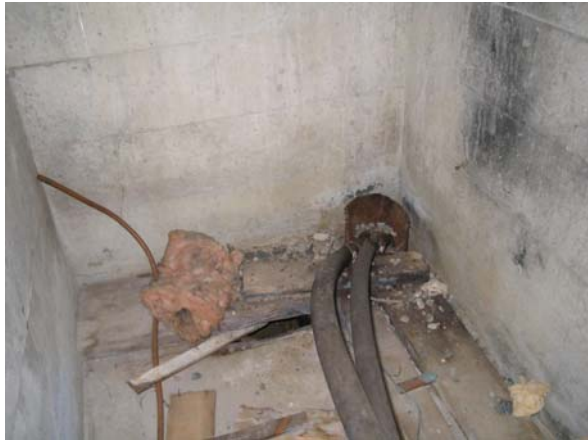
- The well is located within 30 m of potential sources of contamination, including the community septic system;
- Poor surface completion of the well (located below grade in an enclosure off basement, well had no cap);
- The well is not equipped with a surface sanitary seal as required by the Canadian Groundwater Association's Well Construction Guidelines;
- At 13.0 m in depth, this well is considered a shallow well;
- By definition of the Draft Yukon GUDI Assessment Guideline, the well is potentially under the direct influence of surface water because it is a vulnerable type (unconfined aquifer), has a production zone less than 15 m below grade, and does not meet the requirements of the Guidelines for Water Well Construction; and,
- There is no disinfection system present.

If no, describe condition No cap, casing is broken

Photo 0033: M0088 Wellhead in concrete enclosure off from basement of residence

- The well should be superchlorinated and a cap should be installed on the well casing; and,
- A NSF-55 certified UV system with pre-filter should be installed at the point of entry to the building. Pre-treatment may be required.

- A centralized treatment system should be installed in the basement of the RCMP detachment. This treatment system could consist of either a chlorine disinfection system with suitable retention or a UV disinfection (NSF/ANSI 55 certified) system. This is a conceptual design recommendation based on the information available, and is intended to be used for planning and budgeting purposes. Engineering input will be required for final system specifications or design.
- The wellhead construction of the existing detachment well should be improved, including extending the well to at least 500 mm above grade and installing a commercial pitless unit. A surface sanitary seal (grout or bentonite) to at least 3 m

below grade should be retrofitted around the well and then the ground be graded to promote surface drainage away from the wellhead;

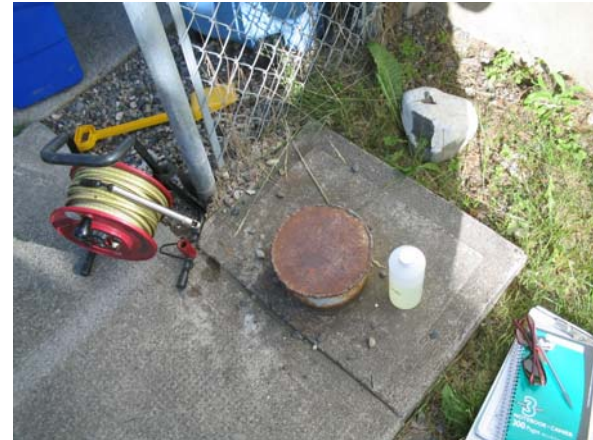
Photo 0037: M0088 Well casing extended above grade – not connected to casing below

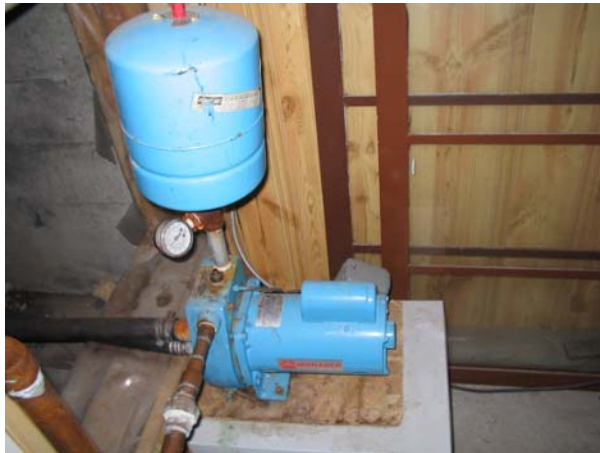
JET PUMP INSTALLATION IS UNSAFE.
THERE IS NO SANITARY SEAL ON WELL HEAD.
THE WELL IS WIDE OPEN TO CONTAMINATION
OF ALL SORTS.
THE INSTALLATION BEYOND THE JET PUMP
IS GOOD.

Photo 0032: M0088 Jet pump and pressure tank

AS THERE IS NO POSSIBILITY OF
PERFORMING ANY WELL MAINTENANCE,
A NEW WELL SHOULD BE DRILLED FOR
THE COMPLEX. PROPER TREATMENT
MUST BE PROVIDED. THIS WELL COULD
POSSIBLY SERVE THE WHOLE COMPLEX.

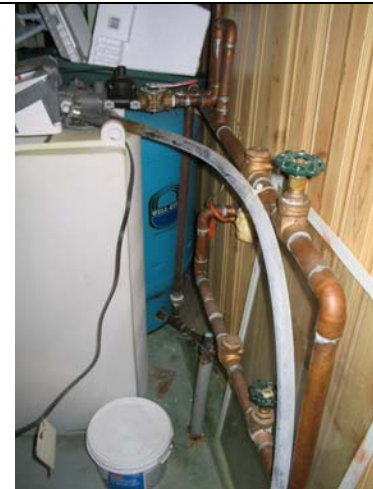
Photo 0034: M0088 Water softener (left), and pressure tank (behind)
