## **15.0 BUILDINGS M0126 AND M0127: WATSON LAKE RCMP RESIDENCE**

SMALL PUBLIC WATER SYSTEMS ASSESSMENT  
 EASTERN REGION

WATSON LAKE RCMP HOUSE  
 BUILDING # M0127  
 SITE LOCATION DIAGRAM  
 WELL ID: M0127-A

TITLE WATER SYSTEM DISTRIBUTION/TREATMENT SCHEMATIC SYSTEM ID.: M0127 WATSON LAKE RCMP HOUSING	
DATE	JULY 2005	DWN.	JSB
CHKD.	FMM	FILE NO.	1260002.002
		DWG.:	FIGURE M0127-B

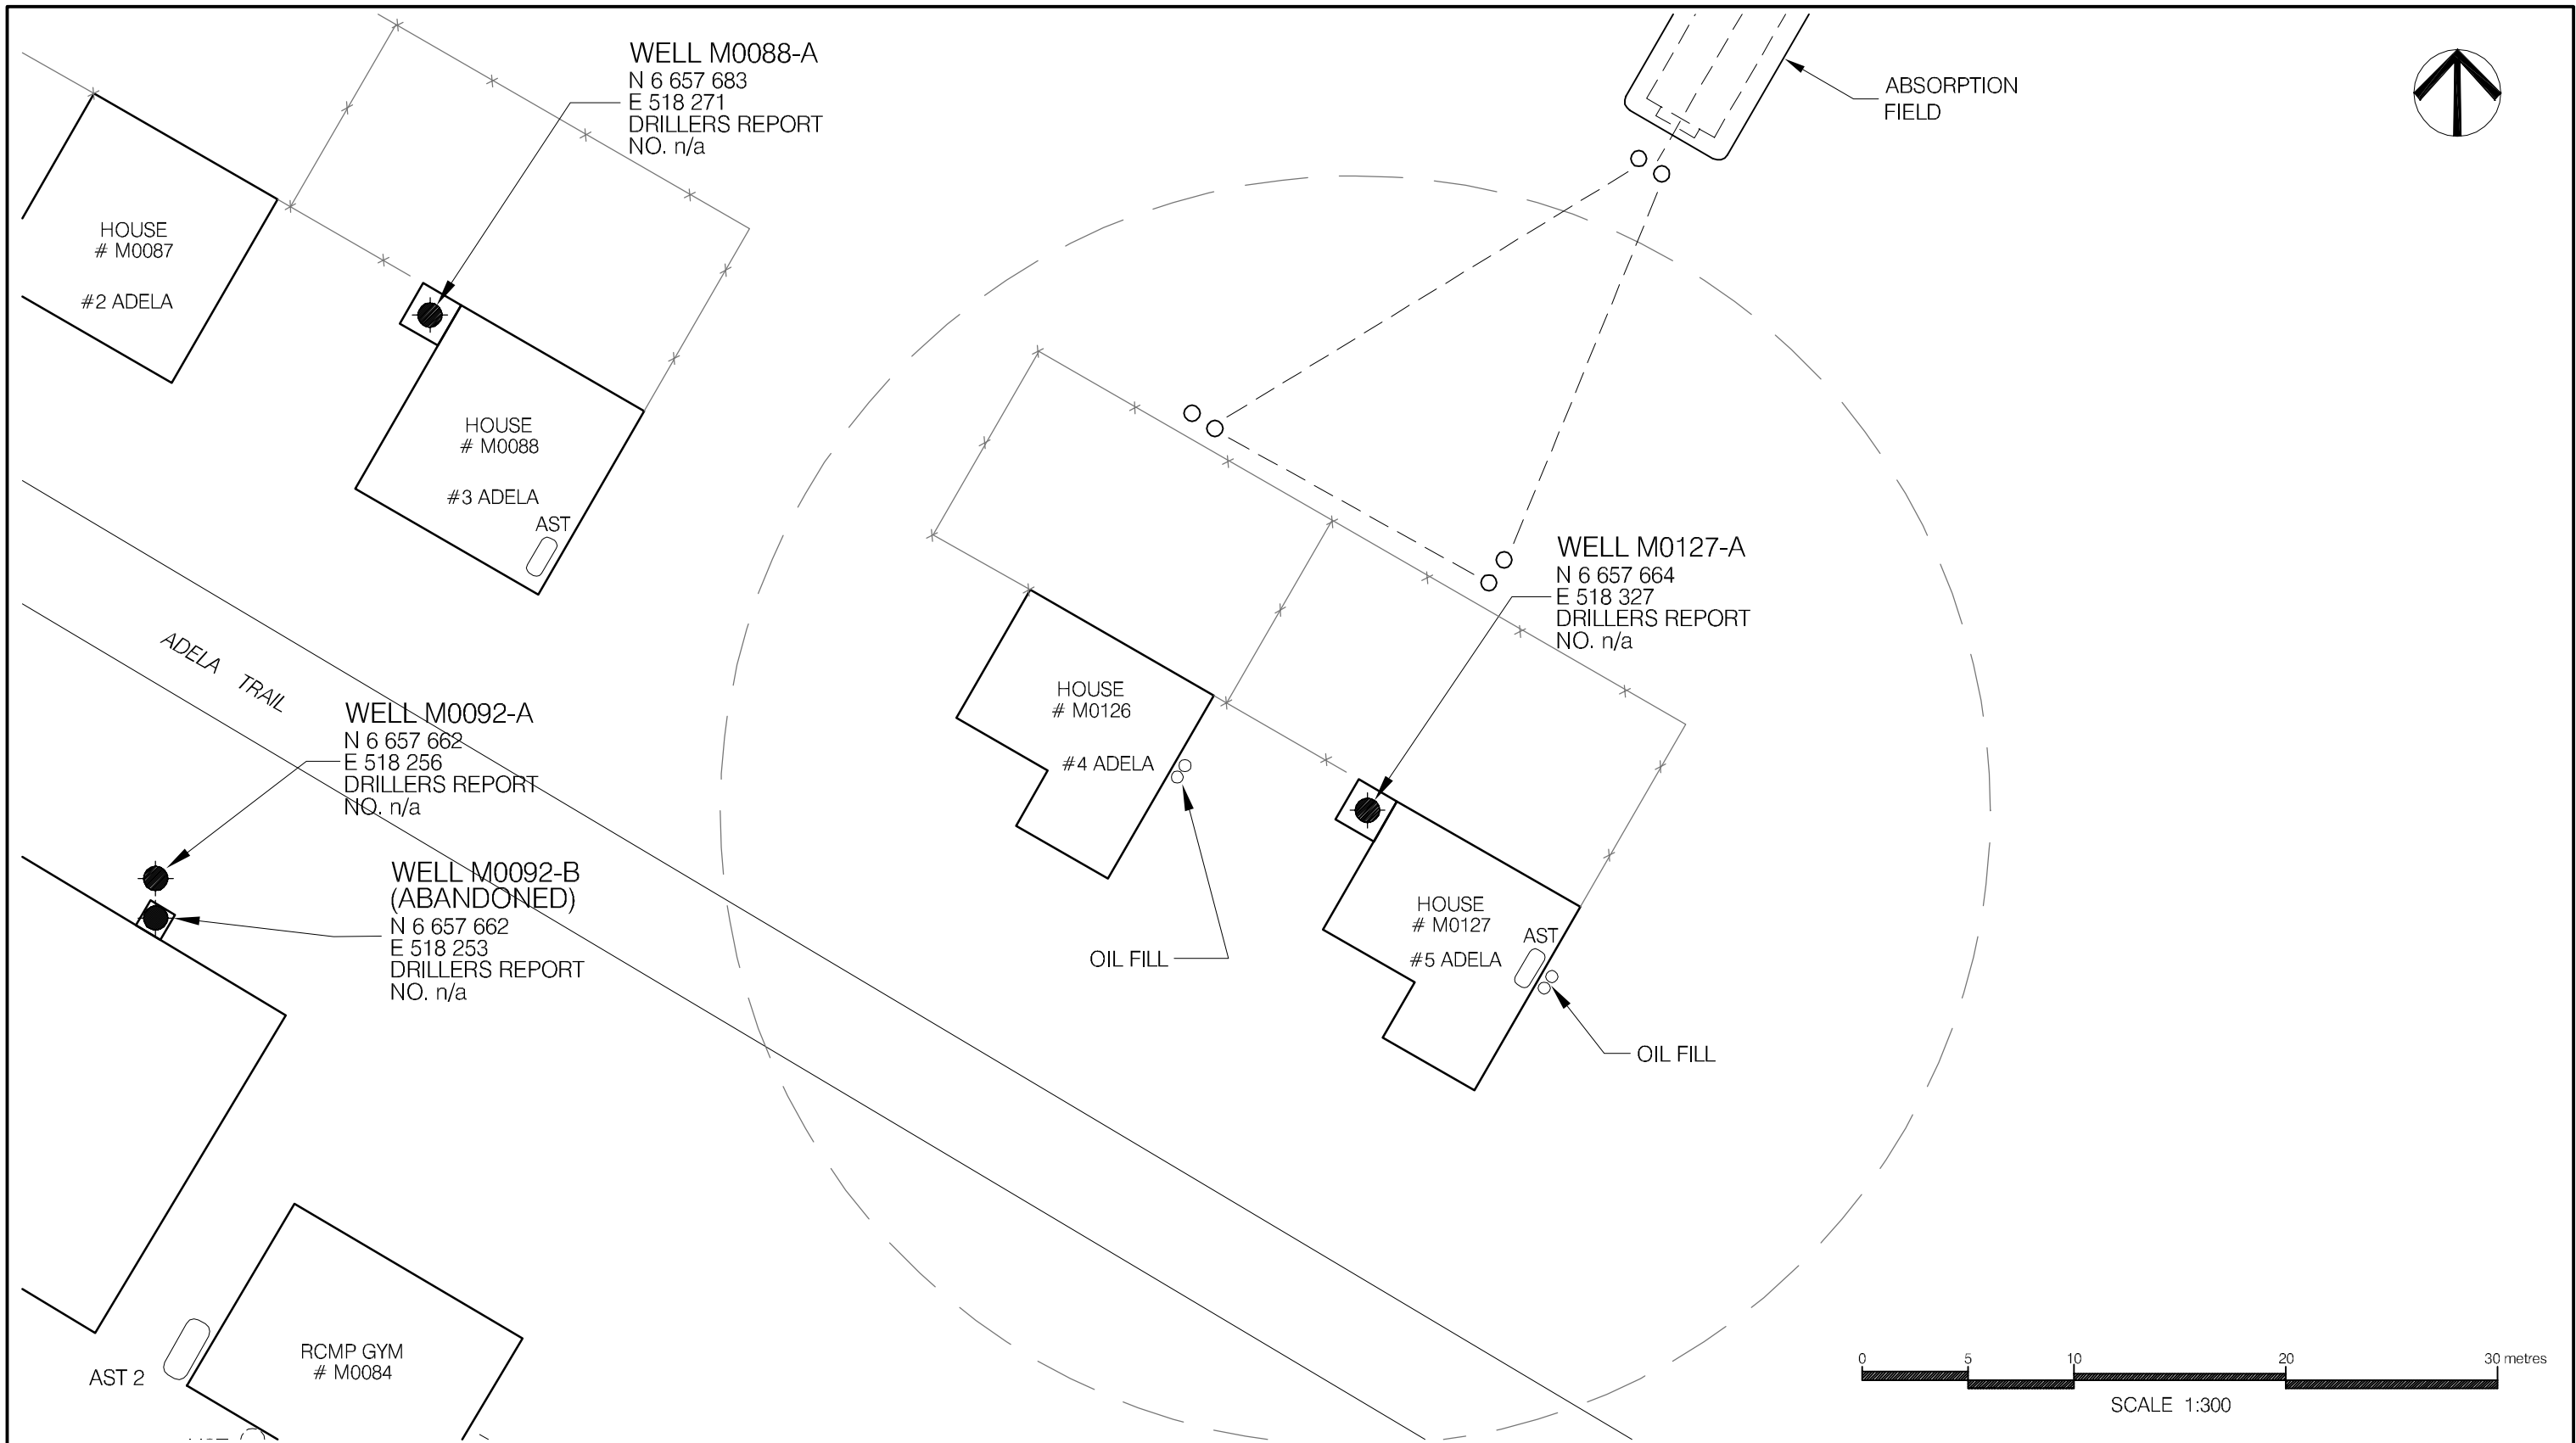
REVISION ISSUE  
 0  
 FIGURE No.  
 M0127-A

There is a community septic field that is used communally by these two residences located approximately 35 m north of the M0127 well. Figure M0127-A, provided in Appendix A15, shows the location of the septic system.

30 m RADIUS FROM WATER WELL FOR CONSIDERATION OF PROXIMITY TO POTENTIAL CONTAMINANT SOURCES.

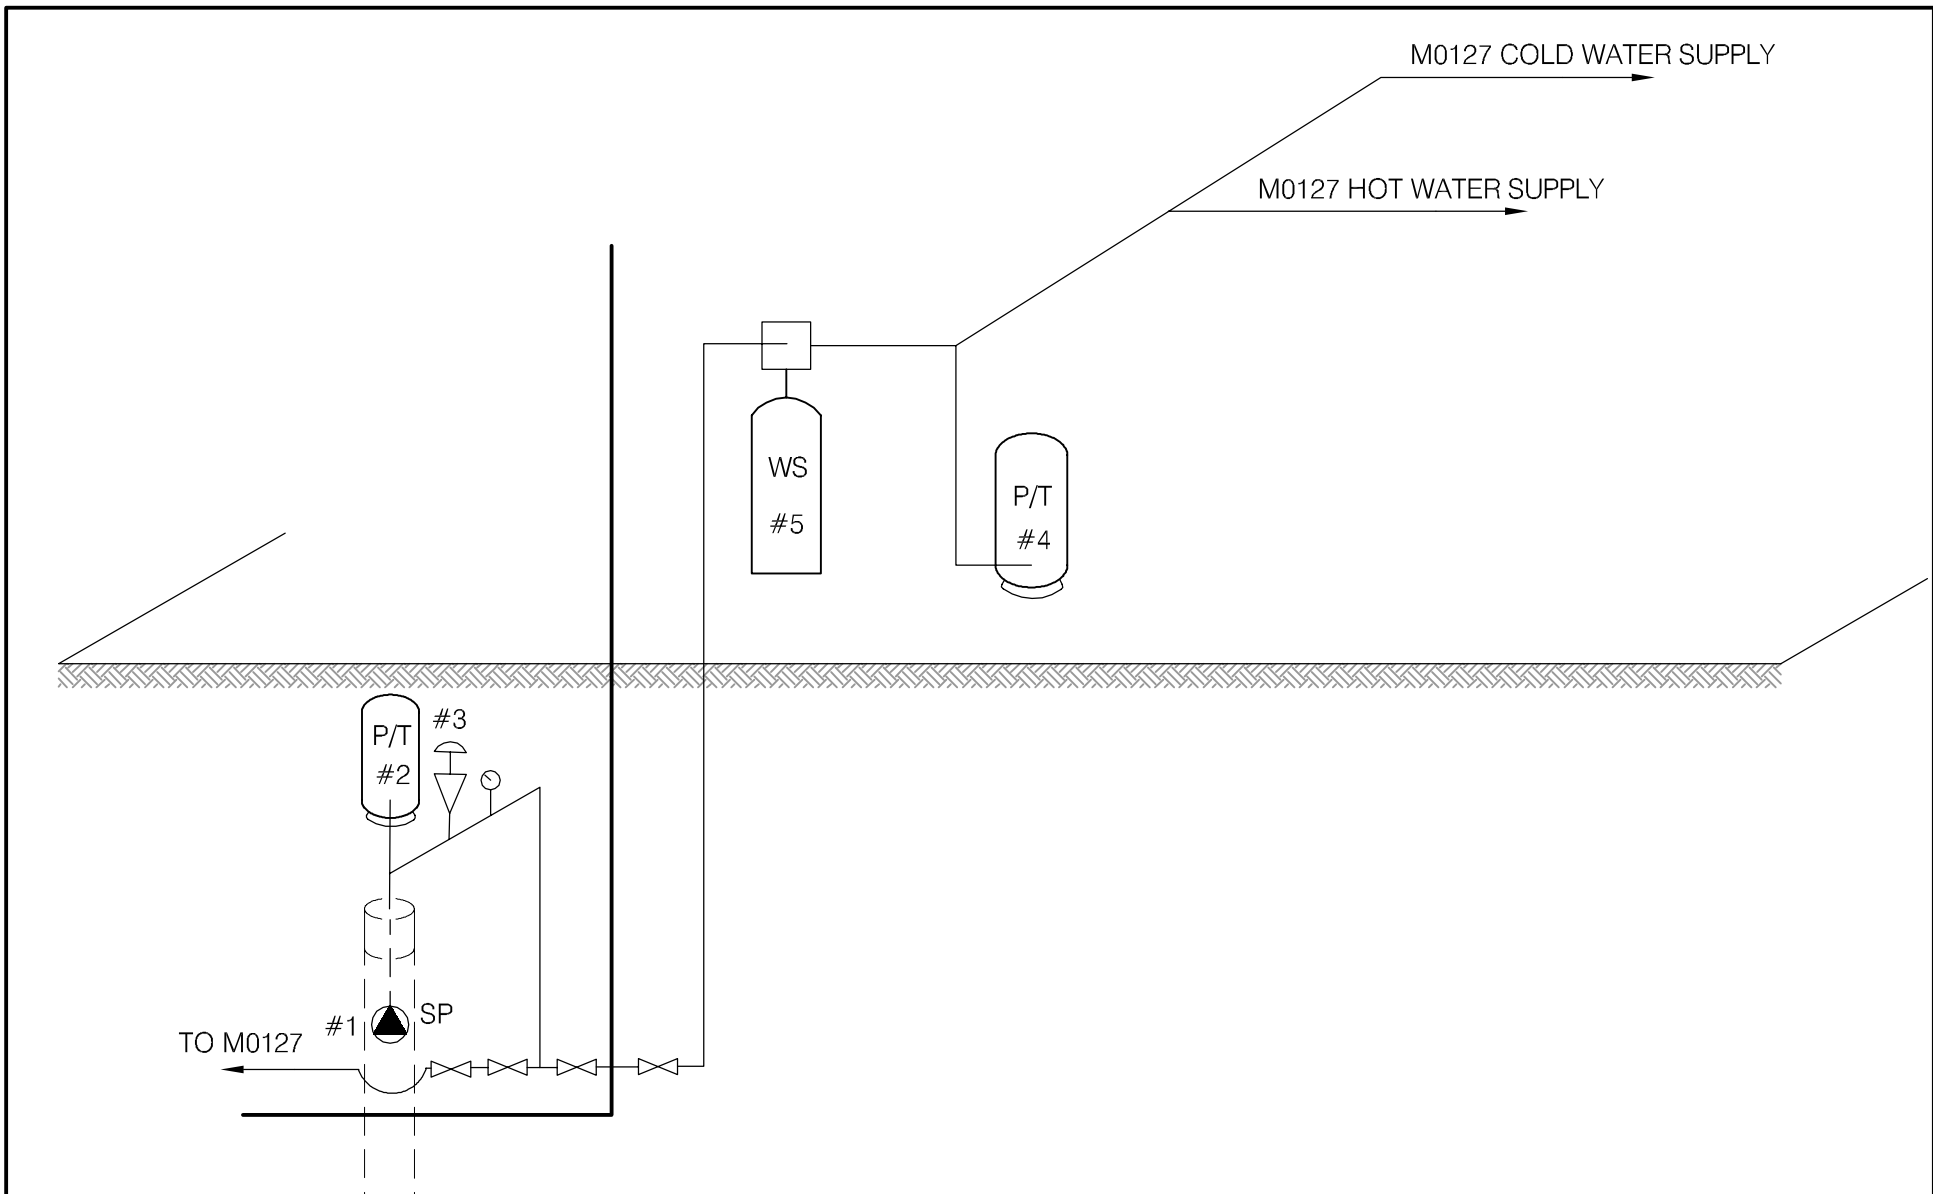
The water system is equipped with a water softener, but no disinfection. A schematic detailing the water system is provided as Figure M0127-B in Appendix A15.

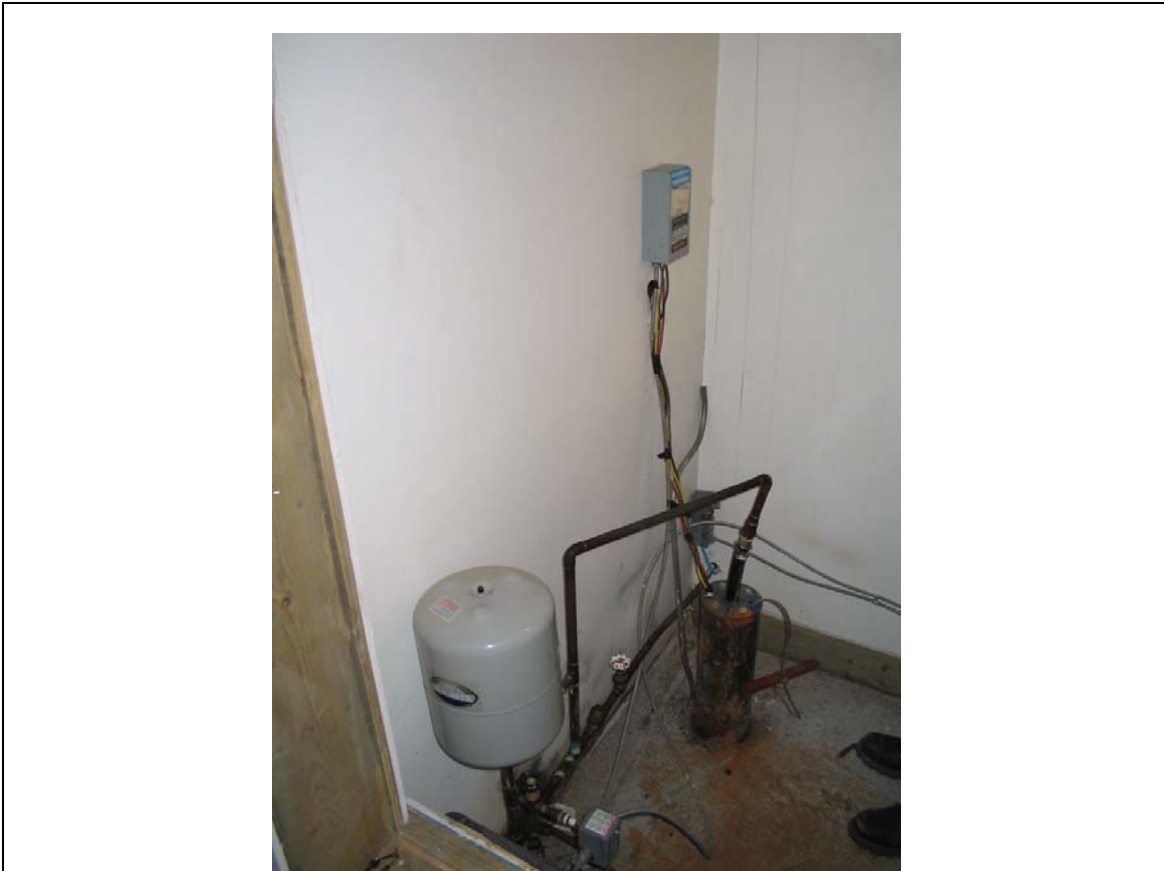
- Poor surface completion of the well (located below grade in an enclosure off from basement);
- The well is not equipped with a surface sanitary seal as required by the Canadian Groundwater Association's Well Construction Guidelines;
- By definition of the Draft Yukon GUDI Assessment Guideline, the well is potentially under the direct influence of surface water because it is a vulnerable type (unconfined aquifer), has a production zone less than 15 m below grade, and does not meet the requirements of the Guidelines for Water Well Construction;

- i. Is the well head below grade? describe in detail ~1.75m below grade
- ii. Are there signs of ponding on the enclosure(e.g. water stains, etc.)?  Yes  No  
Some rusting is present
- iii. Is the wellhead enclosed by fiberglass insulations?  Yes  No  
However, likely in walls of enclosure
- iv. Any evidence of rodents? Specify No, but access is possible
- v. Does the well casing have a proper seal cap?  Yes  No

**Photo 0040:** M0127 Wellhead (right) in wellhead enclosure off from basement of residence, and pressure tank (left)

- The wellhead construction of the existing detachment well should be improved, including extending the well to at least 500 mm above grade and installing a commercial pitless unit. A surface sanitary seal (grout or bentonite) to at least 3 m below grade should be retrofitted around the well and then the ground be graded to promote surface drainage away from the wellhead;

Well casing to be extended to proper height above ground. install pitless adapter. institute a bi annual well maintenance program of shock chlorination of well & piping. install appropriate UV system. water softener must be properly maintained.

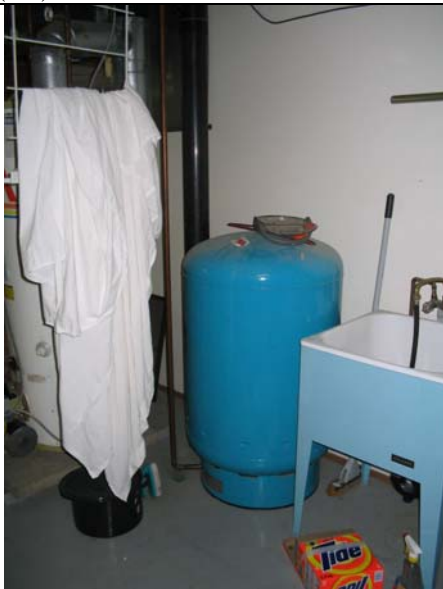
**Photo 0038:** M0127 Pressure tank

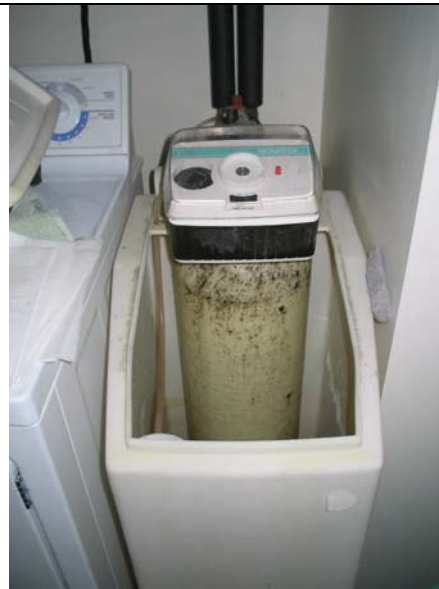
**Photo 0039:** M0127 Water softener
