17.0 BUILDING 4836: WATSON LAKE GRADER STORAGE BUILDING

SMALL PUBLIC WATER SYSTEMS ASSESSMENT
 EASTERN REGION

GOVERNMENT OF YUKON
 HIGHWAYS & PUBLIC WORKS

WATSON LAKE GRADER WORKSHOP
 BUILDING # 4836
 SITE LOCATION DIAGRAM
 WELL ID: 4836-A

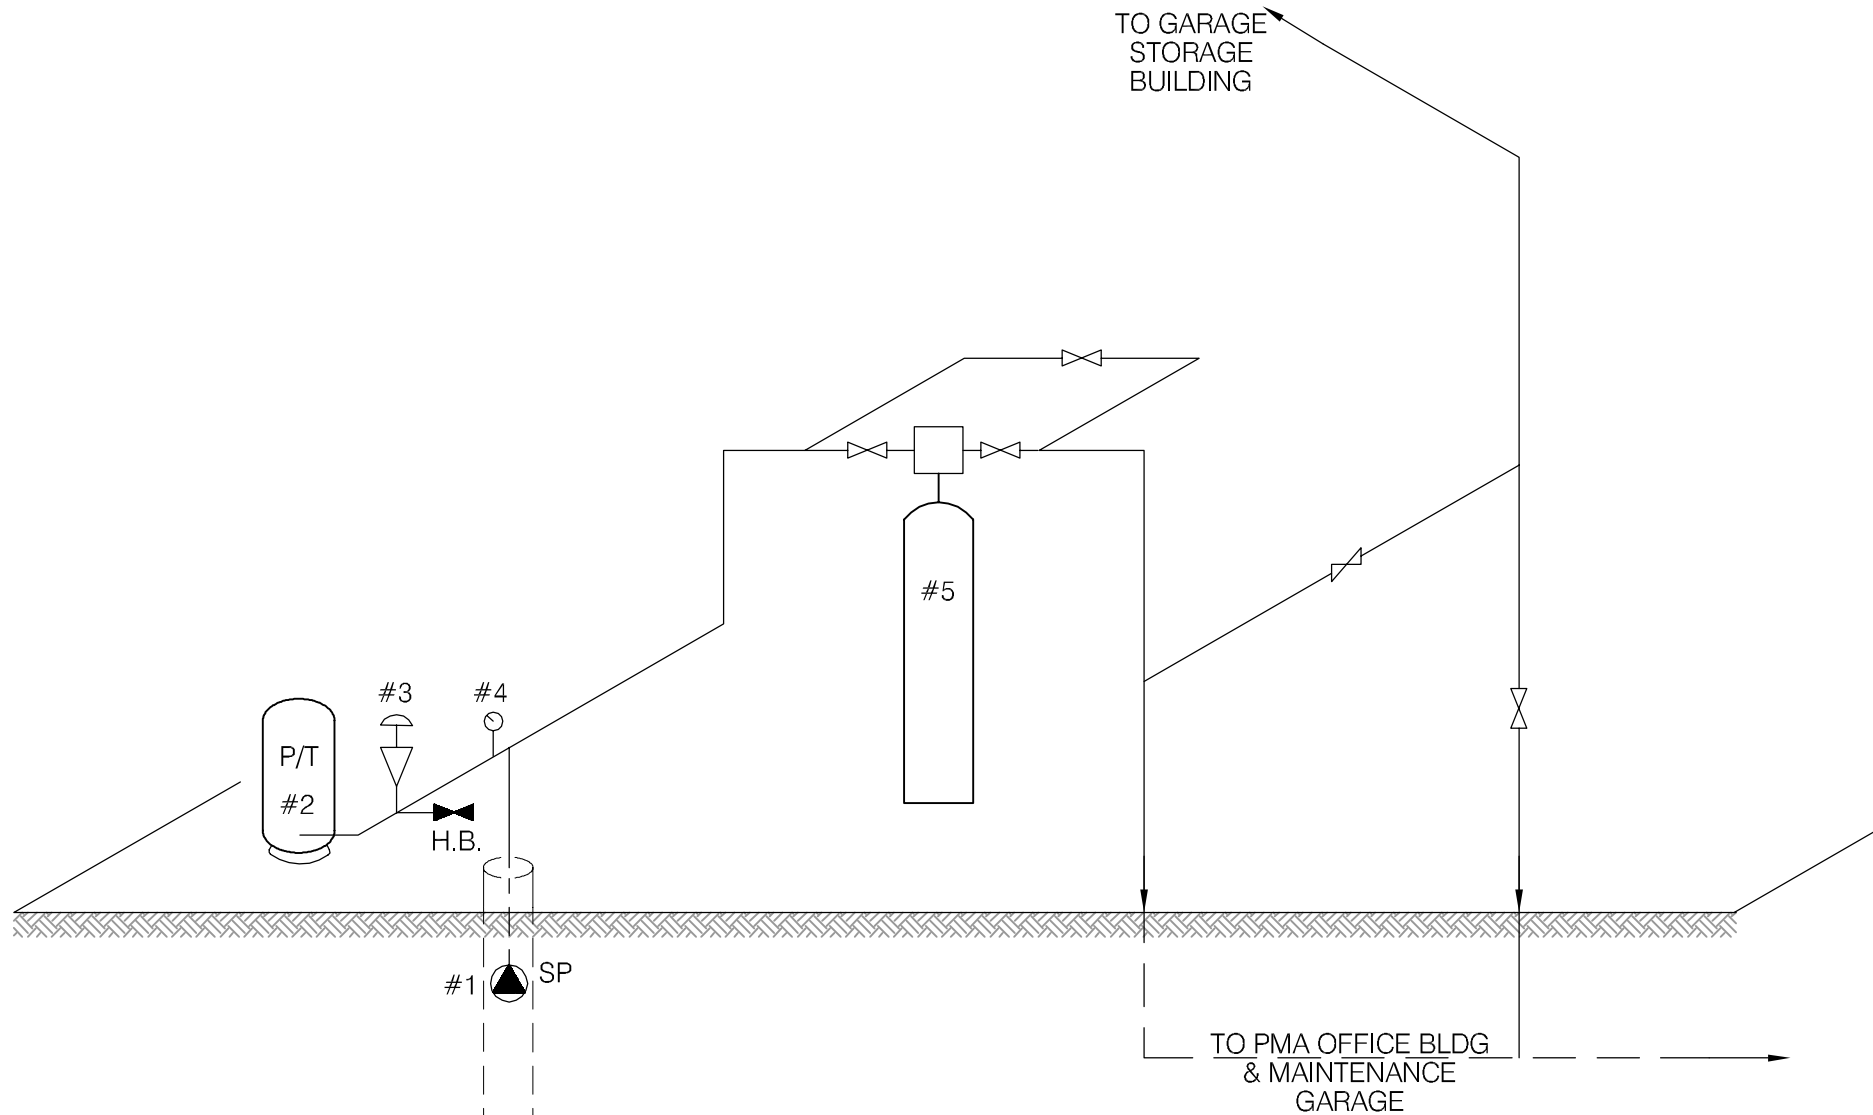
TITLE WATER SYSTEM DISTRIBUTION/TREATMENT SCHEMATIC SYSTEM ID.: 4836 WATSON LAKE GRADER STORAGE BUILDING	
DATE	JULY 2005	DWN.	JSB
CHKD.	FMM	FILE NO.	1260002.002
		DWG.:	FIGURE 4836-B

The grader storage building is equipped with water softening treatment system. The well also serves the grader station maintenance garage and the Property Management Agency Office in Watson Lake. A schematic detailing the water system is provided as Figure 4836-B in Appendix A17.

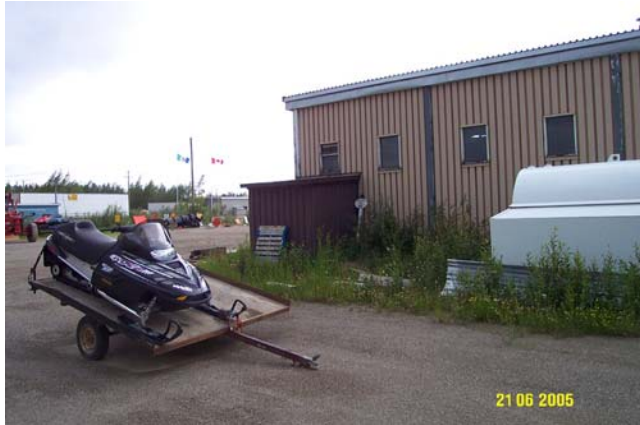
- Waste oil burner at 16 m; and,
- Above ground fuel storage tank at 11 m.

Photo 0273: 4836 Grader Storage Building and wellhead enclosure addition (back), above ground fuel storage tank (right)

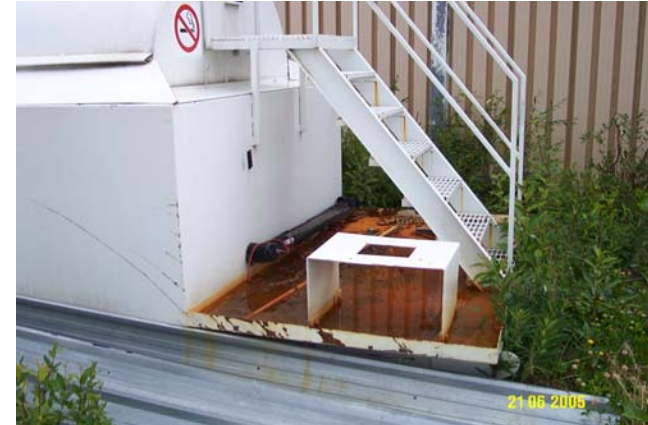
- The wellhead is located within 30 m of potential sources of contamination, including sewer service lines within 30 m and a waste oil burner at 16 m;
- There is an above ground fuel storage tank located 16 m from the well;
- The manganese concentration in the water is in exceedence of CDWQG aesthetic objectives;
- There is and above ground fuel storage tank located 7 m from the well, but it is a double-walled EnviroTank with secondary containment;
- A transformer oil spill at the site, and,
- Total dissolved solids, however, continue to be high post-treatment;

Photo 0275: 4836 Above ground fuel storage tank

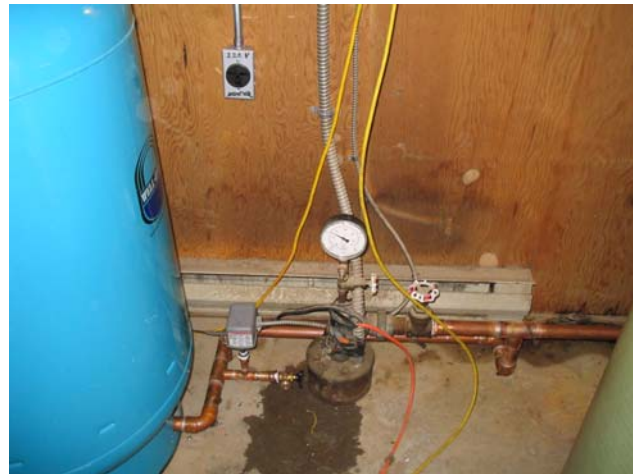
- There is no surface sanitary seal (grout or bentonite seal as required by the Canadian Groundwater Association's Well Construction Guidelines);
- By definition of the Draft Yukon GUDI Assessment Guideline, the well is potentially under the direct influence of surface water (because it does not meet the requirements of the Guidelines for Water Well Construction);

- There is no disinfection system;
- Poor surface completion of the wellhead (located in an attachment to the garage, the wellhead is only 100 mm above grade).

Photo 0017: 4836 Wellhead (centre), pressure tank (left)

- The wellhead completion should be improved. This would involve, among other things, raising the well casing to a minimum of 500 mm above ground level; and,
- A detailed hydrogeological study and water quality assessment should be performed in the area to determine the cause of the elevated barium and chloride concentrations.

- A surface sanitary seal (grout or bentonite) to a depth of at least 3 m below grade should be installed. The ground surface in the vicinity of the wellhead should then be graded to promote surface drainage away from the well.

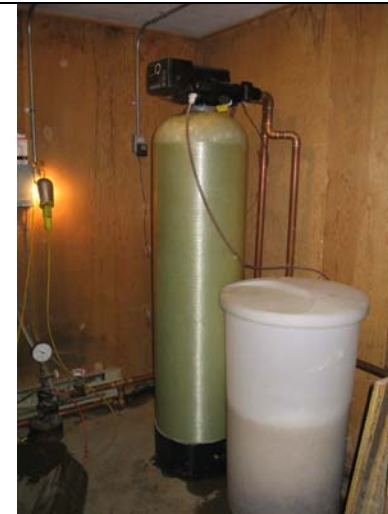
It was observed during the site inspection that the water system at this site is equipped with a new water softener. Results from previous sampling show that there was no functioning water softening system at the time when baseline water quality analysis was taken. Additional analytical results show a significant improvement of the water quality:

Photo 0018: 4836 Water softener and brine tank
