18.0 BUILDING 4841: WATSON LAKE VISITOR RECEPTION CENTRE

TITLE WATER SYSTEM DISTRIBUTION/TREATMENT SCHEMATIC SYSTEM ID.: 4841 WATSON LAKE VISITOR RECEPTION CENTRE	
DATE	JULY 2005	DWN.	JSB
CHKD.	FMM	FILE NO.	1260002.002
		DWG.:	FIGURE 4841-B

PROJECT SMALL PUBLIC WATER SYSTEMS ASSESSMENT
EASTERN REGION

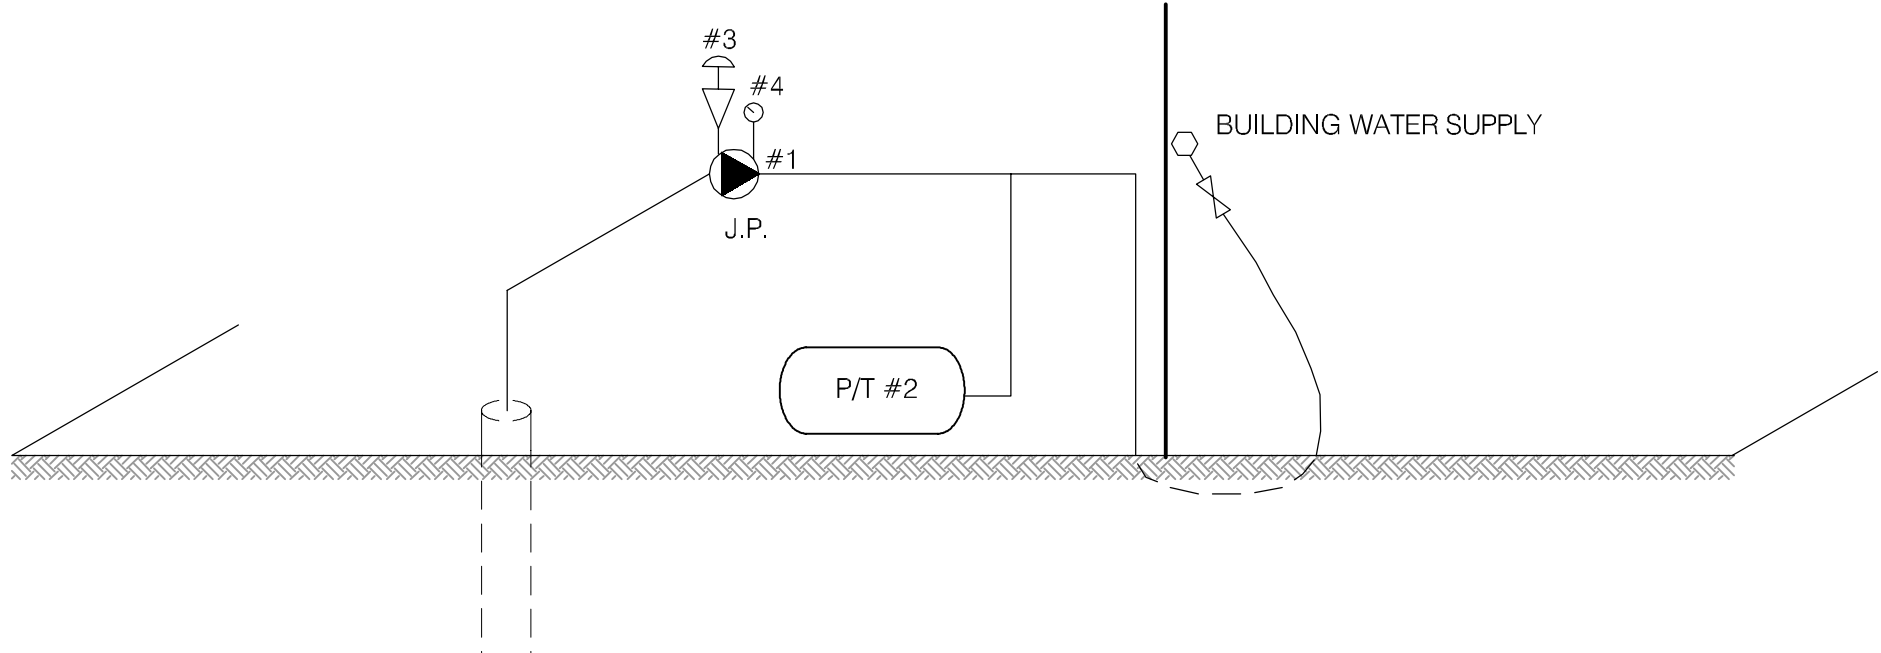
LOCATED IN BASEMENT STORAGE AREA

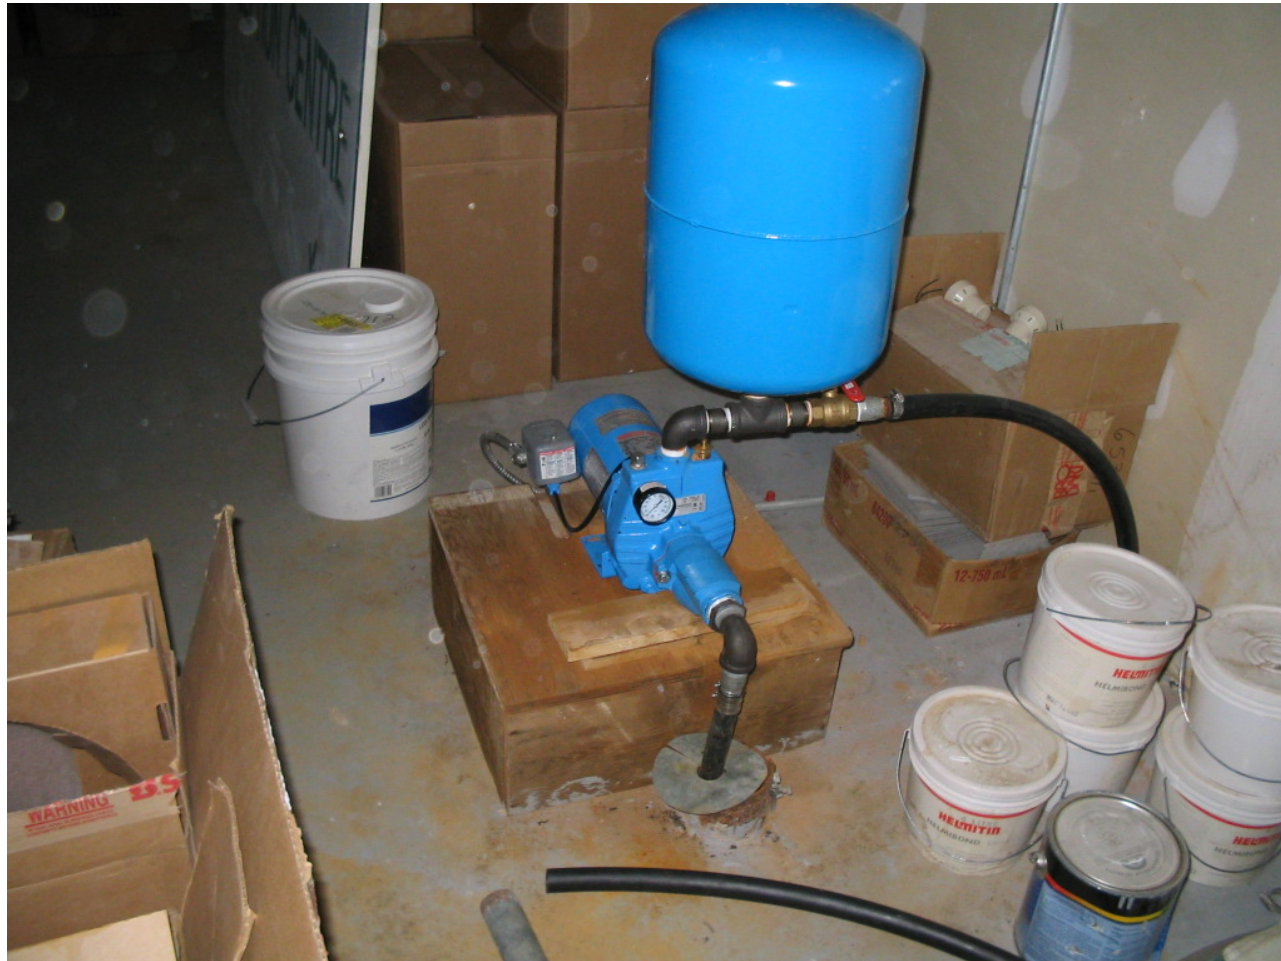
- The wellhead is located in the basement of the visitor reception centre and is not equipped with a proper cap on the casing and is open.
- There is no surface sanitary seal (grout or bentonite seal as required by the Canadian Groundwater Association's Well Construction Guidelines);
- At 10.7 m deep, the well is considered to be a shallow well. The well, therefore, would be considered to be at high-risk of contamination from surface sources;
- By definition of the Draft Yukon GUDI Assessment Guideline, the well is potentially under the direct influence of surface water because it is a vulnerable type (unconfined aquifer with a production zone that is less than 15 m below grade and does not meet the requirements of the Guidelines for Water Well Construction; and,
- There is no treatment or disinfection system present.

Photo 0030: 4841 Well (centre), jet pump (behind well), and pressure tank (behind jet pump) in basement of Visitor Reception Centre – system not currently in use

- In order to protect the aquifer, it would be prudent superchlorinate and install a well cap or welded cover.

- In order to mitigate the deficiencies associated with the existing well at the Watson Lake Visitor Reception Centre, the piped distribution system from the Town of Watson Lake should be repaired as so to prevent freezing, and the existing well should be properly decommissioned in accordance with the Guidelines for Water Well Construction.
