19.0 BUILDING 4842: CASSIAR WEIGH SCALES

SMALL PUBLIC WATER SYSTEMS ASSESSMENT
EASTERN REGION

CASSIAR WEIGH SCALE
BUILDING # 4842
SITE LOCATION DIAGRAM
WELL ID: 4842-A

SMALL PUBLIC WATER SYSTEM ASSESSMENT

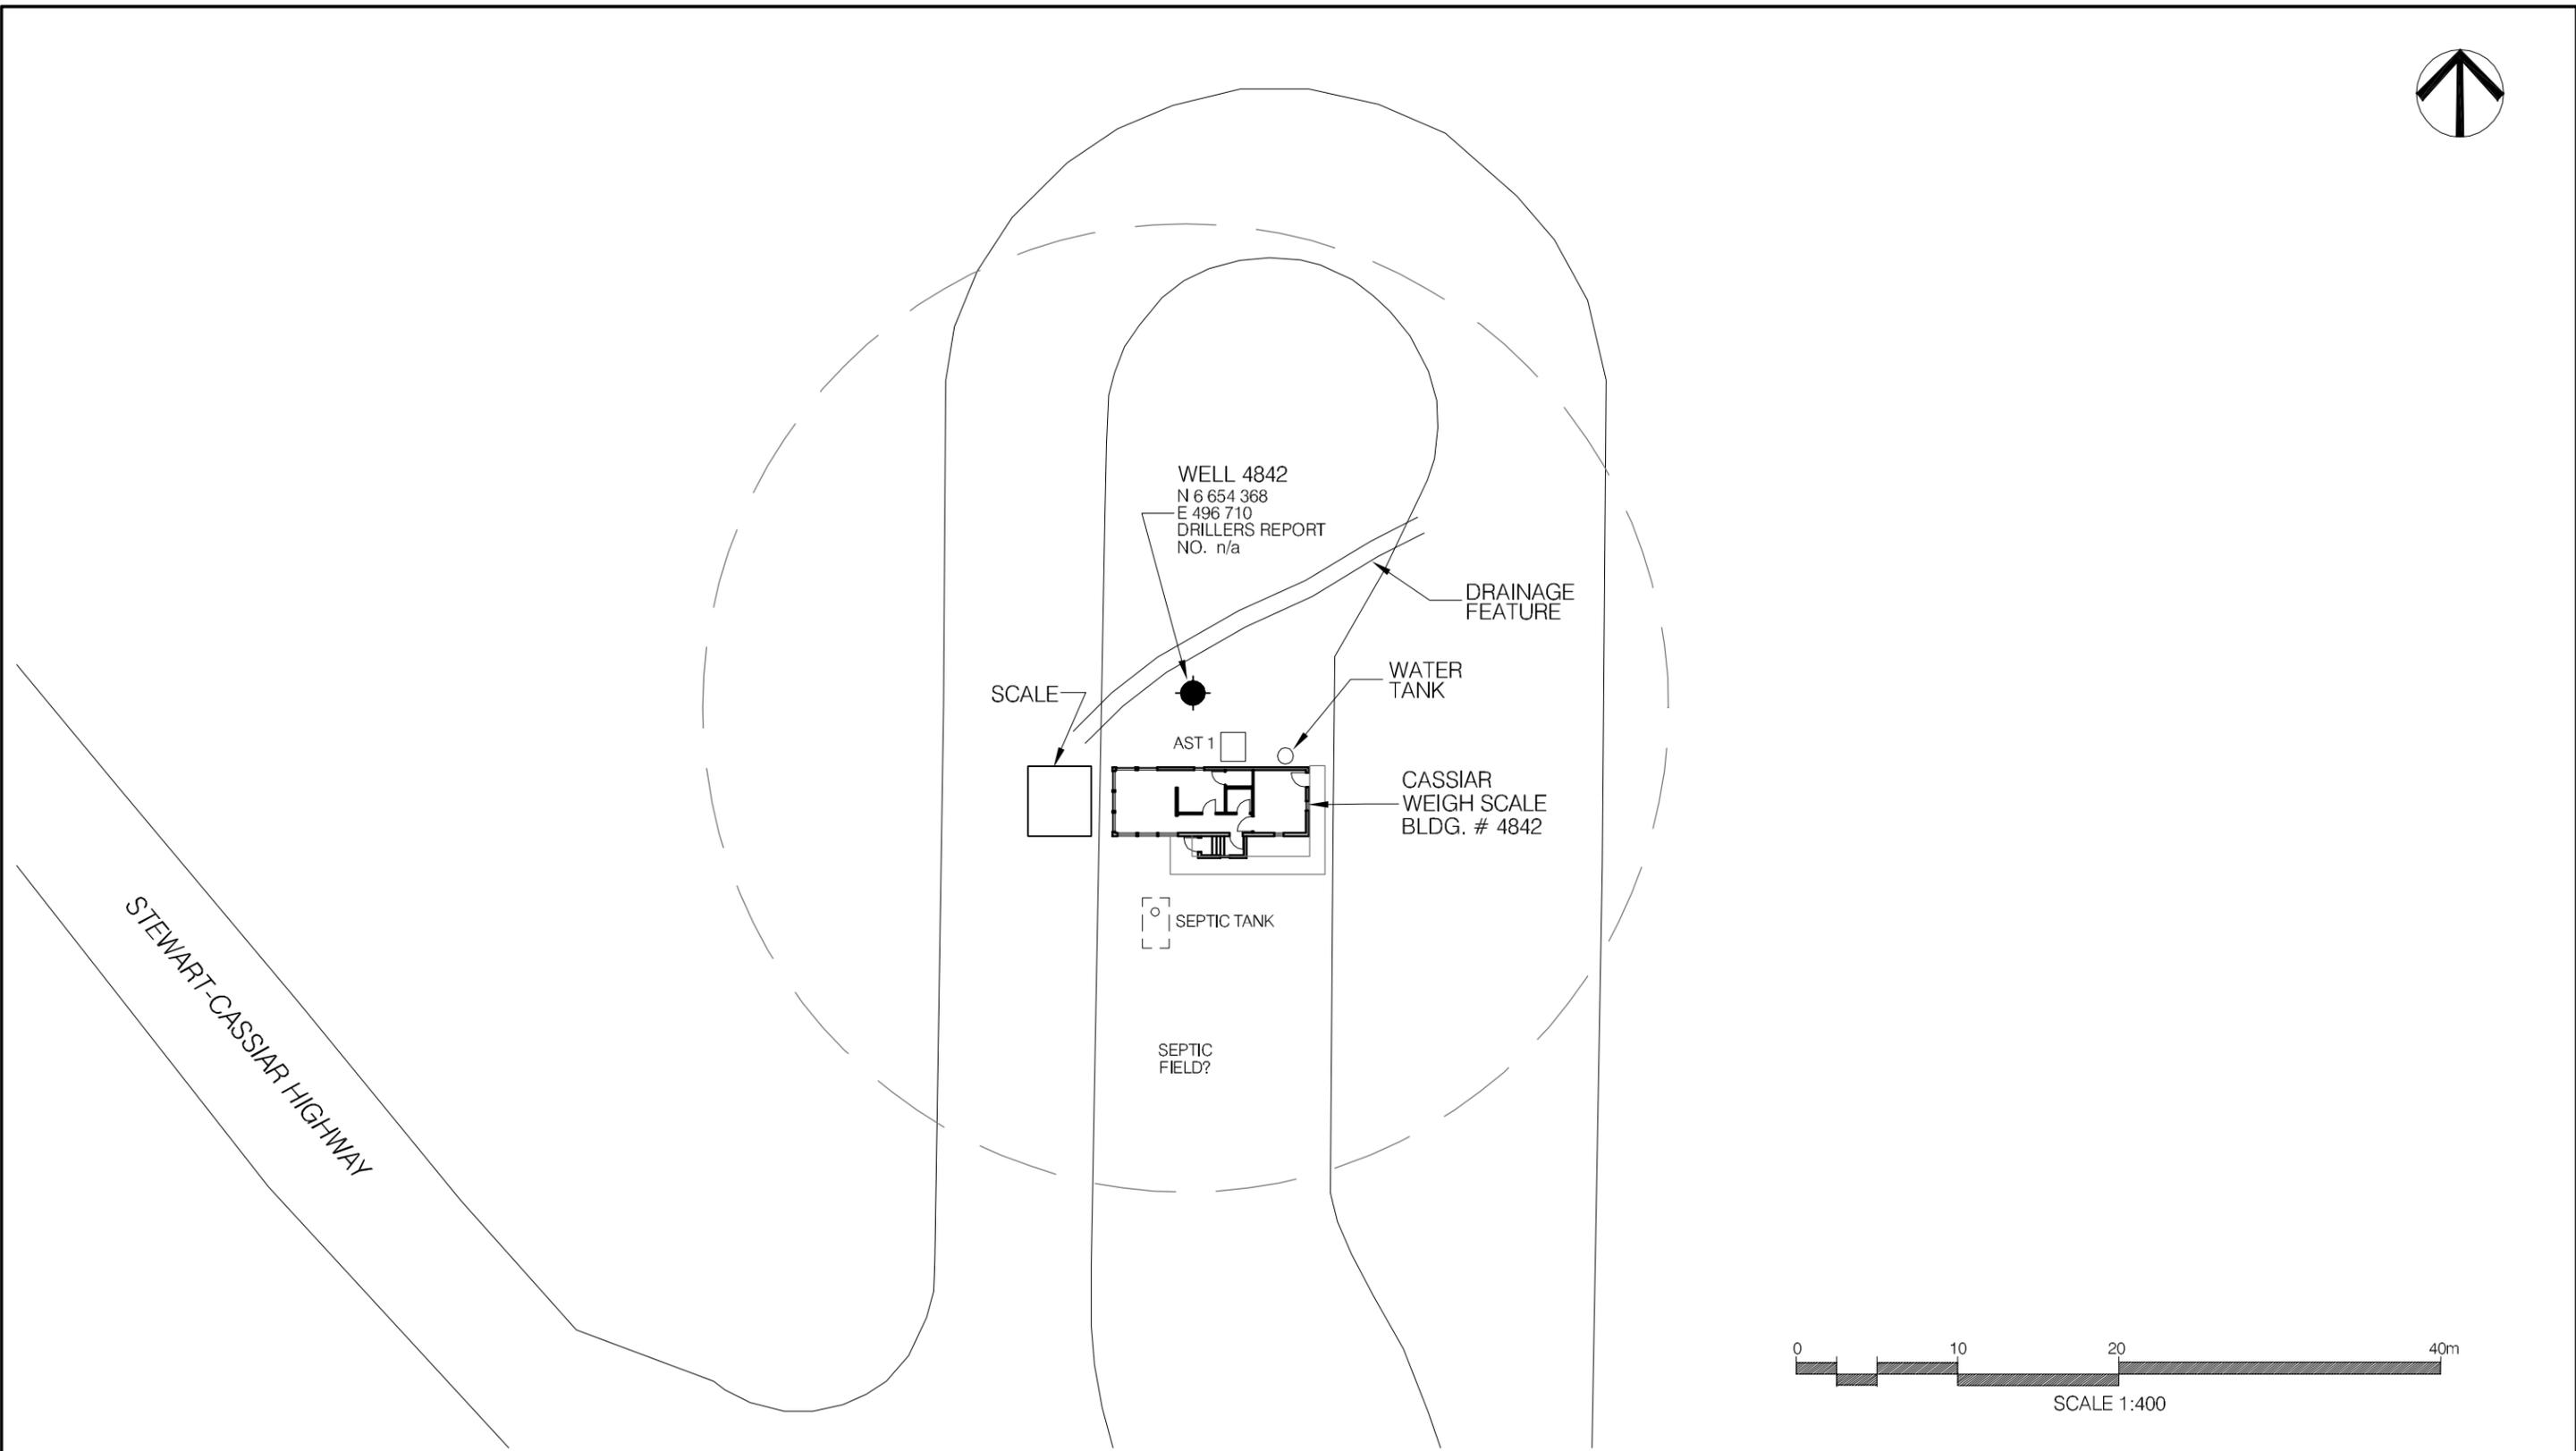
FIGURE No.
4842-A

The septic tank for the Cassiar Weigh Scales is located south of the weigh scales office on the opposite side of the well approximately 13 m away. Whether the septic tank is routinely pumped out, or discharges effluent to an inground sewage disposal field is unknown at this time. A site plan showing the septic system is given by Figure 4842-A in Appendix A19.

-
- Septic tank 13 m from the well (effluent field potentially within 30 m, however, this requires verification);
 - Above ground fuel storage tank 1 m from the well, and;
 - A drainage feature runs within 1 m of the well during wet periods, which may result in surface water infiltration to the well.

It should be noted that it was unclear whether there was a septic field at this site, or whether it was only a holding tank. An investigation should be carried out in order to determine if there is an actual effluent disposal field on the property and its proximity with respect to the well.

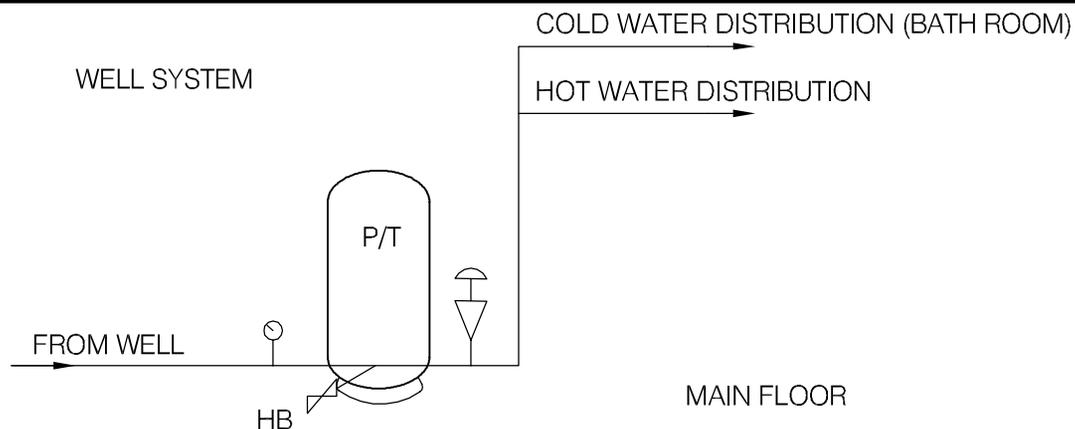
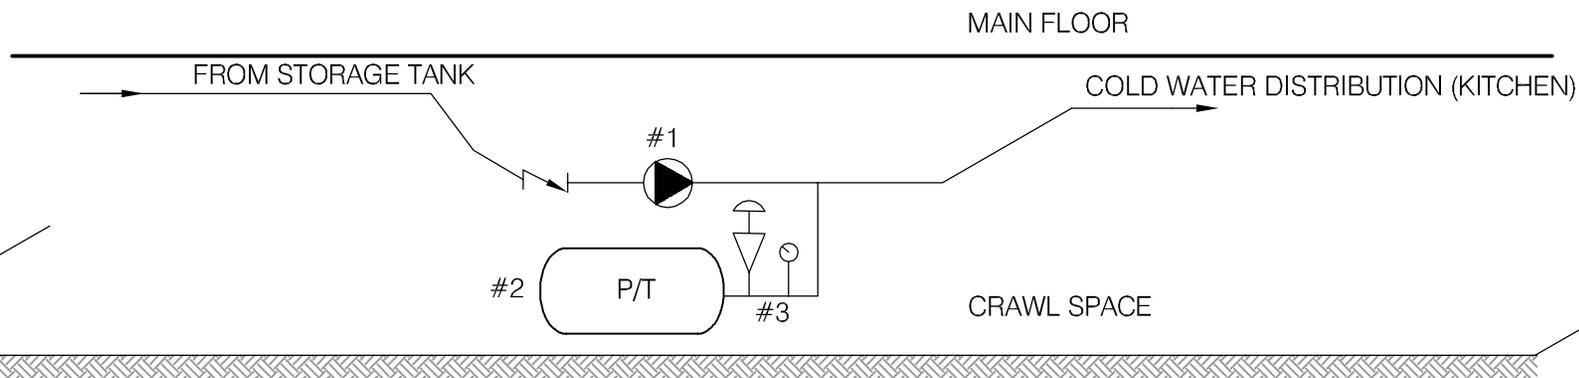
Highways and Public Works Property Management Branch		TITLE WATER SYSTEM DISTRIBUTION/TREATMENT SCHEMATIC SYSTEM ID.: 4842 CASSIAR WEIGH SCALES	
DATE	JULY 2005	DWN.	JSB
CHKD.	FMM	FILE NO.	1260002.002
		DWG.:	FIGURE 4842-B

There is no treatment or disinfection for the water obtained from the well. In addition to the well, there is also an approximately 800 L water storage tank located directly outside the office building that serves the cold water tap in the kitchen. It is likely that this tank receives treated water from delivery for consumption, and the well supply is intended for non-potable use only; however, there were no signs present at the weigh scales that indicated such. The water storage tank was empty during the water system assessment and the only water that was available for sampling was obtained from a bathroom tap served by the well. A schematic detailing the well water system is provided as Figure 4842-B in Appendix A19.

THIS JET PUMP INSTALLATION IS OF POOR QUALITY MATERIAL AND WORKMANSHIP. THE PUMP RUNS CONTINUALLY - IT WILL NOT BRING THE SYSTEM UP TO PRESSURE. THE SUCTION PIPE HAS NUMEROUS HOSE CLAMP JOINT AND IS THERE FOR SUBJECT TO AIR LEAKS.

REPLACE PUMP SYSTEM WITH SUBMERSIBLE PUMP SYSTEM. INSTALL TREATMENT AS REQUIRED. SUPERCHLORINATE THE TOTAL SYSTEM AND INSTALL AN APPROPRIATE UV SYSTEM.

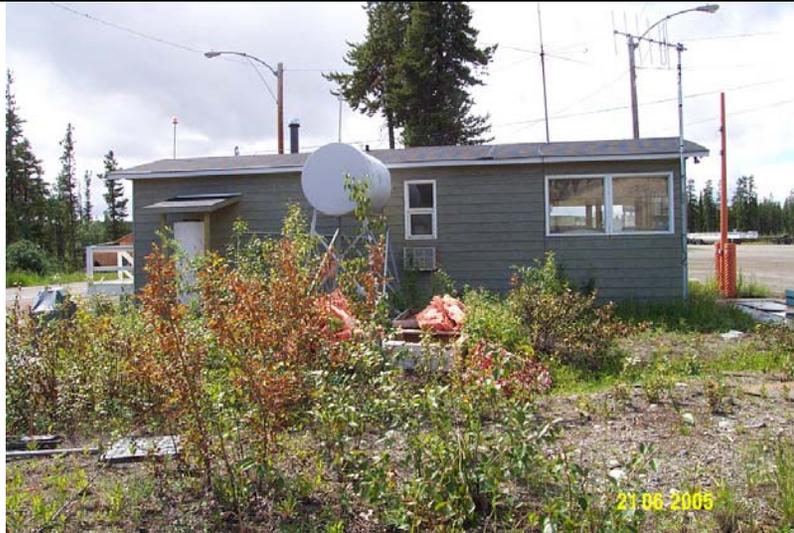
- Potential sources of contamination within 30 m of the well, including the septic tank, and potentially septic field (if present), a drainage stream that runs within 1 m the wellhead, and an above ground fuel storage tank located 1 m from the well;

- There is no treatment disinfection system present;
- Poor surface completion of the wellhead (located in a pit below grade);
- The water intended for drinking water is delivered and stored in a water tank outside of the building. There is no enclosure of any kind around the storage tank, nor is there any insulation to prevent freezing;

Photo 0238: 4842 Cassiar Weigh Scales (back), wellhead enclosure (centre), above ground fuel storage tank (left centre), water storage tank for kitchen cold water tap (left)

- An enclosure should be built around the wellhead in order to prevent freezing or overheating, and to prevent unauthorized human or animal access;
- Signs should be posted in the building at all point of use locations that drinking water should be obtained the cold water faucet in the kitchen only; and,
- It should be ensured that water is properly disinfected at the source.

-
- A NSF-55 certified UV system should be installed after the softener to provide disinfection of drinking water;
 - The water storage tank for delivered water should be removed once the treatment system is installed, and the well be used as the main source of drinking water; and,
 - Secondary containment should be installed around the existing above ground fuel storage tank.

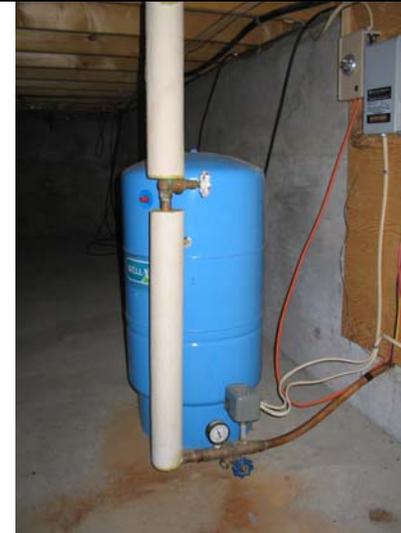
Photo 0237: 4842 Pressure tank (centre) and pump controls (right)

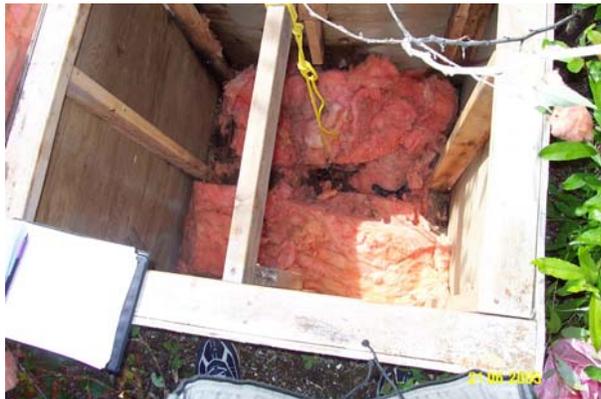
- There is no surface sanitary seal (grout or bentonite seal as required by the Canadian Groundwater Association's Well Construction Guidelines);
- By definition of the Draft Yukon GUDI Assessment Guideline, the well is potentially under the direct influence of surface water (because it does not meet the requirements of the Guidelines for Water Well Construction);

- i. Is the well head below grade? describe in detail 0.90 m below grade (is only 2cm above pit floor)
- ii. Are there signs of ponding on the enclosure(e.g. water stains, etc.)? Yes No
Heavy where piping enters enclosure
- iii. Is the wellhead enclosed by fiberglass insulations? Yes No
- iv. Any evidence of rodents? Specify Access possible
- v. Does the well casing have a proper seal cap? Yes No

Photo 0240: 4842 Wellhead in pit

- The wellhead completion should be improved. This would involve raising the well casing to a minimum of 500 mm above ground level and retrofitting a proper surface-seal to 3 m below grade; and,
- The ground surface around the wellhead should be graded to promote surface drainage away from the well by rerouting the existing drainage feature further away from the well.

- The cost for the wellhead upgrades, including raising the wellhead, installing a surface seal to 3 m below grade, and installing a 150 mm pitless adapter would cost in the order of **\$5,000**;

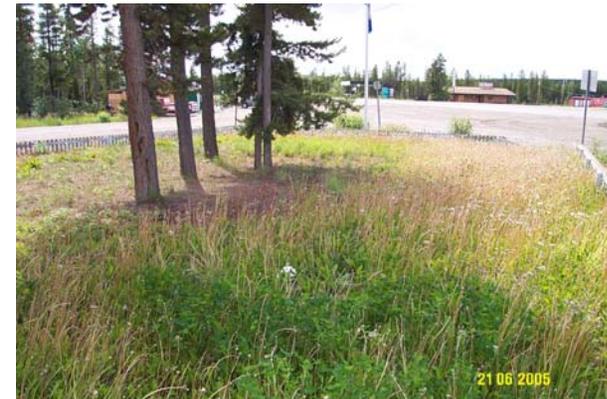
it may only be a holding tank

Photo 0239: 4842 Possible septic field
