20.0 BUILDING 4840: WATSON LAKE ENVIRONMENTAL OFFICE

SMALL PUBLIC WATER SYSTEMS ASSESSMENT
 EASTERN REGION

WATSON LAKE ENVIRONMENTAL
 BUILDING # 4840
 SITE LOCATION DIAGRAM
 WELL ID: 4840-A

TITLE WATER SYSTEM DISTRIBUTION/TREATMENT SCHEMATIC SYSTEM ID.: 4840 WATSON LAKE ENVIRONMENTAL OFFICE	
DATE	JULY 2005	DWN.	JSB
CHKD.	FMM	FILE NO.	1260002.002
		DWG.:	FIGURE 4840-B

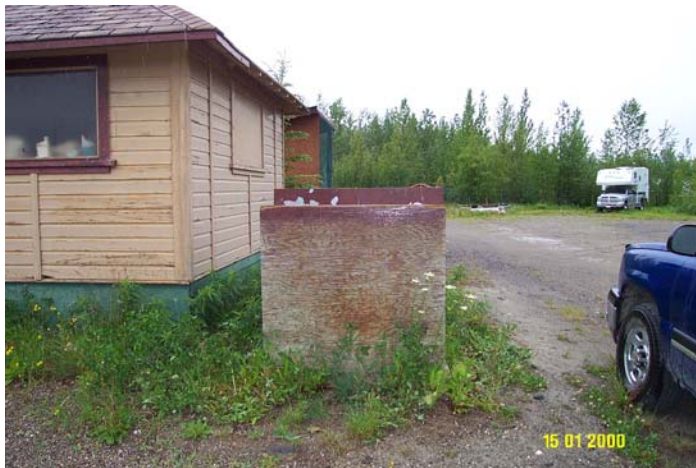
- Poor surface completion of the wellhead (located in a wooden enclosure, the wellhead is only 0.25 m above grade);
 - There is no disinfection system;

Photo 0261: 4840 Wellhead enclosure (centre), and storage building (back left)

- The wellhead completion should be improved. This would involve raising the well casing to a minimum of 500 mm above ground level and retrofitting a proper surface-seal to at least 3 m below grade; and,
- A detailed hydrogeological and water quality assessment should be carried out in the region to determine the cause of the elevated chloride and barium.

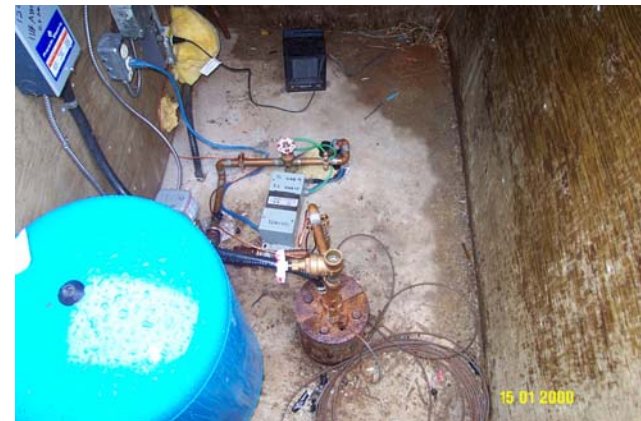
- i. Is the well head below grade? describe in detail No
- ii. Are there signs of ponding on the enclosure(e.g. water stains, etc.)? Yes No
- iii. Is the wellhead enclosed by fiberglass insulations? Yes No
In walls of enclosure, not directly
- iv. Any evidence of rodents? Specify no signs, access is possible
- v. Does the well casing have a proper seal cap? Yes No
If no, describe condition split gasket cap - may not be making proper seal around the rope

wellhead is rusty and inaccessible for inspection

Photo 0260: 4840 Wellhead (centre), and pressure tank (left) in enclosure

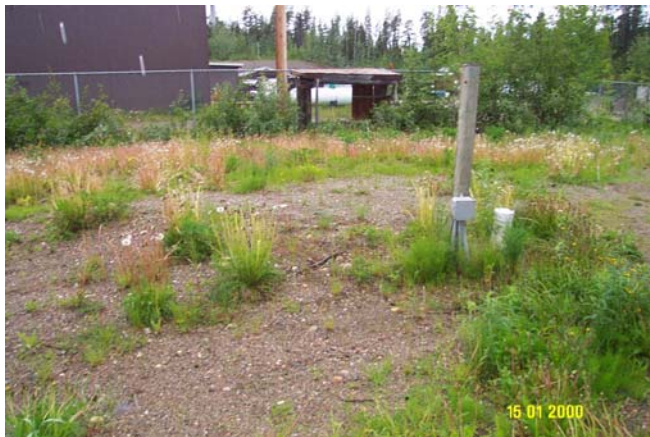
The environmental office is served by a septic system located on the northwest side of the office building opposite from the well. The septic tank is approximately 30 m west of the well and likely discharges effluent to the west of the tank. There was, however, no evidence of clean-out pipes and it is possible that the system is on sewage education.

Photo 0263: 4840 Septic field

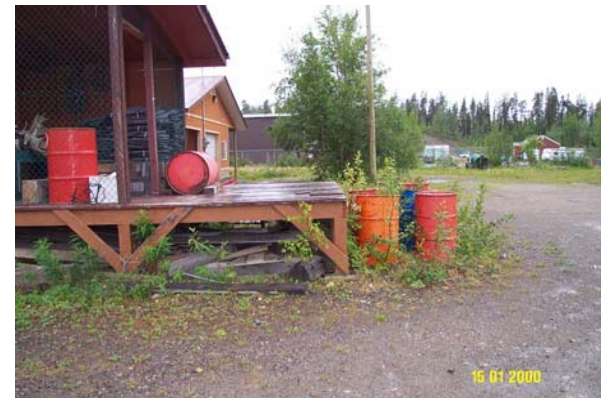
- Fuel drums 13 m.

Photo 0262: 4799 Fuel drums (centre) around storage building

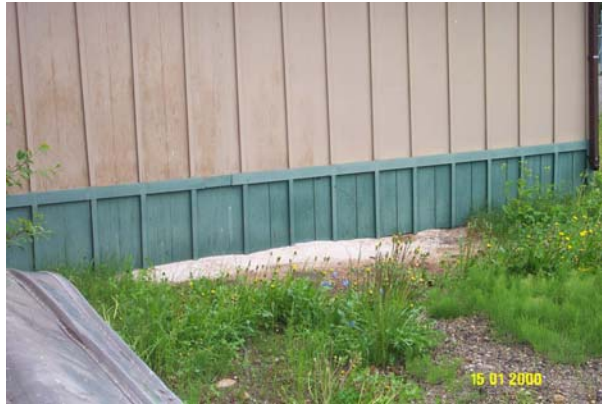
The Government of Yukon Environmental Programs Branch and Environment Canada Environmental Protection Branch did not identify any recorded spill events or contaminated sites issues for this property or neighbouring properties. There was, however, absorb-all observed on the ground approximately 30 m from the well, adjacent to the building, that could potentially mark the location of a former fuel spill.

- Absorb-all was found on the ground at approximately 30 m from the well and may indicate a hydrocarbon spill.

Photo 0264: 4840 Absorb-all on ground behind office building – likely site of hydrocarbon contamination

- Confirm UV transmissivity post softening system.
- It is recommended that a NSF-61 certified filtration system (to 1 micron absolute) be installed, and a UV disinfection system be installed after other treatment. This is a conceptual design recommendation based on the information available for planning and budgeting purposes. Engineering input will be required for final system specifications;
- Environment office staff should be informed to use the reverse osmosis tap as the main source of drinking water;
- Regular maintenance and upkeep should be done to ensure that the water treatment system is working; and,
- The purpose of the absorbol on the ground behind the building should be verified.

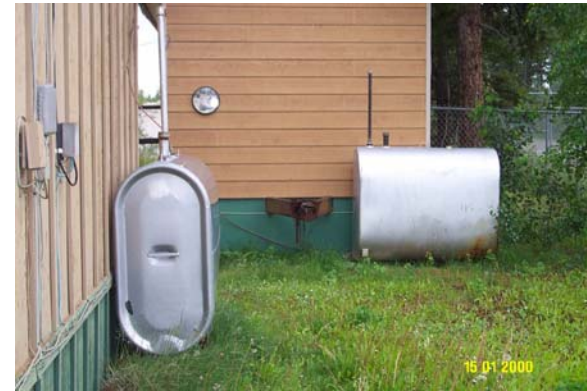
Photo 0265: 4840 Above ground fuel storage tanks

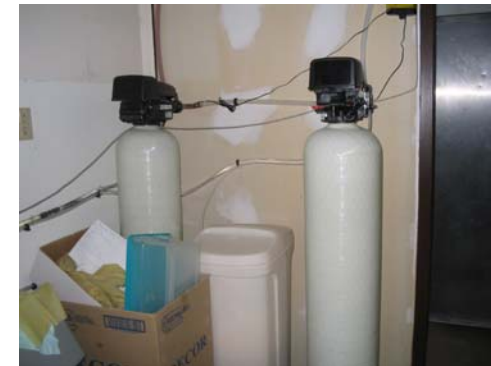
- The hardness in the treated water at 212 mg/L (as CaCO₃), signifying that the water softener may not be functioning properly. The hardness in the water subjected to reverse osmosis had been reduced to 34.4 mg/L (as CaCO₃).

Photo 0003: 4840 Sediment filter (left) and water softener (right)

INSTALL PROPER AIR GAP AND
UV DESINFECTATION AFTER SOFTENER
SUPERCHLORINATE THE WELL BI ANNUALLY.
SUPER CHLORINATE THE COMPLETE
PIPING SYSTEM AFTER UV INSTALLATION
AND RETURN TO SERVICE.

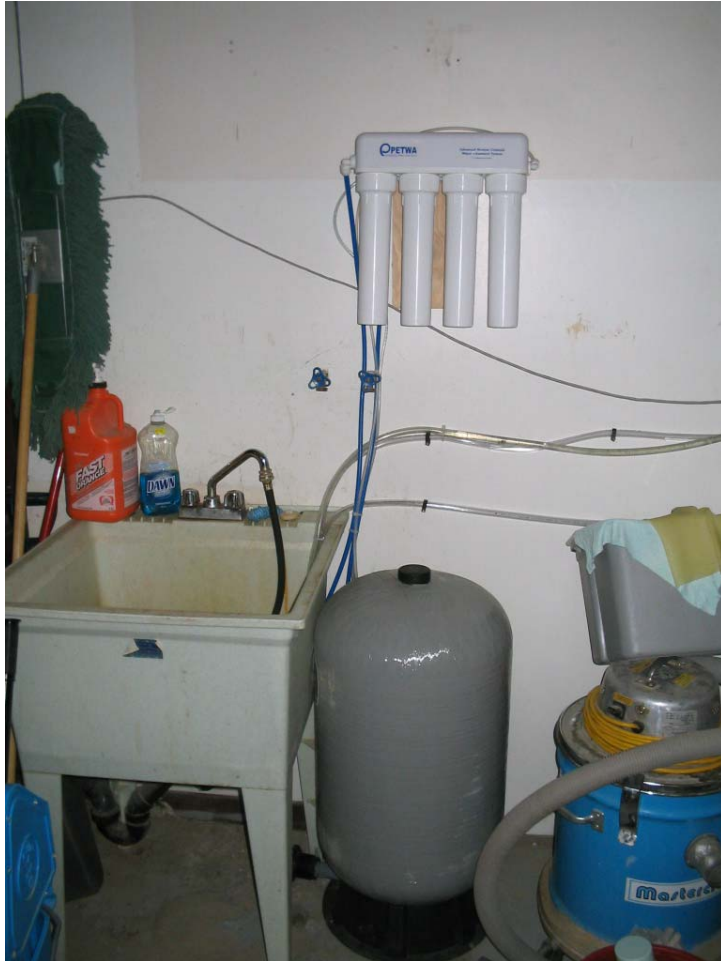
Photo 0004: 4840 Reverse osmosis system

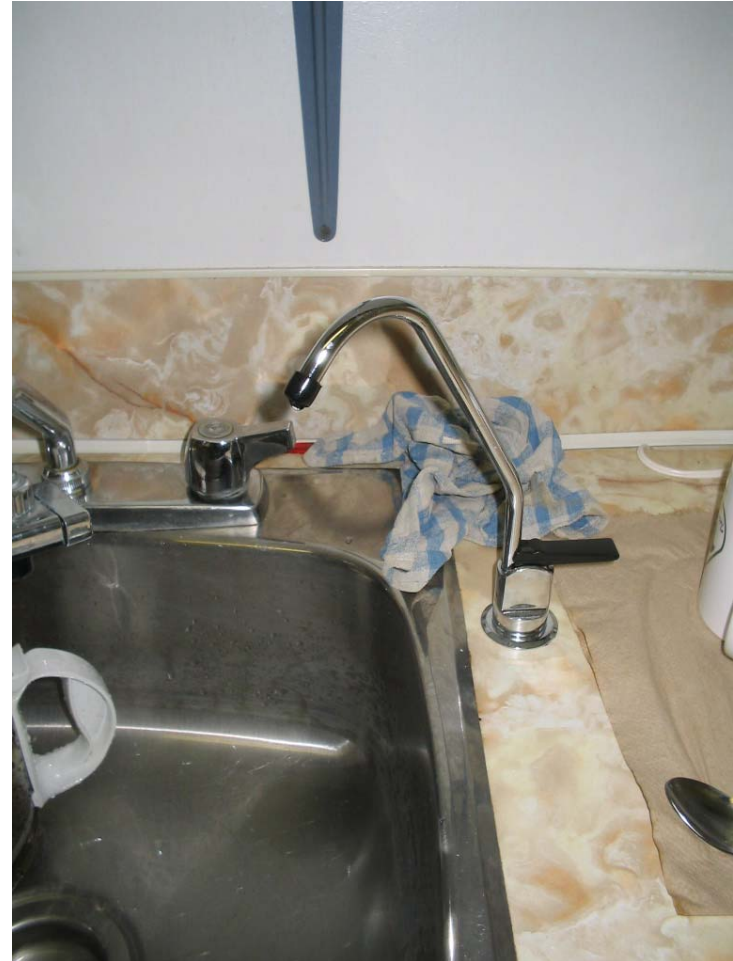
Photo 0007: 4840 Reverse osmosis tap in kitchen
