24.0 BUILDING 4976: WATSON LAKE AMBULANCE BUILDING

SMALL PUBLIC WATER SYSTEMS ASSESSMENT
 EASTERN REGION

SMALL PUBLIC WATER SYSTEM ASSESSMENT

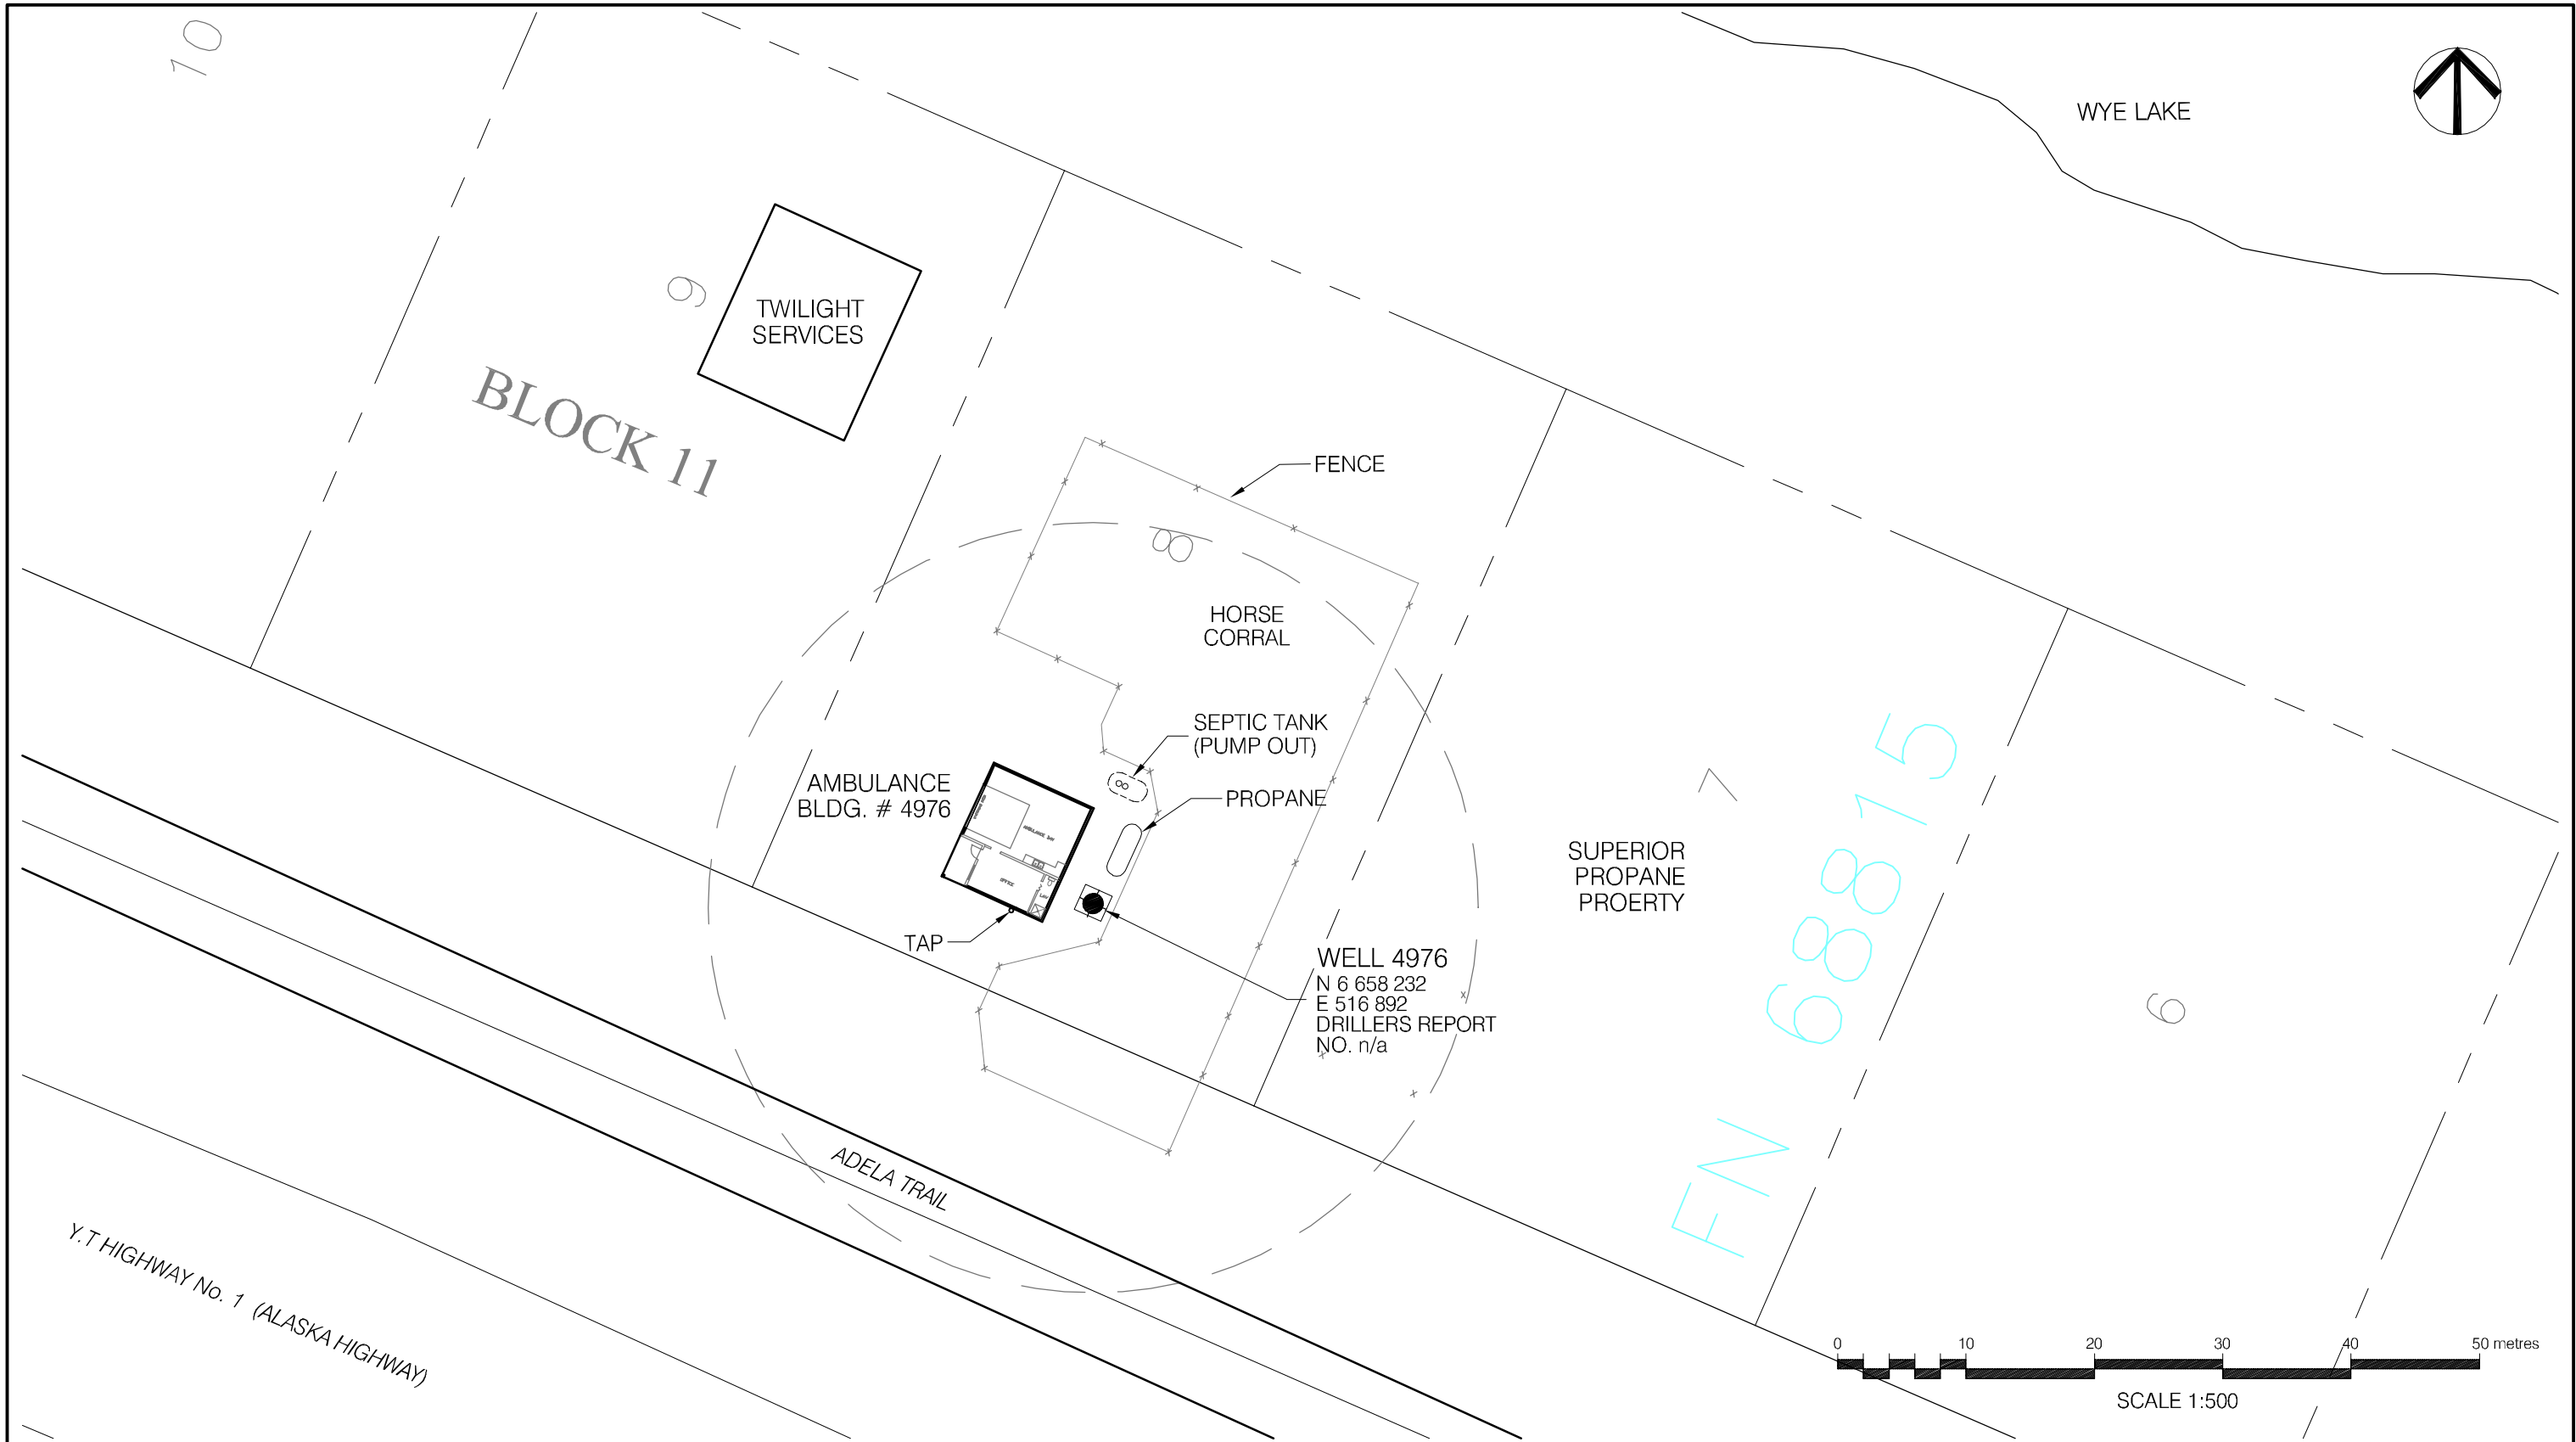
REVISION ISSUE
 0
 FIGURE No.
 4976-A

There is a holding tank near the northeast corner of the Watson Lake Ambulance Building approximately 10 m north of the well. A site plan that shows the position of the septic system relative to the well is given by Figure 4976-A in Appendix A24.

- Septic holding tank 10 m from well (not consistent with regulation); and,
- Horse corrals beginning at 1.5 m from the well.

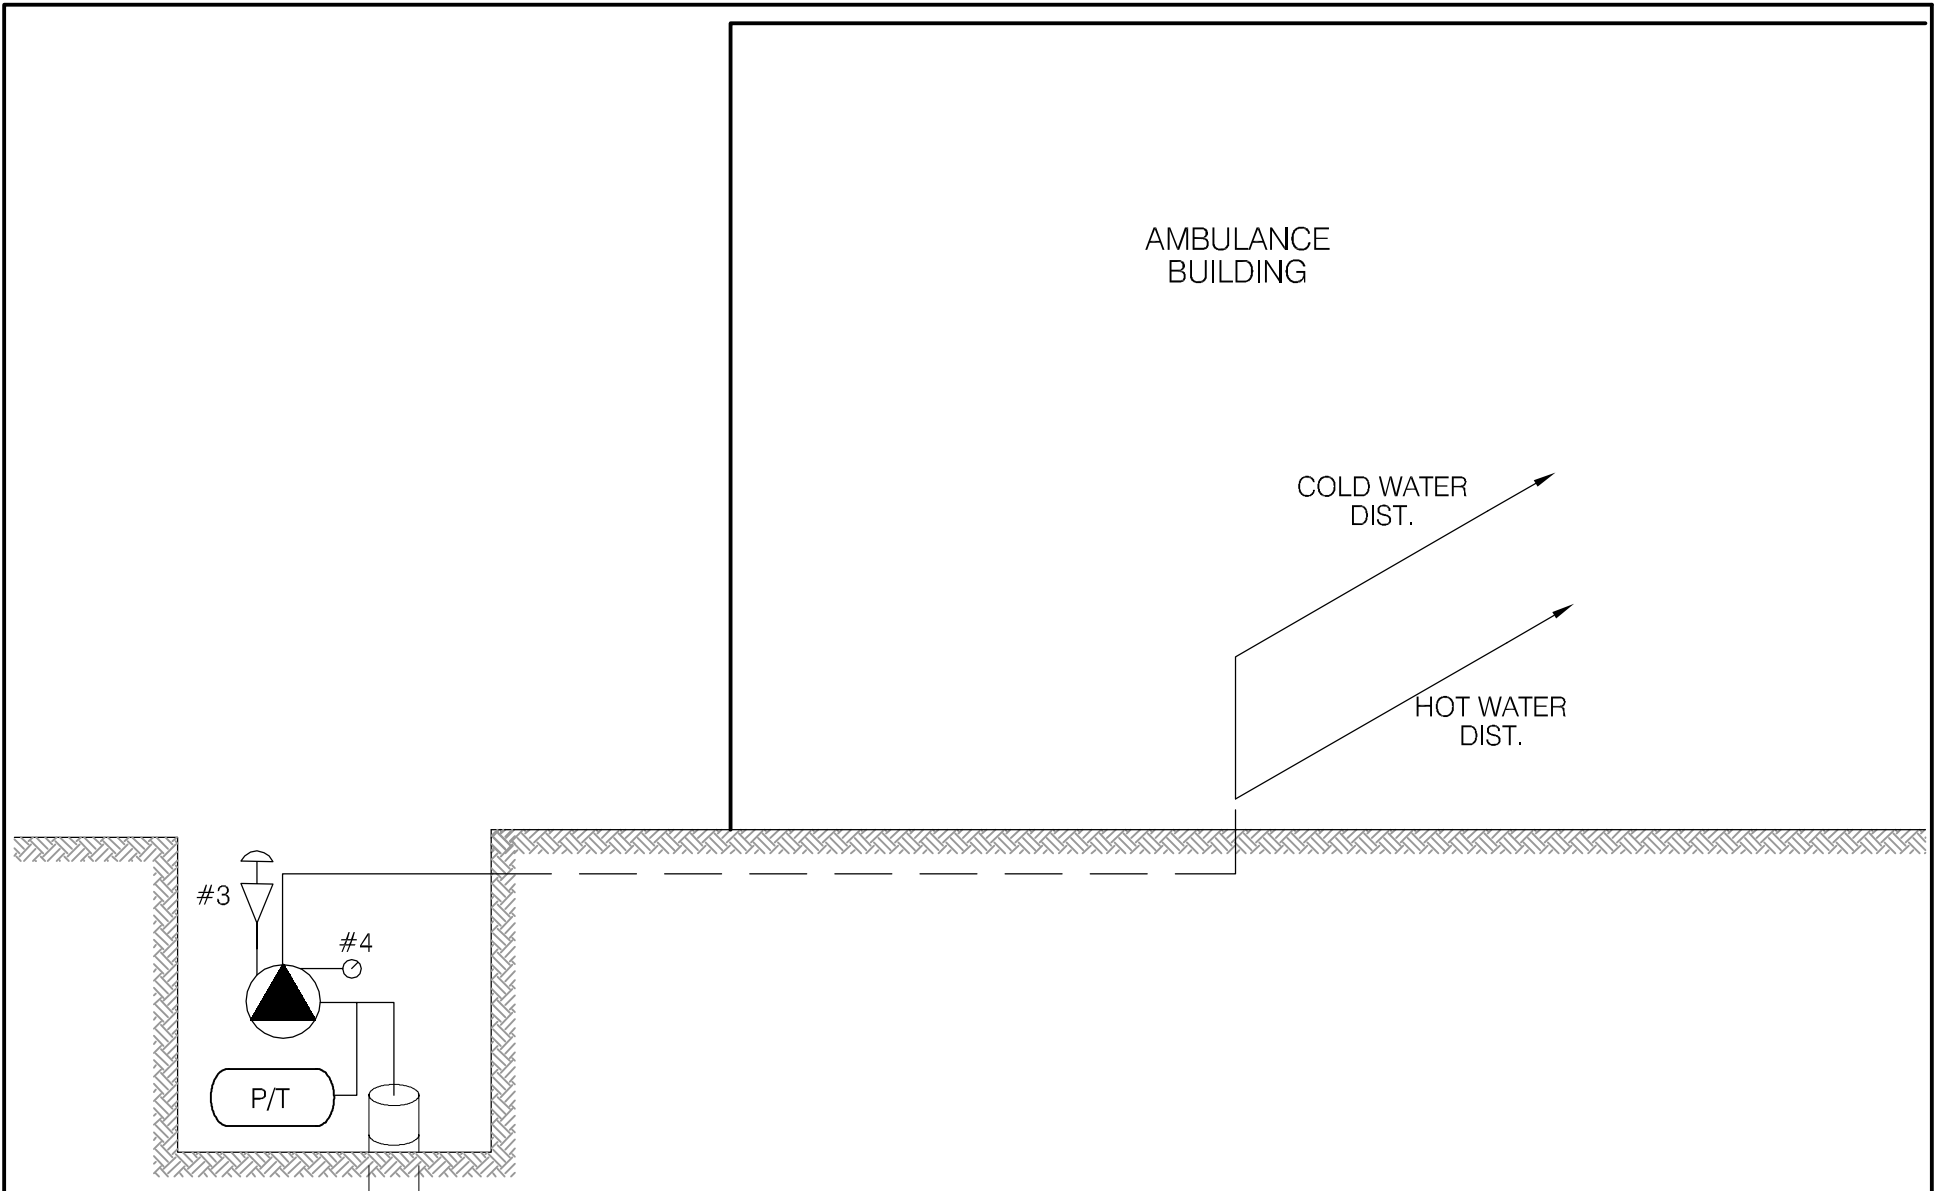
TITLE WATER SYSTEM DISTRIBUTION/TREATMENT SCHEMATIC SYSTEM ID.: 4976 WATSON LAKE AMBULANCE STATION	
DATE	JULY 2005	DWN.	JSB
CHKD.	FMM	FILE NO.	1260002.002
		DWG.:	FIGURE 4976-B

There is no treatment system present on this water system. A schematic detailing the water system is provided as Figure 4976-B in Appendix A24.

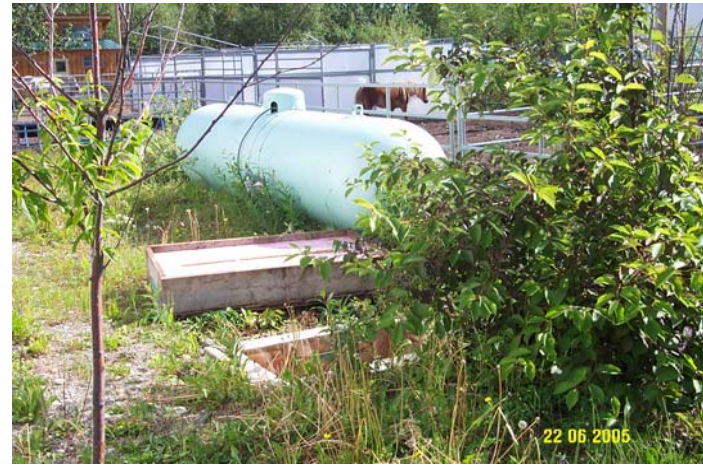
- The well is only 5.23 m deep, and it is very unlikely that there are any low permeability layers to prevent to prevent surface water infiltration;
- The well is located within 30 m of potential contaminant sources, including a septic holding tank and horse corrals;

Photo 0310: 4976 Wellhead enclosure (centre), propane tank (behind), and horse corrals (back)

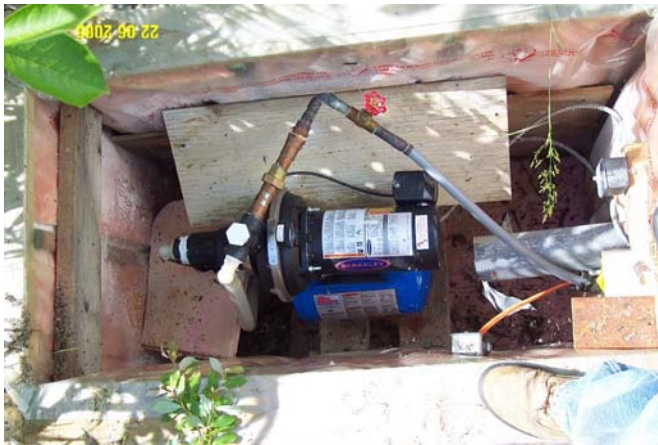
- Poor surface completion of the well (the well is located in a pit below grade, the wellhead is not equipped with a proper cap and is open);
- There is no surface sanitary seal (grout or bentonite seal as required by the Canadian Groundwater Association's Well Construction Guidelines). The well is shallower than the 6 m required for a proper surface sanitary seal; and

THIS INSTALLATION IS TOTALLY INADEQUATE. THE WELL HEAD IS OPEN TO SEVERAL SOURCES OF CONTAMINATION. A HEAVY RAINFALL COULD FILL THE WELL PIT FROM SURROUNDING ANIMAL ENCLOSURES (HORSES) THERE IS EVIDENCE OF MICE LIVING IN THE WELL ENCLOSURE. THE WELL IS BASICALLY SURFACE WATER WITH NO FILTRATION OR TREATMENT.

Photo 0308: 4976 Wellhead in pit (left), and jet pump (centre)

Considering all of the known deficiencies with the current well, it is recommended that it be abandoned and decommissioned. Given the size of the property, existing land use, and distances to potential contaminant sources, it is unlikely that a new well could be safely located on the site. It is recommended that the water system be converted to bulk water delivery. The new water system should meet the following conditions:

- The existing well should be properly decommissioned in accordance with the Guidelines for Water Well Construction. It is estimated that this would cost approximately **\$1,000**.

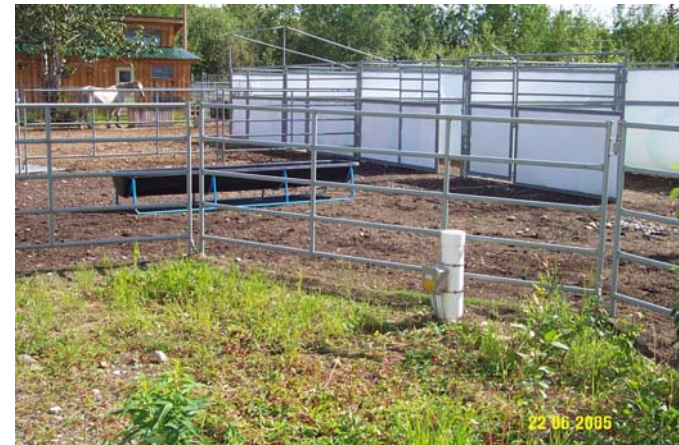
Photo 0311: 4976 Septic holding tank (front), and horse corrals (back)
