## **25.0 BUILDING 4981: WATSON LAKE ENERGY, MINES, AND RESOURCES OFFICE**

SMALL PUBLIC WATER SYSTEMS ASSESSMENT  
EASTERN REGION

WATSON LAKE ENERGY, MINES, &  
RESOURCES BUILDING # 4981  
SITE LOCATION DIAGRAM  
WELL ID: 4981-A

## SMALL PUBLIC WATER SYSTEM ASSESSMENT

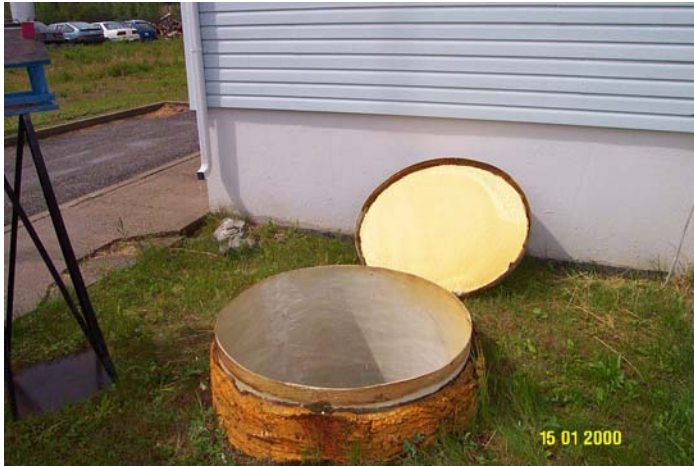
**Photo 0270:** 4981 Wellhead enclosure (front), and EMR office (behind)

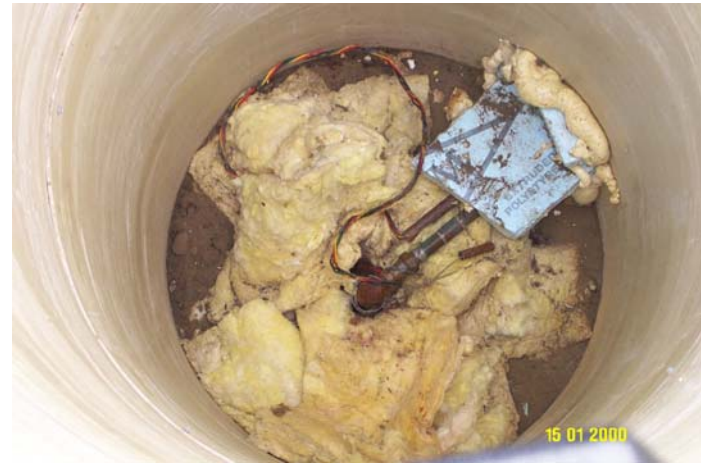
- Poor surface completion of the wellhead (located in a pit, the wellhead was open with no cap on the casing);
- By definition of the Draft Yukon GUDI Assessment Guideline, the well is potentially under the direct influence of surface water because it does not meet the requirements of the Guidelines for Water Well Construction;

If no, describe condition Seal cap is not on well - has been removed  
well is open

**Photo 0269:** 4981 Wellhead in pit

- The well and water system should be superchlorinated and a cap be installed on the wellhead;
- It is recommended that an NSF/ANSI 55 certified UV disinfection system be installed. This is a conceptual design recommendations based on the information available for planning and budgeting purposes. Engineering input will be required for final system specifications;
- Regular monitoring, maintenance should be completed on a daily basis to ensure the water treatment system is always functioning properly;

- The wellhead completion should be improved. This would involve raising the well casing to a minimum of 500 mm above ground level and retrofitting a proper surface-seal to 3 m below grade;
- The ground surface around the wellhead should be graded to promote surface drainage away from the well;
- An additional assessment should be done in order to determine the location of the start of the effluent field; and,
- A detailed hydrogeological assessment should be carried out in order to determine if the sewage lagoon and the barite plant are contaminating the aquifer that provides groundwater to this facility.

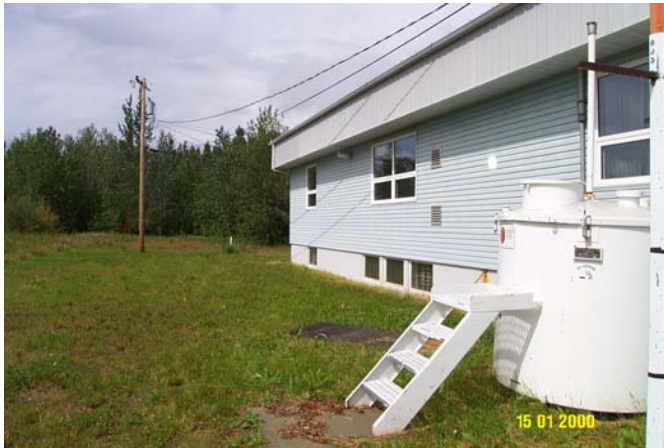
- Septic tank at 13 m (in contravention of regulation);
- Above ground fuel storage tank at 13 m;
- An industrial junkyard at 20 m; and,
- Scrap metal parts at 20 m.

**Photo 0272:** 4981 Above ground fuel storage tank (right), EMR office (behind), and septic field (back left)

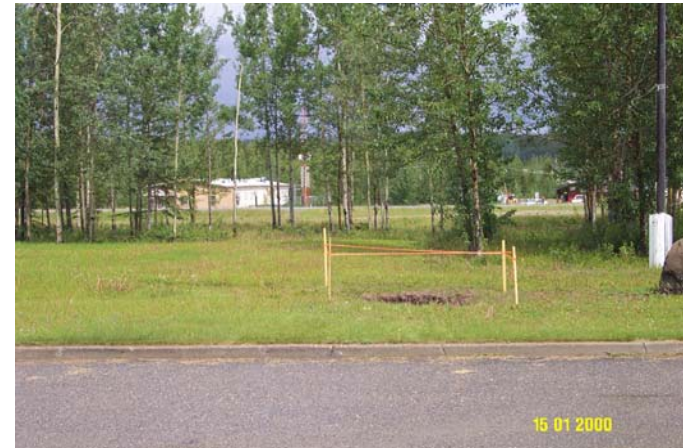
Sink hole → could be old septic, septic field and service lines < 30m  
@ ~ 2m, 2nd septic field @ ~ 45m

**Photo 0267:** 4981 Sinkhole – could be abandoned septic tank

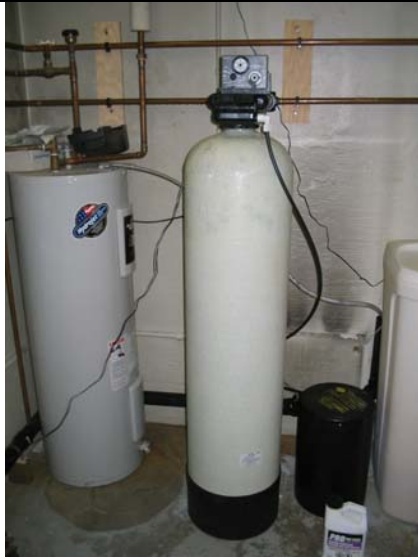
**Photo 0012:** 4981 AMG filter

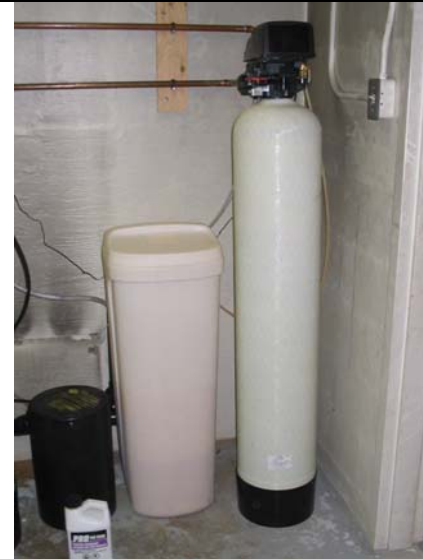
**Photo 0013:** 4981 Water softener

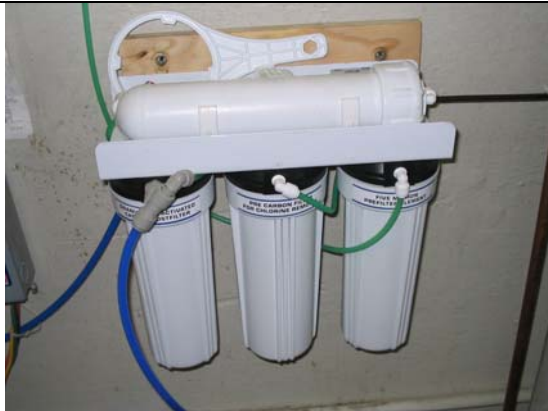
**Photo 0011:** 4981 Reverse osmosis system

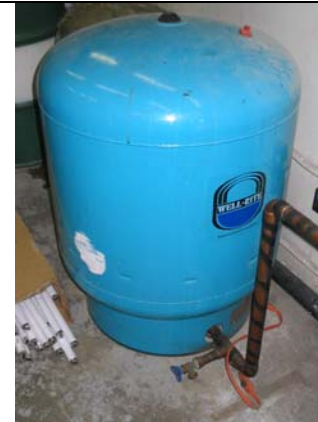
**Photo 0009:** 4981 Pressure Tank
