26.0 BUILDINGS 4993 AND 4994: WATSON LAKE EMR FIRE CONTROL CENTRE AND TANKER BASE

SMALL PUBLIC WATER SYSTEMS ASSESSMENT
EASTERN REGION

WATSON LAKE EMR FIRE CONTROL
CENTRE (4993) &
EMR TANKER BASE (4994)
SITE LOCATION DIAGRAM
WELL ID: 4994-A

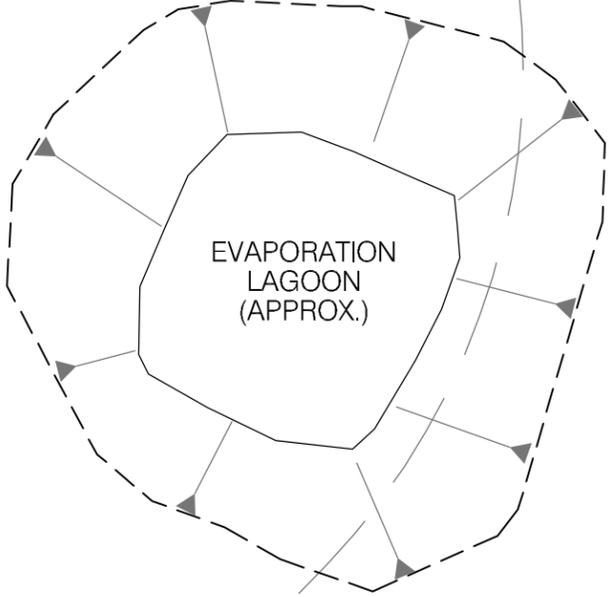
FIGURE No.
4994-A

- The wellhead is located within 30 m of potential sources of contamination, including an evaporation lagoon 10 m from the well;
- There is no surface sanitary seal (grout or bentonite seal as required by the Canadian Groundwater Association's Well Construction Guidelines);

30 m RADIUS FROM WATER WELL FOR CONSIDERATION OF PROXIMITY TO POTENTIAL CONTAMINANT SOURCES.

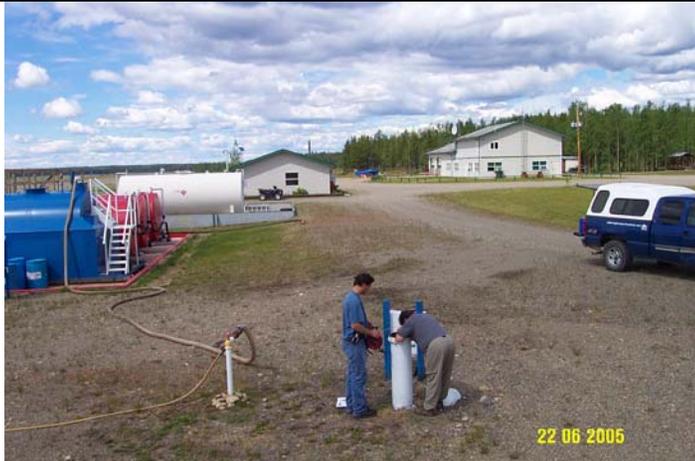
Photo 0319: 4993/4994 Pitless unit (front centre), EMR Fire Control Centre (4993, back right), EMR Tanker Base (4994, back centre), above ground fuel storage and fire retardant tanks (left)

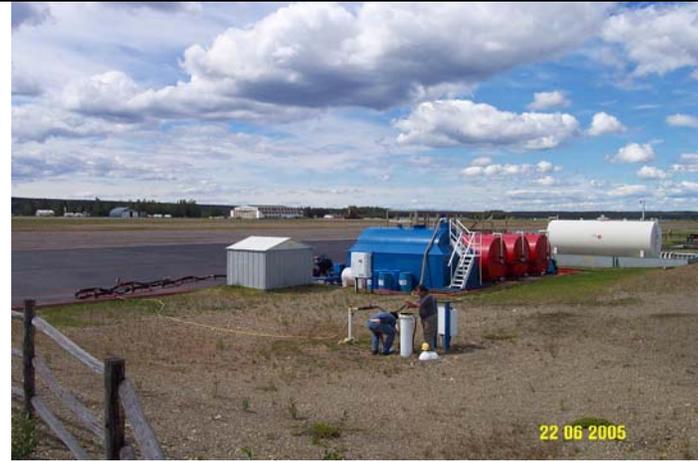
- Fire retardant tanks from 15 m to 25 m;
- Above ground aviation fuel storage tank at 30 m; and,
- Evaporation lagoon at 10 m.

Photo 0318: 4993/4994 Pitless unit (front centre), above ground fuel storage tank (back right), fire retardant tanks (back right centre), chemical storage (back centre), and airport tarmac (behind)

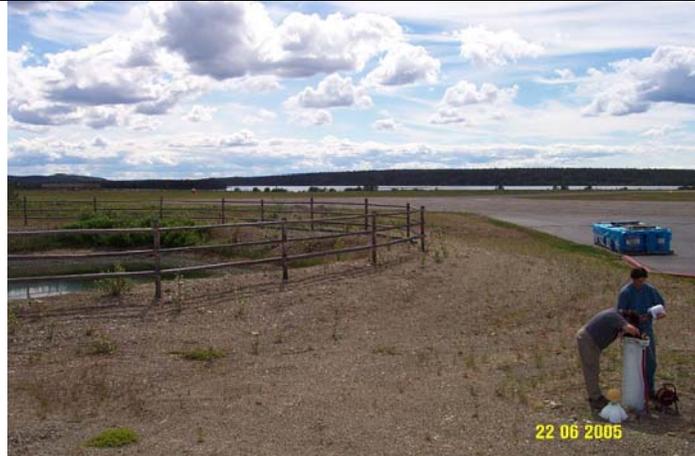
Even off from runway (w/retardant in it likely) goes into nearby evaporation lagoon

Photo 0317: 4993/4994 Pitless unit (front right), evaporation lagoon (left)

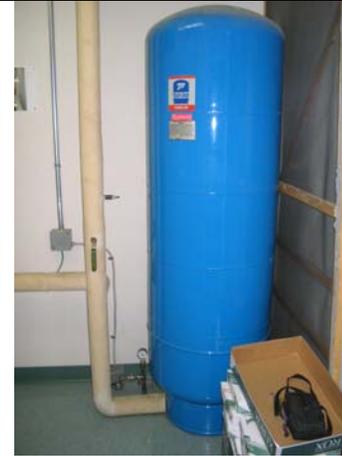
Photo 0048: 4993 pressure tank
