## **22.0 BUILDING 4873: TUCHITUA PUMPHOUSE**

SMALL PUBLIC WATER SYSTEMS ASSESSMENT  
EASTERN REGION

TUCHITUA PUMPHOUSE  
BUILDING # 4873  
SITE LOCATION DIAGRAM  
WELL ID: 4873-A

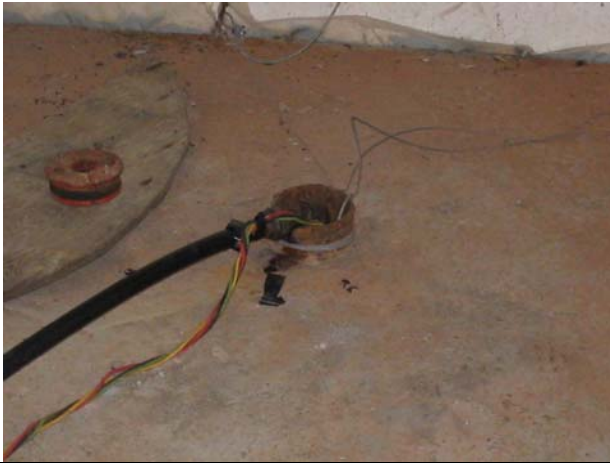
- Poor surface completion of the wellhead (there was no cap on the well casing);
- The wellhead is only 70 mm above grade and is at risk of potential flooding;

Casing seal had been removed casing open - Access in building and in well possible

**Photo 0053:** 4873 Wellhead

- The well and water system should be immediately superchlorinated and a cap be installed to seal the well from the surface;
- The casing should be raised to a minimum of 500 mm above grade;
- All fuel, paint, and kerosene drums that are within 30 m of the pumphouse should be relocated. Fuel or chemicals are not to be stored within 30 m of the pumphouse; and,
- An NSF/ANSI 55 certified UV disinfection system with pre-filter should be installed. This is a conceptual design recommendation based on the information available, and is intended to be used for planning and budgeting purposes. Engineering input will be required for final system specifications or design.

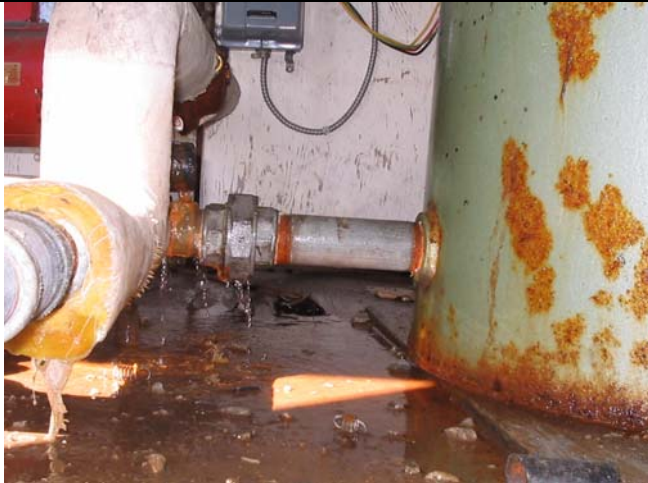
- The plumbing from the well was found during the site inspection to be in disrepair. The pressure tank is very old, and it as well as much of the piping was leaking.

**Photo 0055:** 4873 Leak in piping from pressure tank

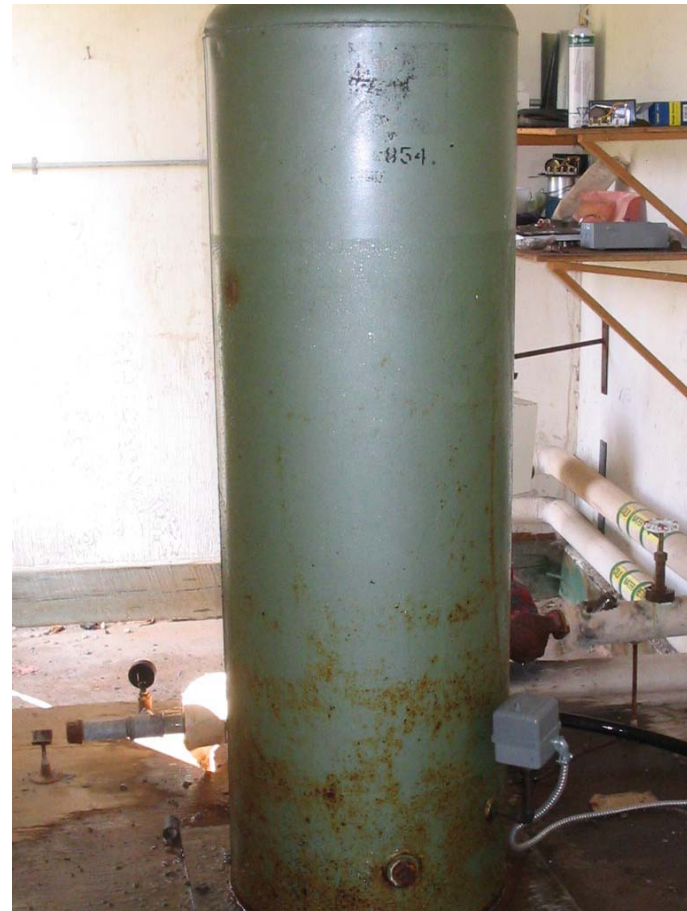
**Photo 0054:** 4873 Pressure tank
