## **9.0 BUILDING 4793: SWIFT RIVER GRADER STATION**

SMALL PUBLIC WATER SYSTEMS ASSESSMENT  
 EASTERN REGION

## SMALL PUBLIC WATER SYSTEM ASSESSMENT

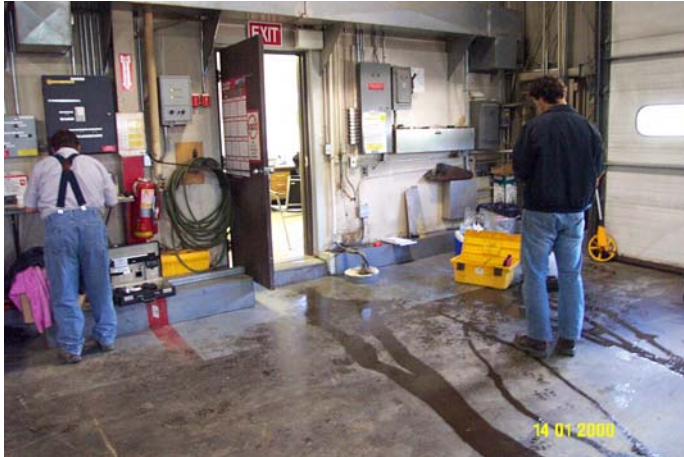
- Poor surface completion of the well (located in maintenance garage, only 80 mm above grade);
- The well is not equipped with a surface sanitary seal, (grout or bentonite as required by the Canadian Groundwater Association's Well Construction Guidelines);

**Photo 0232:** 4793 Wellhead in maintenance garage

- Extending the steel culvert around the wellhead to at least 500 mm above the maintenance garage floor, as well as other standard upgrades to protect the aquifer, would cost in the order of **\$500**.

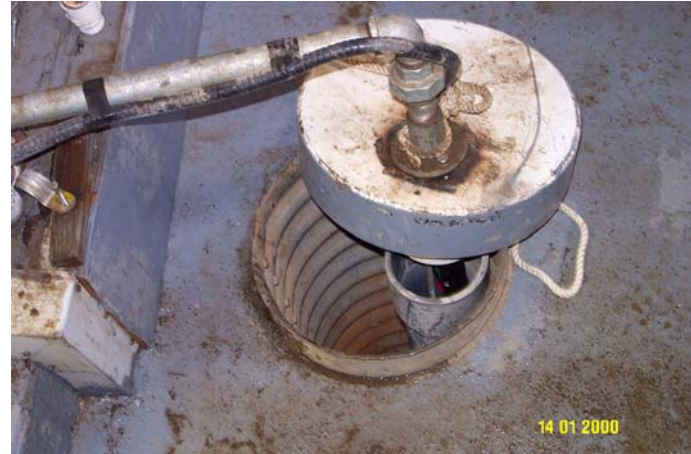
**Photo 0229:** 4793 Wellhead

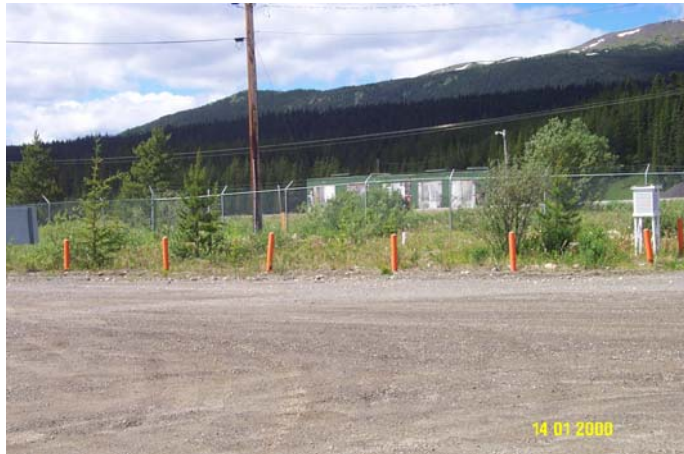
The septic field for the Swift River Grader Station is located on the southwest corner of the property approximately 38 m from the well. A site plan showing the location of the septic system is given by Figure 4793-A in Appendix A9.

**Photo 0235:** 4793 Septic field

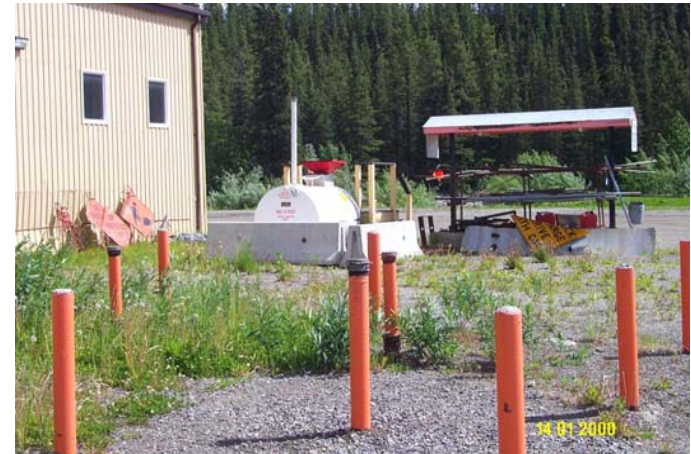
- Used oil tank at 16 m;
- Active industrial activity within 30 m.

**Photo 0236:** 4793 Underground fuel storage tank nest (front), used oil tank (back), maintenance garage (back left)

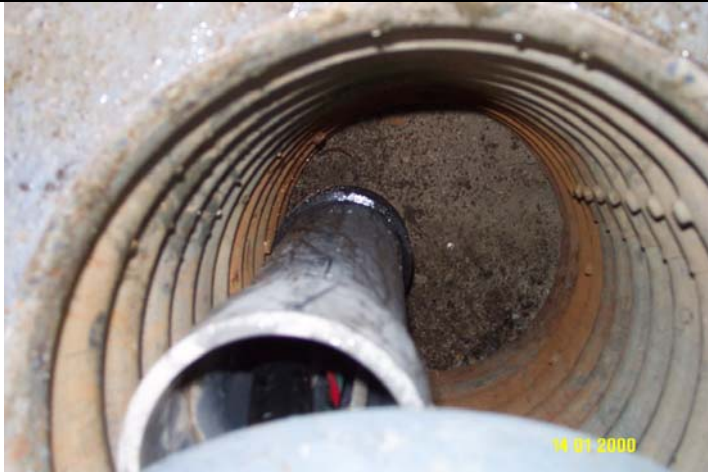
**Photo 0230:** 4793 Well

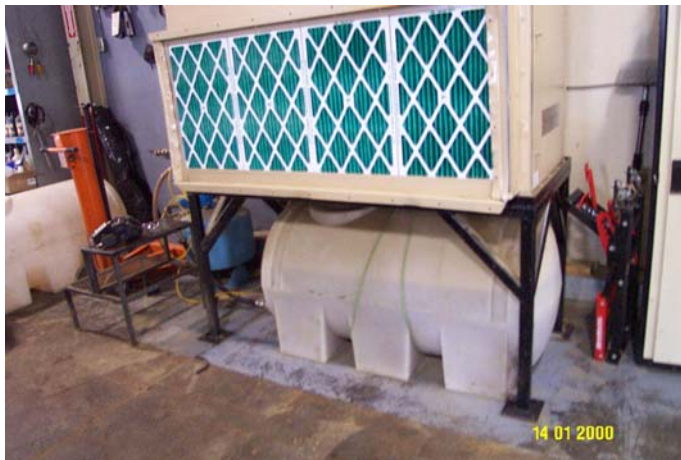
**Photo 0231:** 4793 Water storage tank

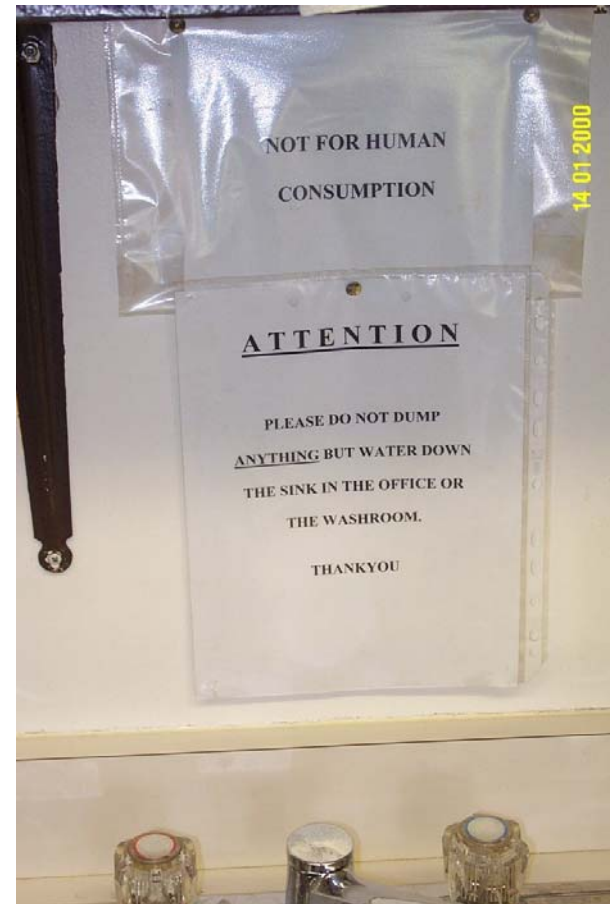
Because there is a sign posted warning that the water is not to be used for human consumption and drinking water is provided for grader station staff, all deficiencies associated with this water system are considered either medium or low risk.

**Photo 0228:** 4793 Sign warning that water is not to be used as drinking water
