11.0 BUILDING 4799: SWIFT RIVER LIVING COMPLEX

SMALL PUBLIC WATER SYSTEMS ASSESSMENT
EASTERN REGION

SWIFT RIVER LIVING COMPLEX
BUILDING # 4799
SITE LOCATION DIAGRAM
WELL ID: 4799

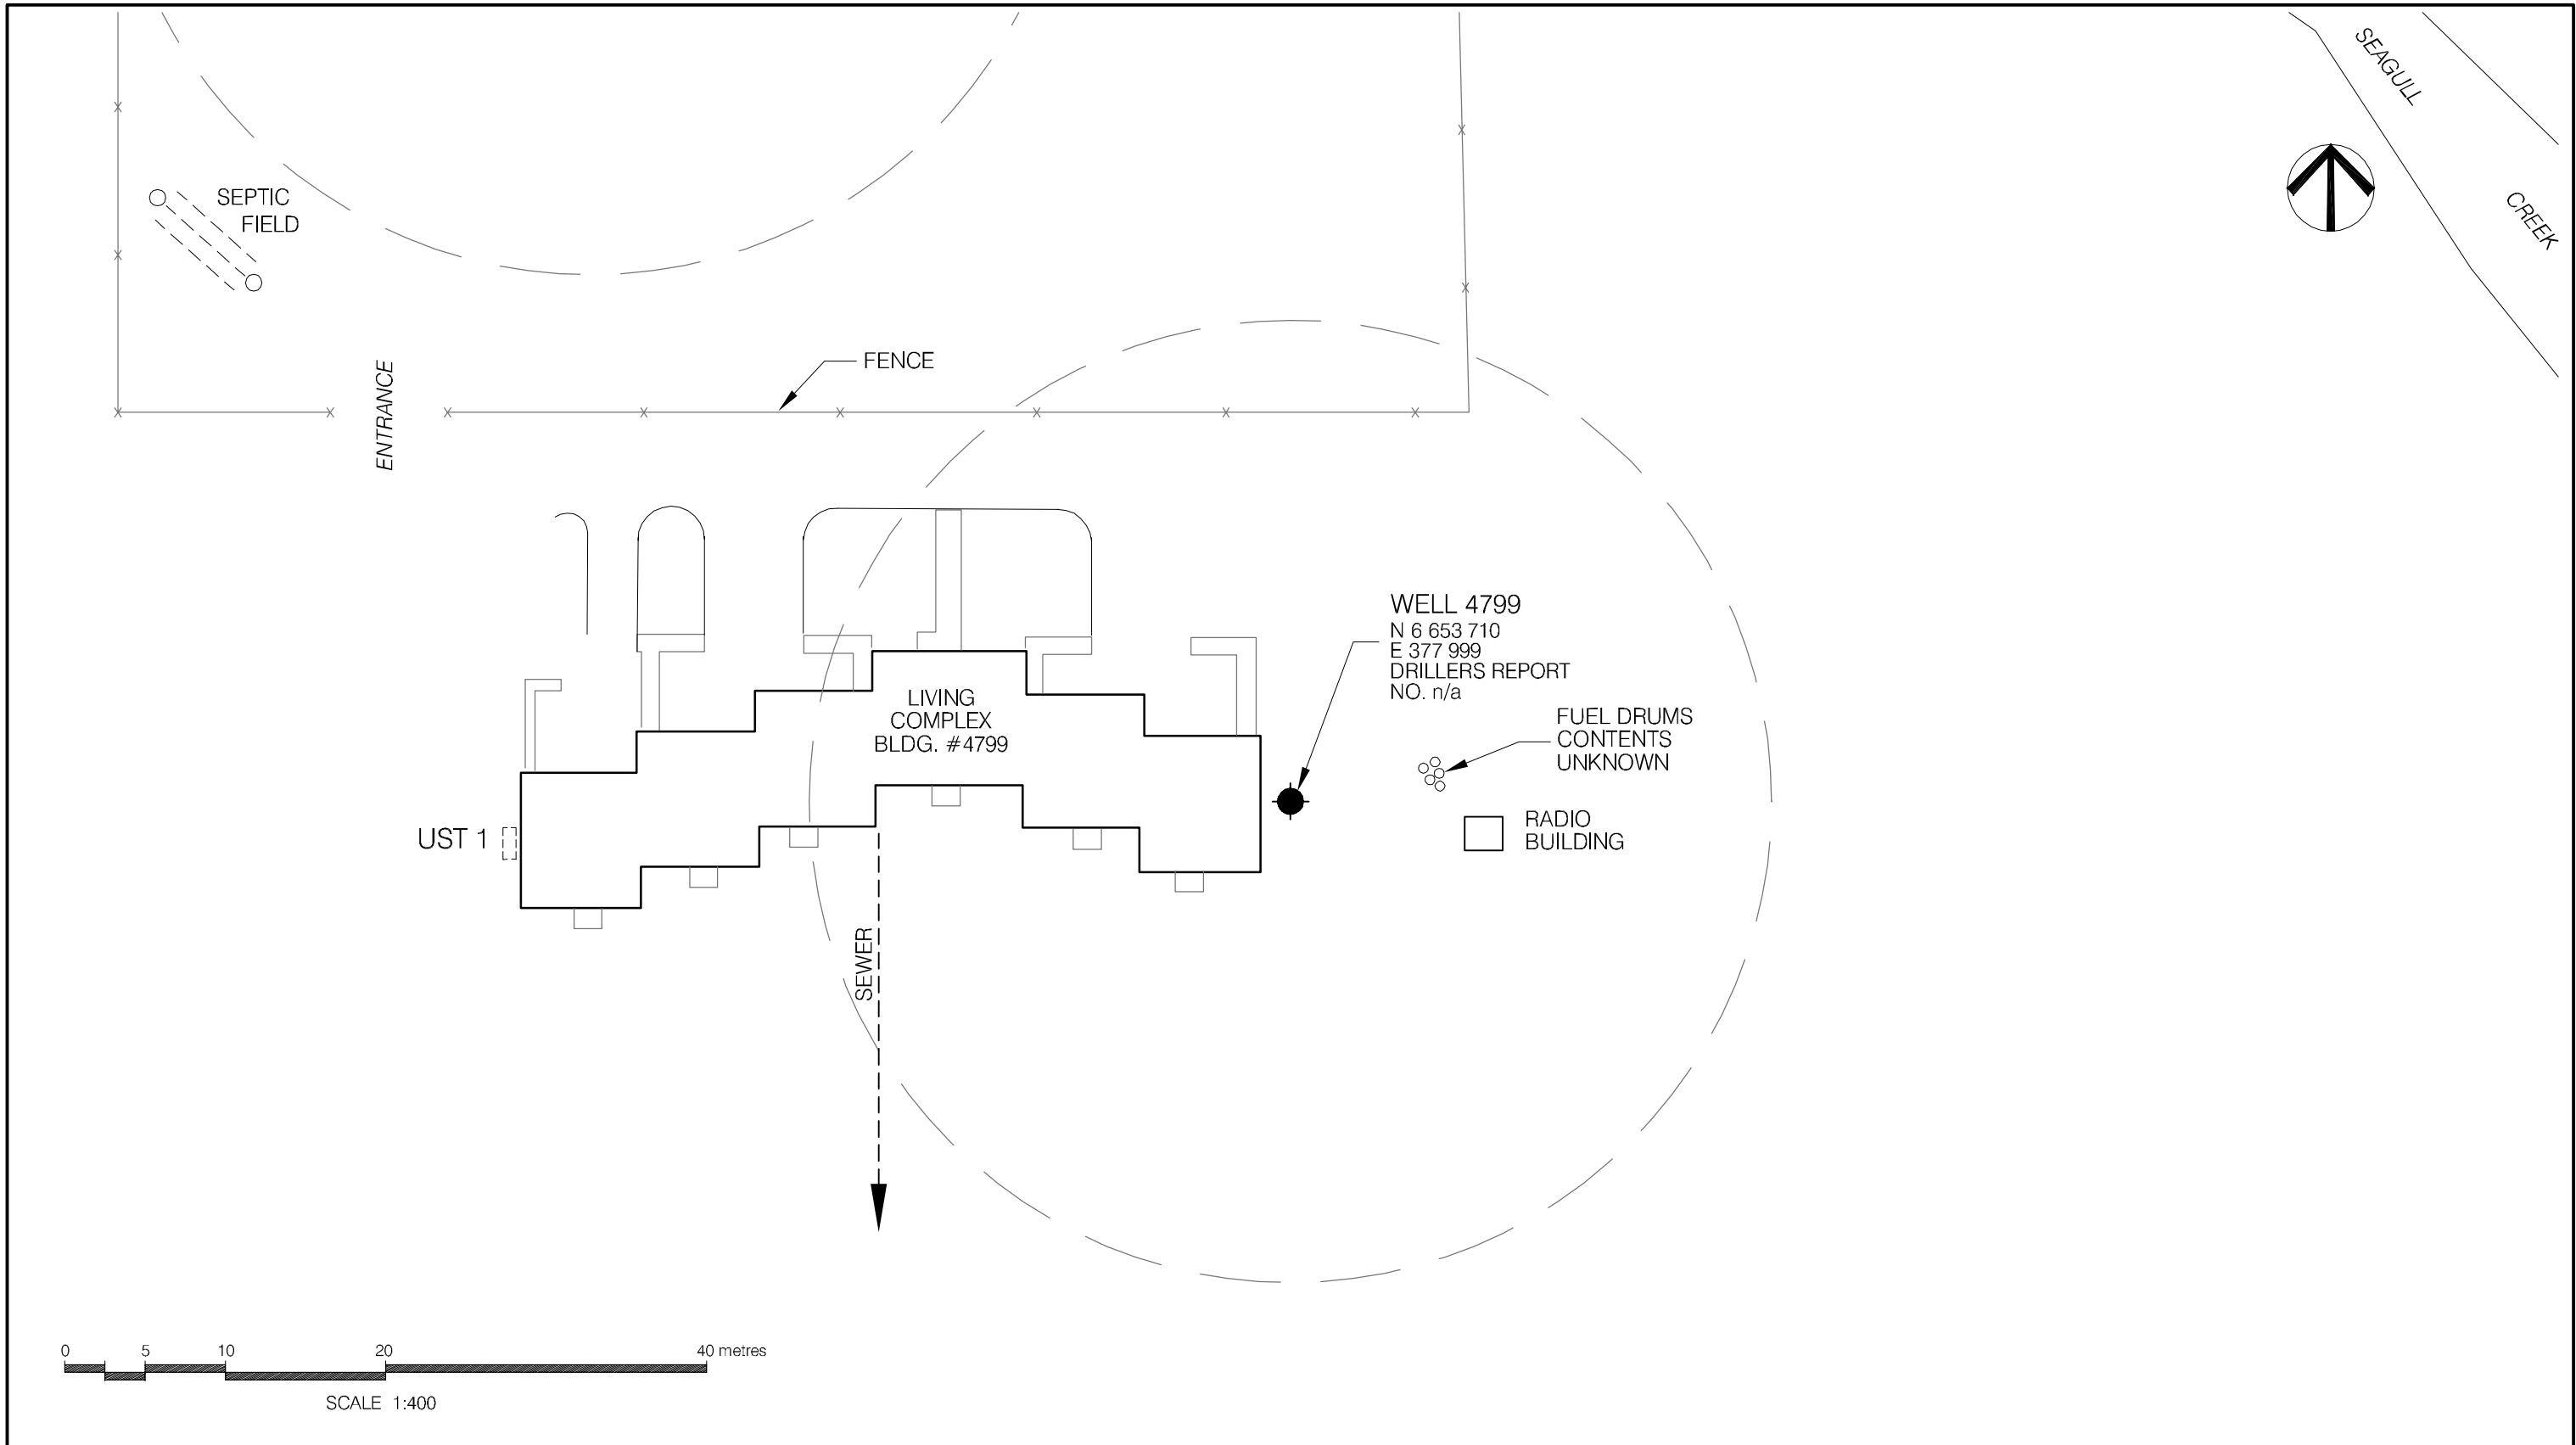
FIGURE No.
4799-A

Building 4799, the Swift River Living Complex, is a five-unit complex that houses highway maintenance workers and is served by a well located in a pit approximately 1 m from the living complex. The well location and other details about the surrounding area are provided in Figure 4799-A in Appendix A11. The coordinates of the wellhead were recorded as:

- Wood stave sewage line at 25 m; and,
- Fuel drums at 8 m.

- The well is located within 30 m of potential sources of contamination, including a wood stave septic line and fuel drums;
- Poor surface completion of the well (located in a pit below grade);

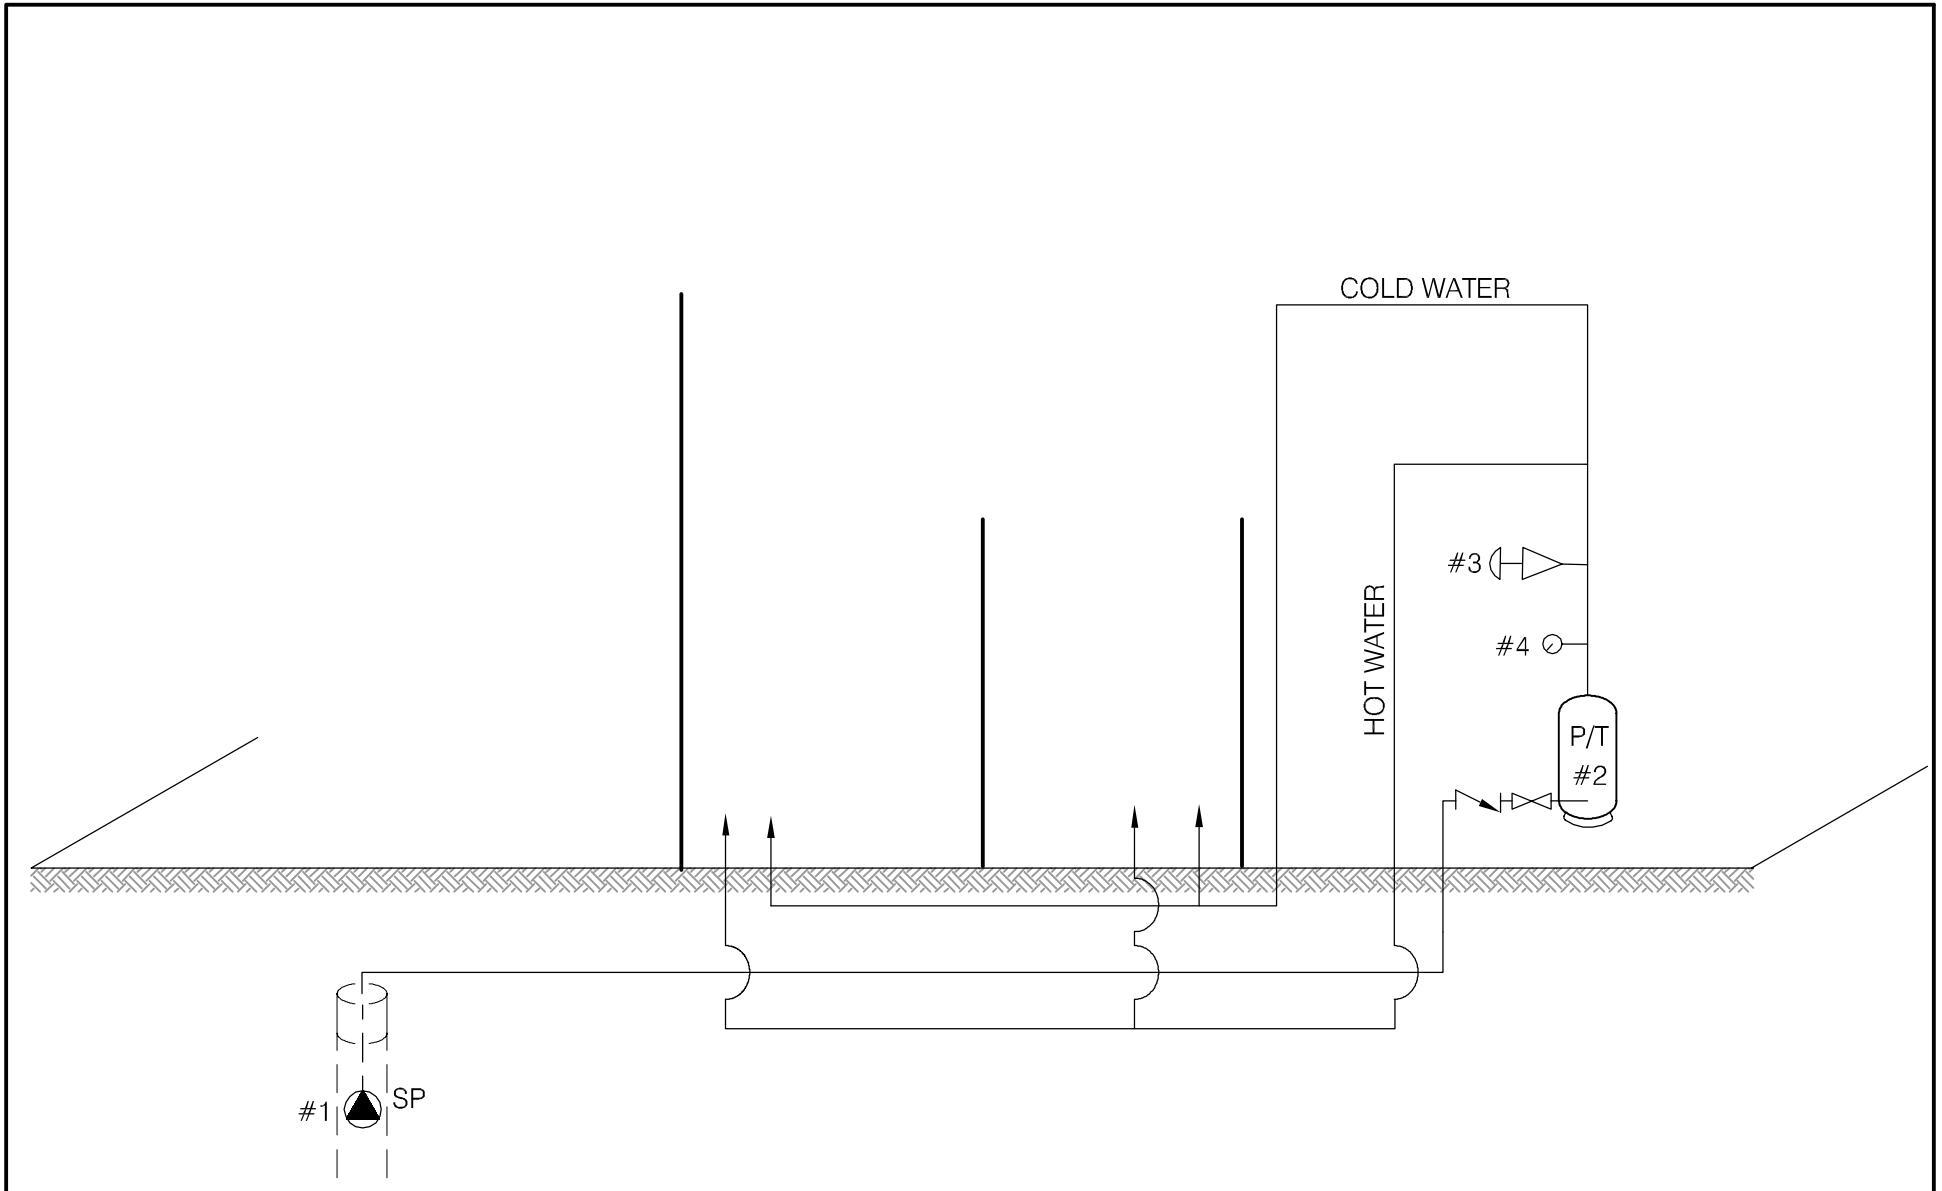
TITLE WATER SYSTEM DISTRIBUTION/TREATMENT SCHEMATIC SYSTEM ID.: 4799 SWIFT RIVER LIVING COMPLEX	
DATE	JULY 2005	DWN.	JSB
CHKD.	FMM	FILE NO.	1260002.002
		DWG.:	FIGURE 4799-B

At the time of the assessment, there was no treatment in place for this system. A schematic detailing the water system is provided as Figure 4799-B in Appendix A11.

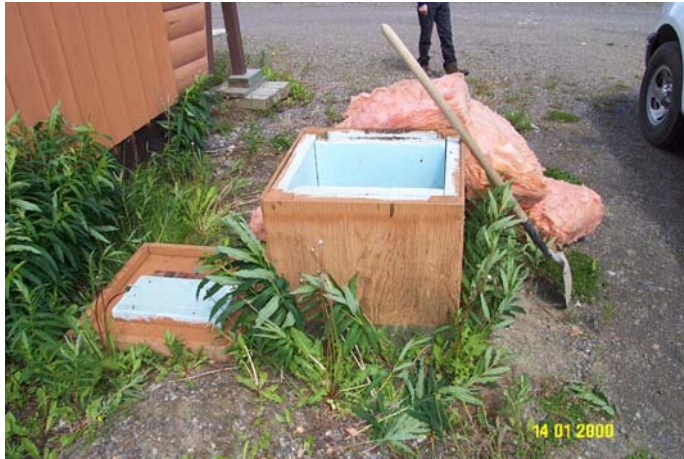
Unauthorized access by humans? Yes No
unlocked wooden enclosure

Entrance by animals? Yes No
Access possible - signs of rodents

Photo 0238: 4799 Wellhead enclosure

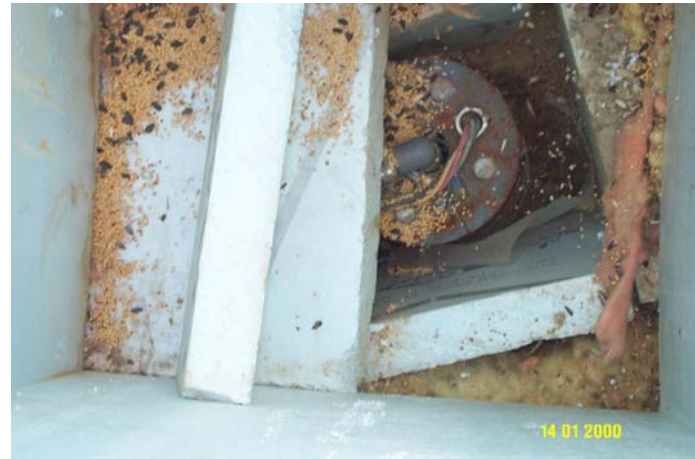
-
- The well is not equipped with a surface sanitary seal as required by the Canadian Groundwater Association's Well Construction Guidelines;
 - By definition of the Draft Yukon GUDI Assessment Guideline, the well is potentially under the direct influence of surface water because it is likely completed within a vulnerable type (unconfined aquifer), and does not meet the requirements of the Guidelines for Water Well Construction;
 - The copper concentration has been previously reported to be in exceedence of CDWQG MAC. The most recent water sampling results, however, were below the CDWQG MAC; and,
 - There is no treatment or disinfection system present.

- i. Is the well head below grade? describe in detail Yes, 0.65 m below grade
- ii. Are there signs of ponding on the enclosure(e.g. water stains, etc.)? Yes No
- iii. Is the wellhead enclosed by fiberglass insulations? Yes No
- iv. Any evidence of rodents? Specify some evidence, access possible
- v. Does the well casing have a proper seal cap? Yes No

If no, describe condition split gasket cap - does not appear to be properly fastened

Photo 0237: 4799 Wellhead in pit

- If the well is deemed suitable to supply all three buildings, it will require physical upgrades including installation of a surface sanitary seal (grout or bentonite) to a depth of at least 3 m, and extending the well casing at least 500 mm above grade;
- A underground piped water distribution line should be installed, and should be properly freeze-protected through heat-trace and insulation; and,
- An NSF/ANSI 55 certified UV disinfection system complete with NSF-61 certified pre-filtration to 1 micron absolute should be installed near the point of entry in the Swift River Living complex.

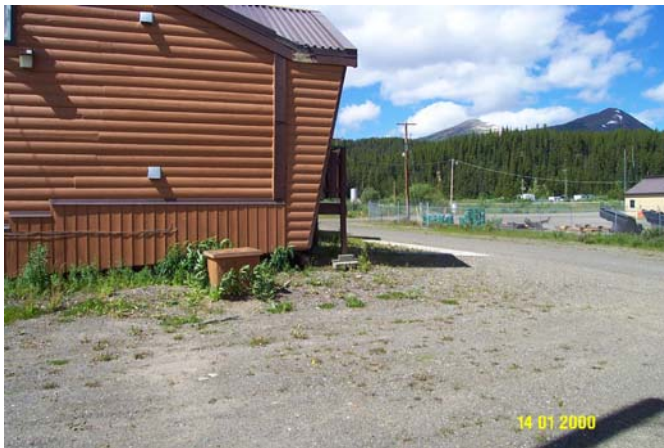
Photo 0240: 4799 Swift River Living Complex (back) and wellhead enclosure (in front)

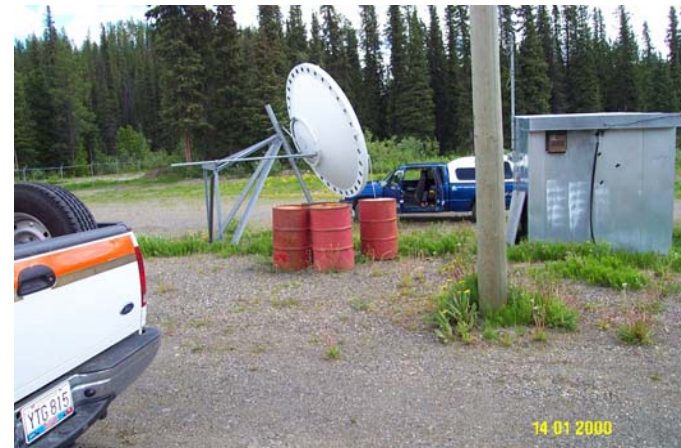
Potential Source 1: Fuel drums; Distance from well to Potential Source 1: 8m

Photo 0239: 4799 Fuel drums (centre), and radio building (right)
