5.0 BUILDING M0181 – TESLIN RCMP RESIDENCE

SMALL PUBLIC WATER SYSTEMS ASSESSMENT
 EASTERN REGION

TESLIN RCMP RESIDENCE
 M0181
 SITE LOCATION DIAGRAM
 WELL ID: N/A

SMALL PUBLIC WATER SYSTEM ASSESSMENT

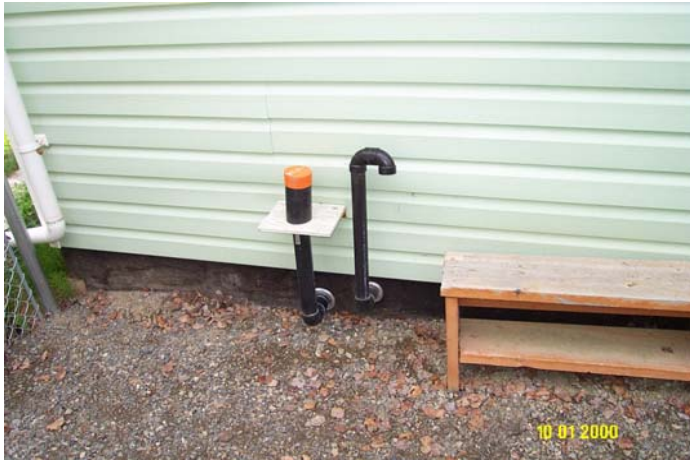
Photo 0215: M0181 delivery water fill

- Piping is constructed of ABS and is not suitable for drinking water.

- Replace ABS piping with PVC piping.

- Replacing the ABS fill pipe with PVC would cost in the order of **\$200** for materials and labour.

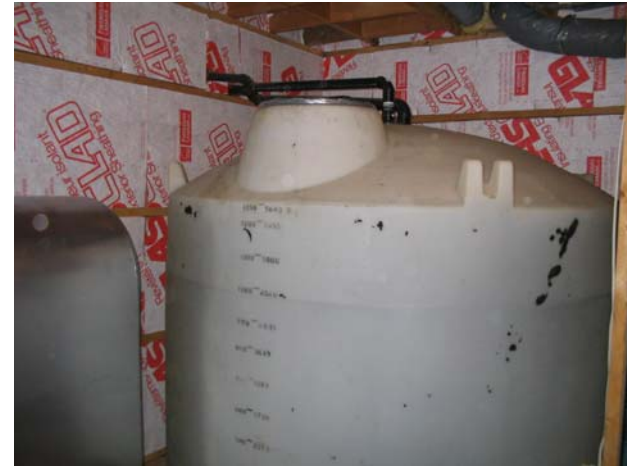
Photo 0022: M0181 5000 L water storage tank

- Low free available chlorine concentration; and,
- Lack of regular water holding tank cleaning and residual chlorine monitoring.

- Undertake immediate cleaning of holding tank including superchlorination of the tank and piping.
- Institute a regular FAC monitoring program and if residual chlorine concentrations continue to be low, consult with the Village of Teslin to ensure that concentrations upon delivery are above 4 mg/L as required by regulation.
- Implement a regular water storage tank cleaning program every 6 months.

Clean tank, superchlorinate
system.

Clean tank per manufacturer instructions.
