8.0 BUILDING 4782 – TESLIN WATER RESERVOIR

SMALL PUBLIC WATER SYSTEMS ASSESSMENT
 EASTERN REGION

TESLIN WATER RESERVOIR
 BUILDING # 4782
 SITE LOCATION DIAGRAM
 WELL ID: 4782

WATER SYSTEM DISTRIBUTION/TREATMENT
SCHEMATIC SYSTEM ID.: 4782
TESLIN GRADER STATION

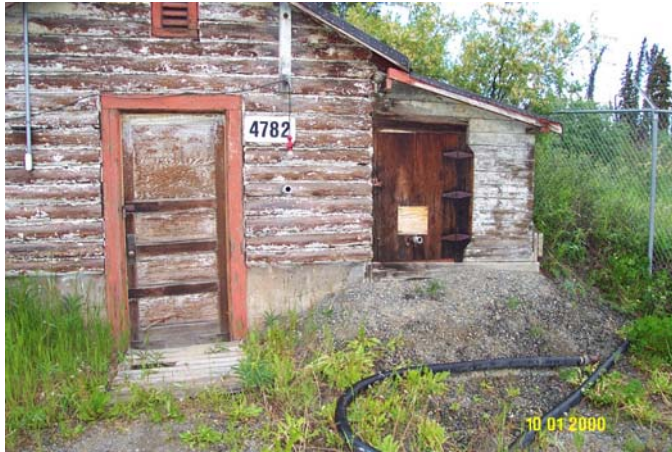
Photo 0218: 4782 Water Reservoir building

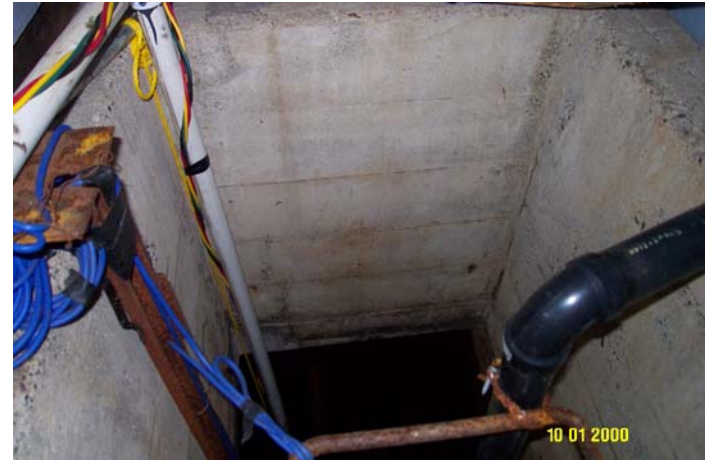
- This concrete cistern is not suitable for drinking water storage;
- There is no water disinfection system;
- There are no bacteriological results available for review.

Comments: IRON STAINING

Photo 0220: 4782 Cistern inside Water Reservoir building

In consideration of the condition of the cistern, and the difficulty to rehabilitate it to make it suitable for storage of a drinking water supply, it is advisable to find an alternate source of drinking water for the grader station building.

CLEAN THE CONCRETE CISTERN. INSTALL PROPERLY SEALED LID. REPIPE THE SUB. PUMP SYSTEM WITH PROPER SEALED WRM SLEEVES. INSTALL PROPERLY SEALED FILL LINE TO THE CISTERN. SUPERCHARGE THE COMPLETE PIPING SYSTEM. INSTITUTE PROPER CHLORINE RESIDUAL TESTING.

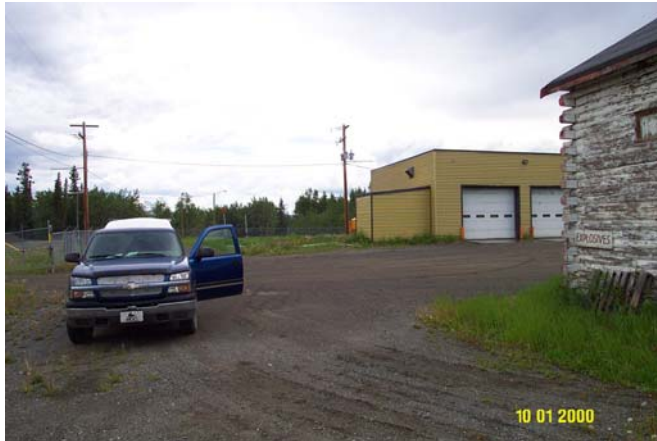
Photo 0222: 4782 Teslin Grader Station (back) and Water Reservoir building (right)

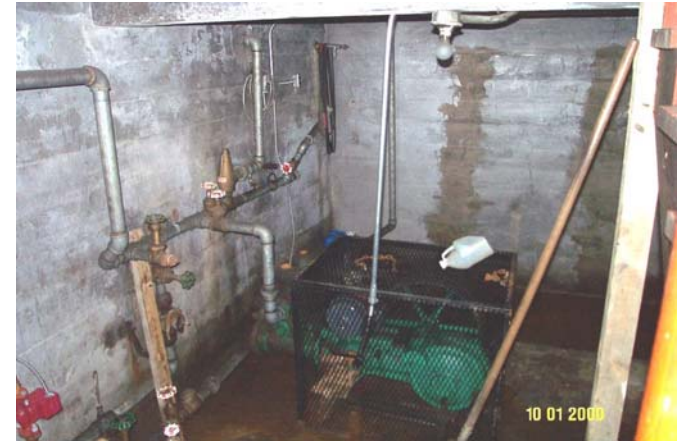
- Both the truck fill and cistern fill lines do not have proper caps;
- There is no drain at the lower level of the reservoir;
- There is no regular cistern cleaning schedule;

- i. Is the well head below grade? describe in detail The water reservoir is made of concrete and installed below grade
- ii. Are there signs of ponding on the enclosure(e.g. water stains, etc.)? Yes No
The basement of the building has been flooded in 5cm of water
- iii. Is the wellhead enclosed by fiberglass insulations? Yes No
- iv. Any evidence of rodents? Specify There was no evidence of rodents inside building
- v. Does the well casing have a proper seal cap? Yes No
N/A
If no, describe condition _____

Photo 0221: 4782 Basement of Water Reservoir building. Water pump (centre), cistern behind left wall, note flooding on the floor.

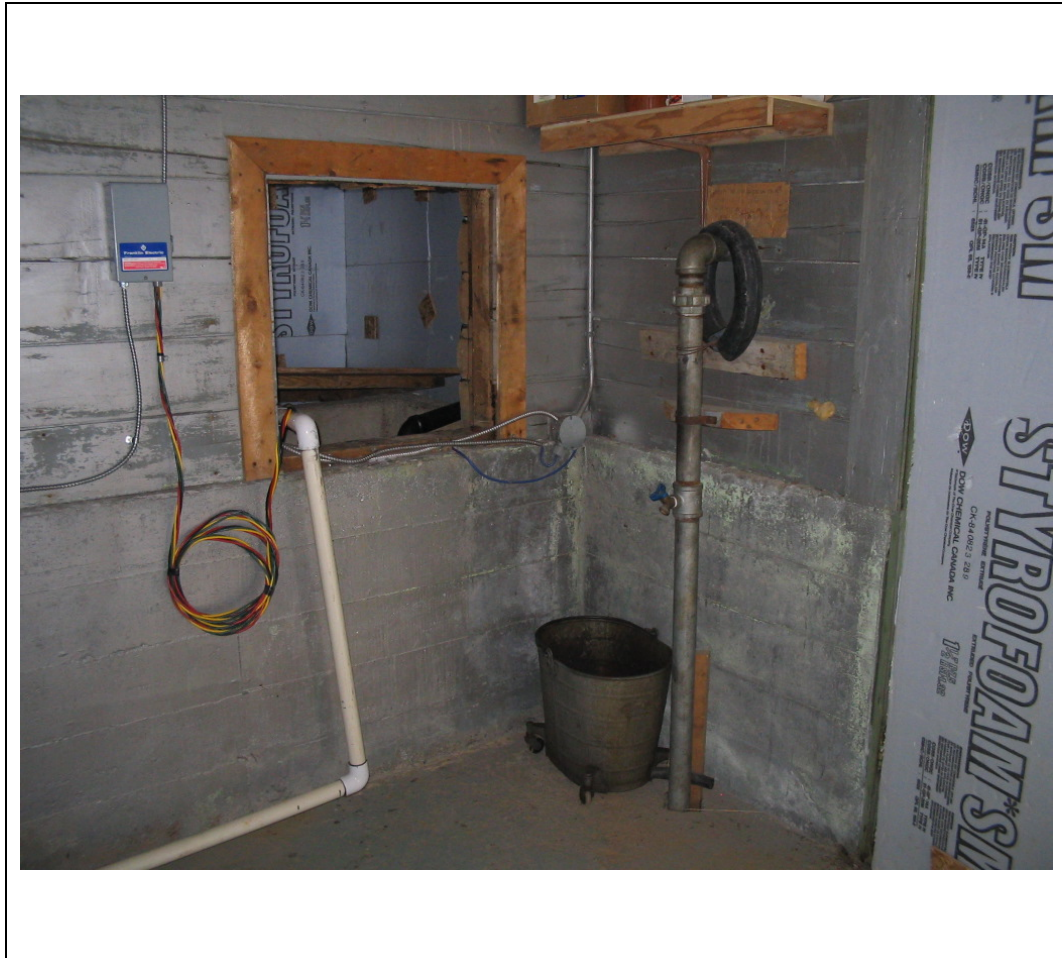
THIS INSTALLATION DOES NOT MEET DRINKING WATER SYSTEM STANDARDS. THE CISTERN ACCESS IS NOT SECURED WITH A LID OF ANY KIND. THERE IS A STRONG DIESEL FUEL ODOUR IN THIS BUILDING. BOTH THE TRUCK FILL LINE AND THE CISTERN FILL LINE ARE EXPOSED WITHOUT A PROPER CAP. THERE IS NO DRAW OR SUMP PUMP AT THE LOWER LEVEL.

Photo 0009: 4782 Entrance to cistern

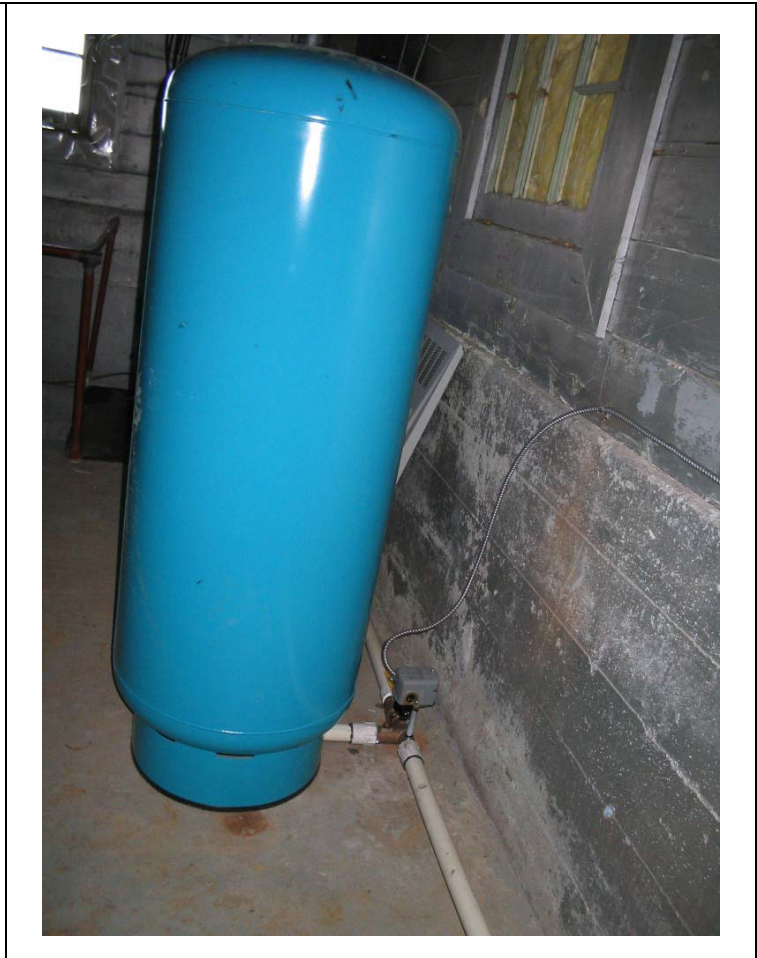
Photo 0009: 4782 Pressure tank
