## **6.0 BUILDING 1153: CARCROSS GRADER STATION**

PROJECT SMALL PUBLIC WATER SYSTEMS ASSESSMENT  
WHITEHORSE REGION

## SMALL PUBLIC WATER SYSTEM ASSESSMENT

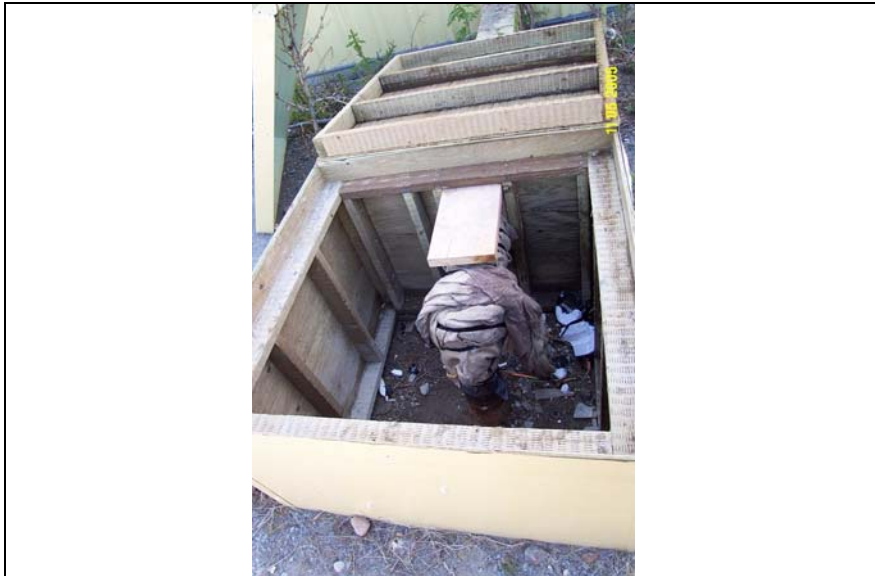
**Photo 0131:** 1153 Well Head

High-risk deficiencies identified for the Carcross Grader Station water supply include the lack of disinfection, poor surface completion of the wellhead, and proximity of the well to surface sources of contamination including the wastewater disposal system, rock pit, waste oil tank, vehicle parking lot and salt storage area (assessed as high risk in light of current well construction). By definition of the Draft Yukon GUDI Assessment Guideline, the well is potentially under the direct influence of surface water because it does not meet the requirements of the Guidelines for Water Well Construction.

Unauthorized access by humans?  Yes  No Entrance by animals?  Yes  No  
only painted tin casing and put plywood unfastened on top There are few signs of animals

o. Is well site subject to flooding?  Yes  No  
Heavy water stains and dampness, still wet after a long period of dry weather. Signs of flooding.

p. Is the well site well drained?  Yes  No  
There is little drainage surrounding ground is level with the height of the well head or slightly above

-There is a major concern with flooding. There is evidence that the well casing and surface casing has been flooded due to rust, status, ect.  
-The well is in very close proximity to many potential contaminants such as salt, metal, used oil, effluent,  
\_\_\_\_\_  
\_\_\_\_\_

If Option 1 is selected for Priority 1 upgrades, then the following Priority 2 upgrades are recommended. The wellhead completion should be improved to prevent the ponding of surfacewater around the well casing. This would involve raising the well casing to a minimum of 500 mm above ground level and retrofitting a proper surface seal to 3 m depth around the well casing. The ground surface should then be graded to promote surface drainage away from the well. The well should be assessed for well depth; depth to water and depth of pump installation to confirm assumed information on the well.

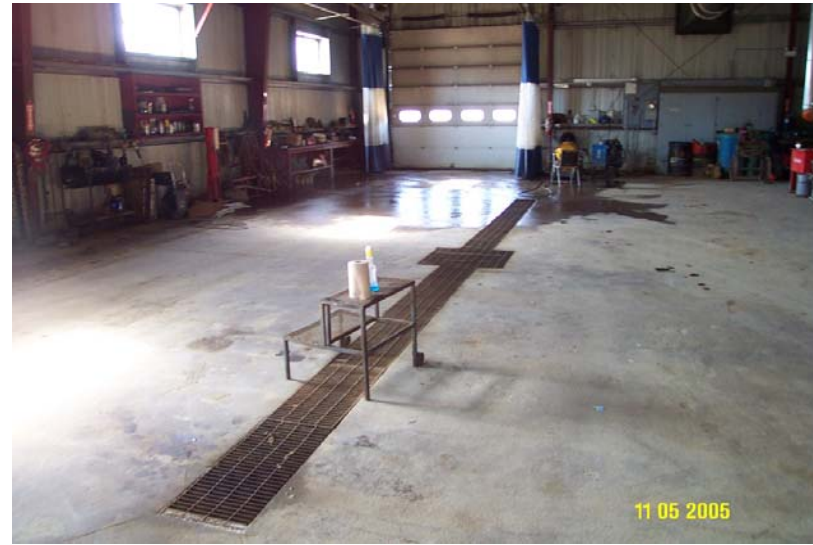
**Photo 0134:** Floor Drain System

There was no oil-water separator or grease trap observed within the floor drain system.

Install an oil-water separator or grease trap within the floor drain system.

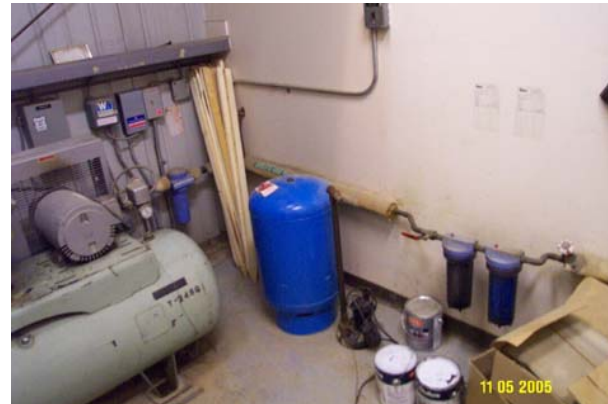
**Photo 0136:** Pressure Tank and Three In-Line Filters

Explain (filtration, disinfection etc...) only a 3-line filters

Installation of a proper disinfection system is recommended for the Carcross Grader Station water supply. The possibilities of using either chlorination or a NSF/ANSI 55 certified UV system may be evaluated for this well. A dual disinfection system (with filtration and disinfection) would mitigate the risk of the proximity to the sewer pipe (22 m). UV treatment is generally less expensive than chlorination; however pre-treatment would be required. An ion exchange system such as a softener used for pretreatment for iron, manganese and hardness in order to ensure proper operation of the UV system may also reduce the content of arsenic in the water depending on the form of arsenic (III or V). If chlorination is the preferred disinfection option, it would be worthwhile considering installation of the water softener system from a cost benefit perspective to increase the lifetime of fixtures and plumbing, while decreasing maintenance and cleaning.
