26.0 BUILDING 1131 – CARCROSS SEARCH AND RESCUE OFFICE

SMALL PUBLIC WATER SYSTEMS ASSESSMENT
 WHITEHORSE REGION

PART A: EBA Site Inspection

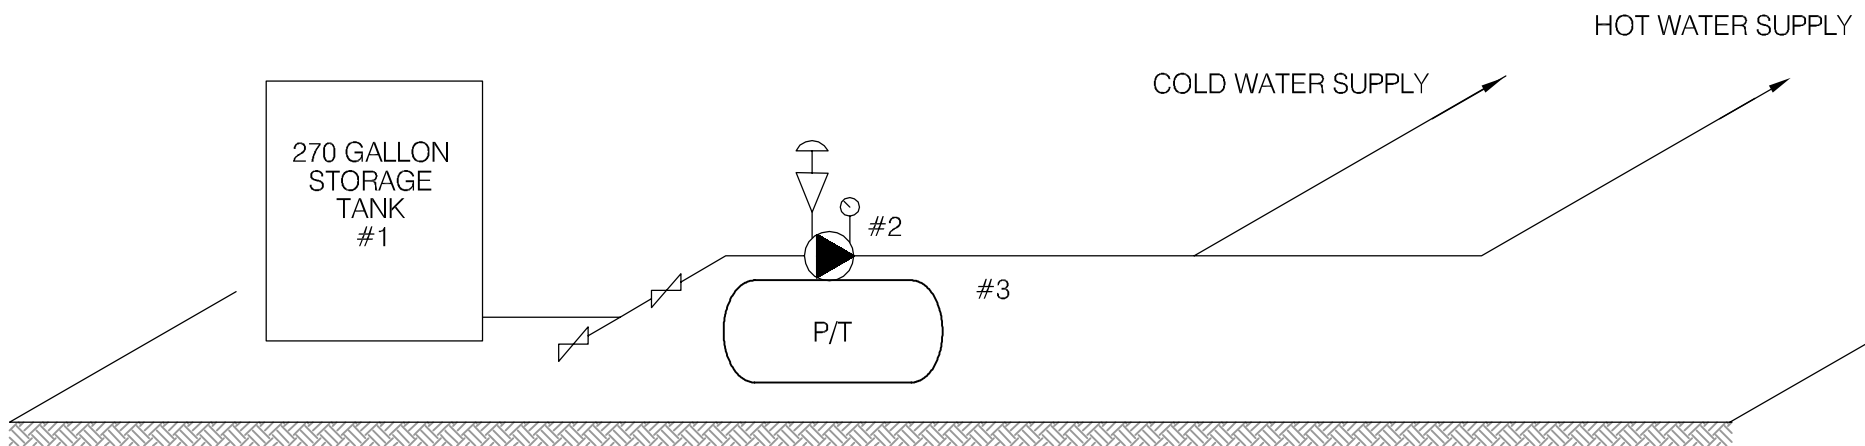
TITLE WATER SYSTEM DISTRIBUTION/TREATMENT SCHEMATIC SYSTEM ID.: 1131 CARCROSS SEARCH & RESCUE BUILDING			
DATE APRIL 2006	DWN. JSB	CHKD. RMM	FILE NO. 1260002.005	DWG.: FIGURE 1131-B

STATION IS ON WATER DELIVERY INTO A 270 IMP. GAL UPRIGHT POLY TANK.
THE WATER IS DRAFTED FROM THE TANK WITH A 1/2 HP., 115V JET PUMP WITH
1" POLY TUBING FOR SUCTION AND 1" POLY TUBING (DISCHARGE) TIED INTO POLY B
MANIFOLD.

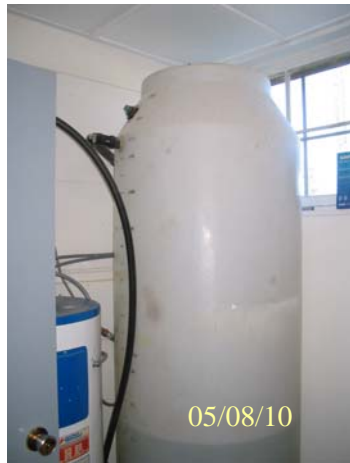
- FAC at the point of use was 0.01 mg/L, below the required 0.2 mg/L, and there is no routine monitoring of residual chlorine concentrations;
- The vent/overflow does not have a vermin proof screen; and,
- The water tank is not easily accessible for routine inspection and cleaning. It may be difficult to install a watertight access hatch in a polyethylene tank. If it is not possible to clean this tank in its current state, a replacement tank with suitable access should be installed.

ONLY 10" BETWEEN TOP OF TANK (LID) AND CEILING.

Photo 141: 1131 Water storage tank.

- Undertake immediate cleaning of holding tank including superchlorination. If it is not possible to clean this tank in its current state, a new tank should be installed with suitable access for routing cleaning;
- Implement a regular water storage tank cleaning program every 6 months; and,
- Initiate a routine bacteriological testing program.

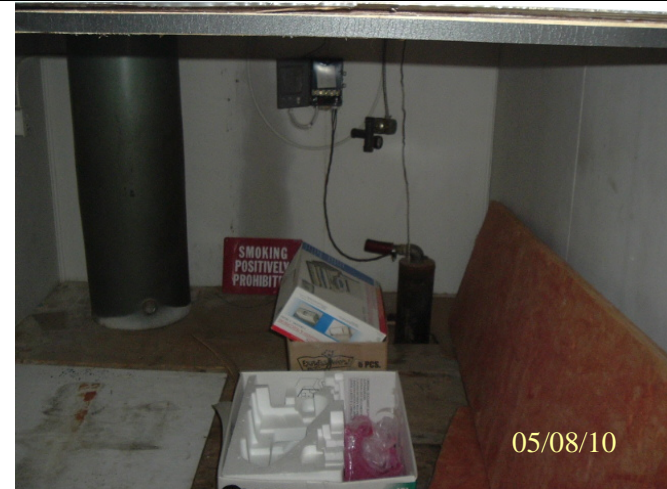
An abandoned well is located in an enclosure on the northwest corner of the building. It is anticipated that use of this well was discontinued due to elevated arsenic concentrations that are found in groundwater in the Carcross area.

As the system is supplied by water delivery, the abandoned well does not pose a threat to the safety of the water supply. However, if the aquifer was ever to be used as a drinking water source the abandoned well could act as a preferential pathway for contaminants to reach the aquifer. It is recommended that this well be properly decommissioned.

Photo 027: 1131 Abandoned well.

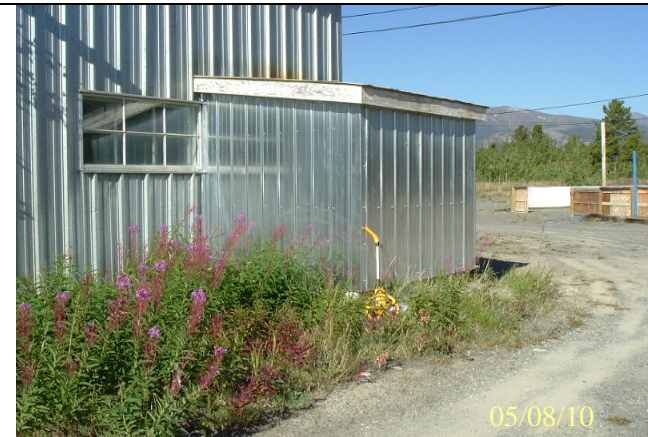
- i. Is the well head below grade? describe in detail No, ~60cm above grade
- ii. Are there signs of ponding on the enclosure(e.g. water stains, etc.)? Yes No
- iii. Is the wellhead enclosed by fiberglass insulations? Yes No likely in walls of enclosure
- iv. Any evidence of rodents? Specify Yes, mouse droppings
- v. Does the well casing have a proper seal cap? Yes No
If no, describe condition Split gasket cap

Photo 028: 1131 Abandoned wellhead enclosure.
