4.0 BUILDING 1134-CARCROSS SCHOOL

SMALL PUBLIC WATER SYSTEMS ASSESSMENT
 WHITEHORSE REGION

CARCROSS SCHOOL
 BUILDING 1134
 SITE LOCATION DIAGRAM
 WELL ID: 1134A & 1134B

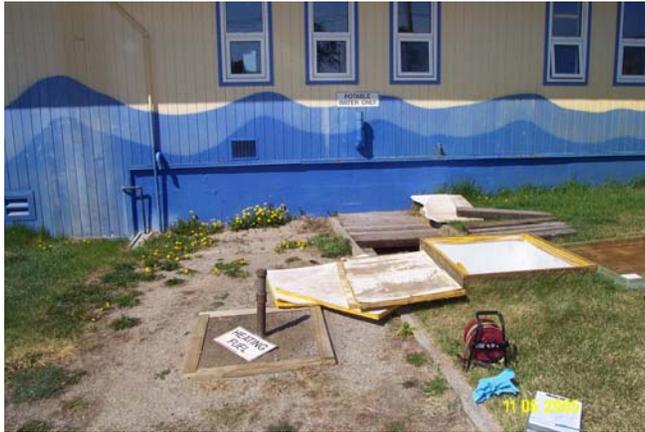
Photo 0115: 1134 Wells 1 and 2, Water Fill, Underground Fuel Storage Tank

The only potential contaminant source within 40 m of the wells is an underground fuel storage tank that is approximately 2 m from nearest wellhead.

The underground storage tank should be removed and proper testing completed to ensure that there is no residual hydrocarbon contamination associated with the previously mentioned fuel spill.

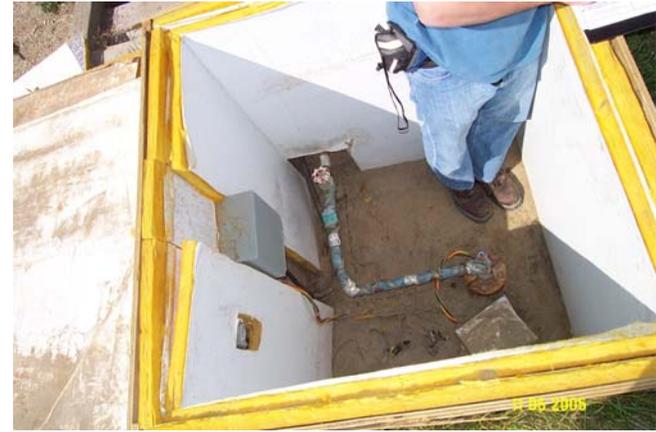
Photo 0120: 1134 Well 2 Well Head in Pit

Well Construction Details				
Wellhead Above ground (m)	Well Cap	Well Screen	Surface Seal	Apron Grading
W1- 1.8 below grade	Split Cap Gasket	?	Unlikely	No, but ground slopes away from pit
W2 - 1.1 below grade	Split Cap Gasket, 2 missing bolts	?	Unlikely	No, but ground slopes away from pit

If no, describe condition both have split seal gasket caps, though rusty, W2 has 2 missing bottom plates and may not be properly sealed.

Consideration should be given to upgrading these non-potable water wells to ensure contamination of the aquifer in which these wells are completed does not occur. Mitigative upgrades would include installation of a sanitary surface seal, casing extension, and re-plumbing and electrical upgrades.

Consideration should be given to ensuring that the water wells have a proper sanitary seal, and are raised above grade. It is estimated that the “standard well upgrade” could be completed for both wells for approximately **\$8000**.

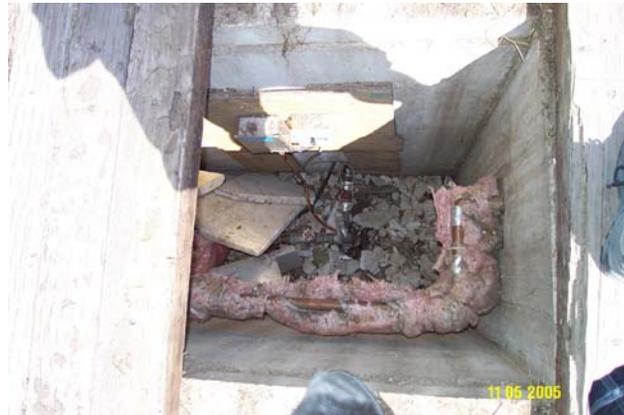
Photo 0121: 1134 Well 1 Well Head in Pit

- i. Is the well head below grade? describe in detail Yes W1 180cm, W2 84cm
- ii. Are there signs of ponding on the enclosure (e.g. water stains, etc.)? Yes No
W1 has serious signs of flooding and water stains
W2 has no evidence of ponding
- iii. Is the wellhead enclosed by fiberglass insulations? Yes No
In both cases
- iv. Any evidence of rodents? Specify W2 is clean, no evidence of rodents
W1 has some mouse droppings
- v. Does the well casing have a proper seal cap? Yes No

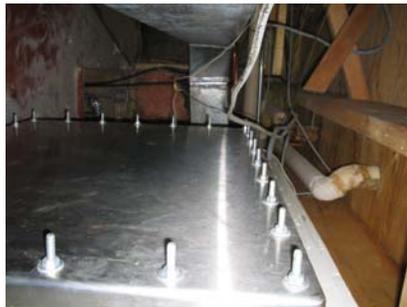
Photo 0500: 1134 Storage Tank

- As indicated previously, the concentration of residual chlorine in the Carcross School potable water system was measured at 0.0 mg/L at the time of the assessment. The lack of residual chlorine in the potable water distribution system is considered to be a high-risk deficiency.
- The potable water system lacked of a fill cap on the water holding tank and screen on the vent pipe for the delivered potable water system.

A proper fill cap should be placed in the water tank intake, and a proper screen should be placed over the vent pipe.
