9.0 BUILDING 1334: LAKEVIEW FIRE HALL

PROJECT SMALL PUBLIC WATER SYSTEMS ASSESSMENT
WHITEHORSE REGION

SMALL PUBLIC WATER SYSTEM ASSESSMENT

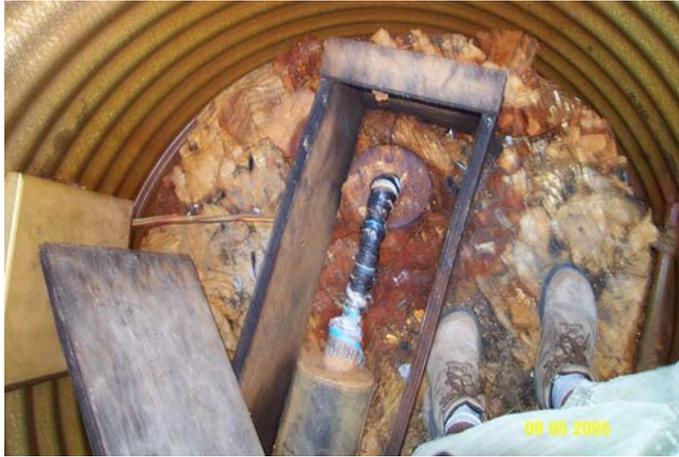
Photo 0071: 1334 Wellhead

- Poor surface completion of the wellhead below ground;
- By definition of the Draft Yukon GUDI Assessment Guideline, the well is potentially under the direct influence of surface water because it does not meet the requirements of the Guidelines for Water Well Construction;
- Chlorine injection valve cracked;
- Present piping configuration may allow water from the fire truck fill tanks to enter the potable water system which presents a health risk; and
- There is no backflow preventer on the hose bib line.
- Fire truck fill tanks do not appear to be cleaned regularly.
- The well is approximately 20 m from the sewer discharge pipe.

- i. Is the well head below grade? describe in detail 1.8m below grade
- ii. Are there signs of ponding on the enclosure(e.g. water stains, etc.)? Yes No
Evidence of water stains on culvert and the pit is in a generally unsanitary condition
- iii. Is the wellhead enclosed by fiberglass insulations? Yes No
- iv. Any evidence of rodents? Specify There is no direct evidence of rodents, despite general unsanitary condition of pit
- v. Does the well casing have a proper seal cap? Yes No

The wellhead completion should be improved to decrease the susceptibility to surface contamination. This would involve raising the well casing to a minimum of 500 mm above ground level and retrofitting a proper surface seal to 3 m depth around the well casing. The ground surface should then be graded to promote surface drainage away from the well. A fence should also be placed around the well to prevent access for animals and people.

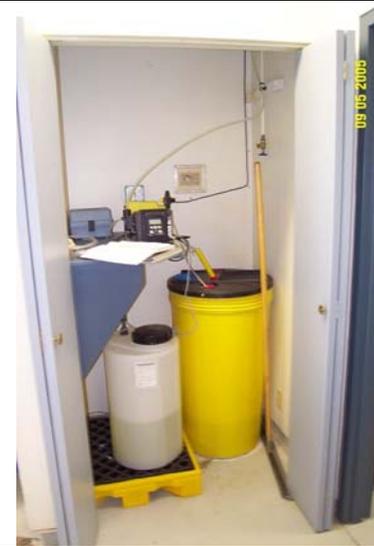
Photo 0072: 1334 DME Chlorinator and LMI Chlorinator back-up system.

PRESENT PIPING CONFIGURATION PRESENTS A HEALTH RISK FROM CONTAMINATED WATER OF FIRE TANK. CL2 INJECTION VALVE CRACKED.

Reportedly, the chlorine injection valve has already been repaired by YTG.
