8.0 BUILDING 1322 GOLDEN HORN SCHOOL

**SMALL PUBLIC WATER SYSTEMS ASSESSMENT
WHITEHORSE REGION**

**GOLDEN HORN SCHOOL
BUILDING 1322
SITE LOCATION DIAGRAM
WELL ID: 1322**

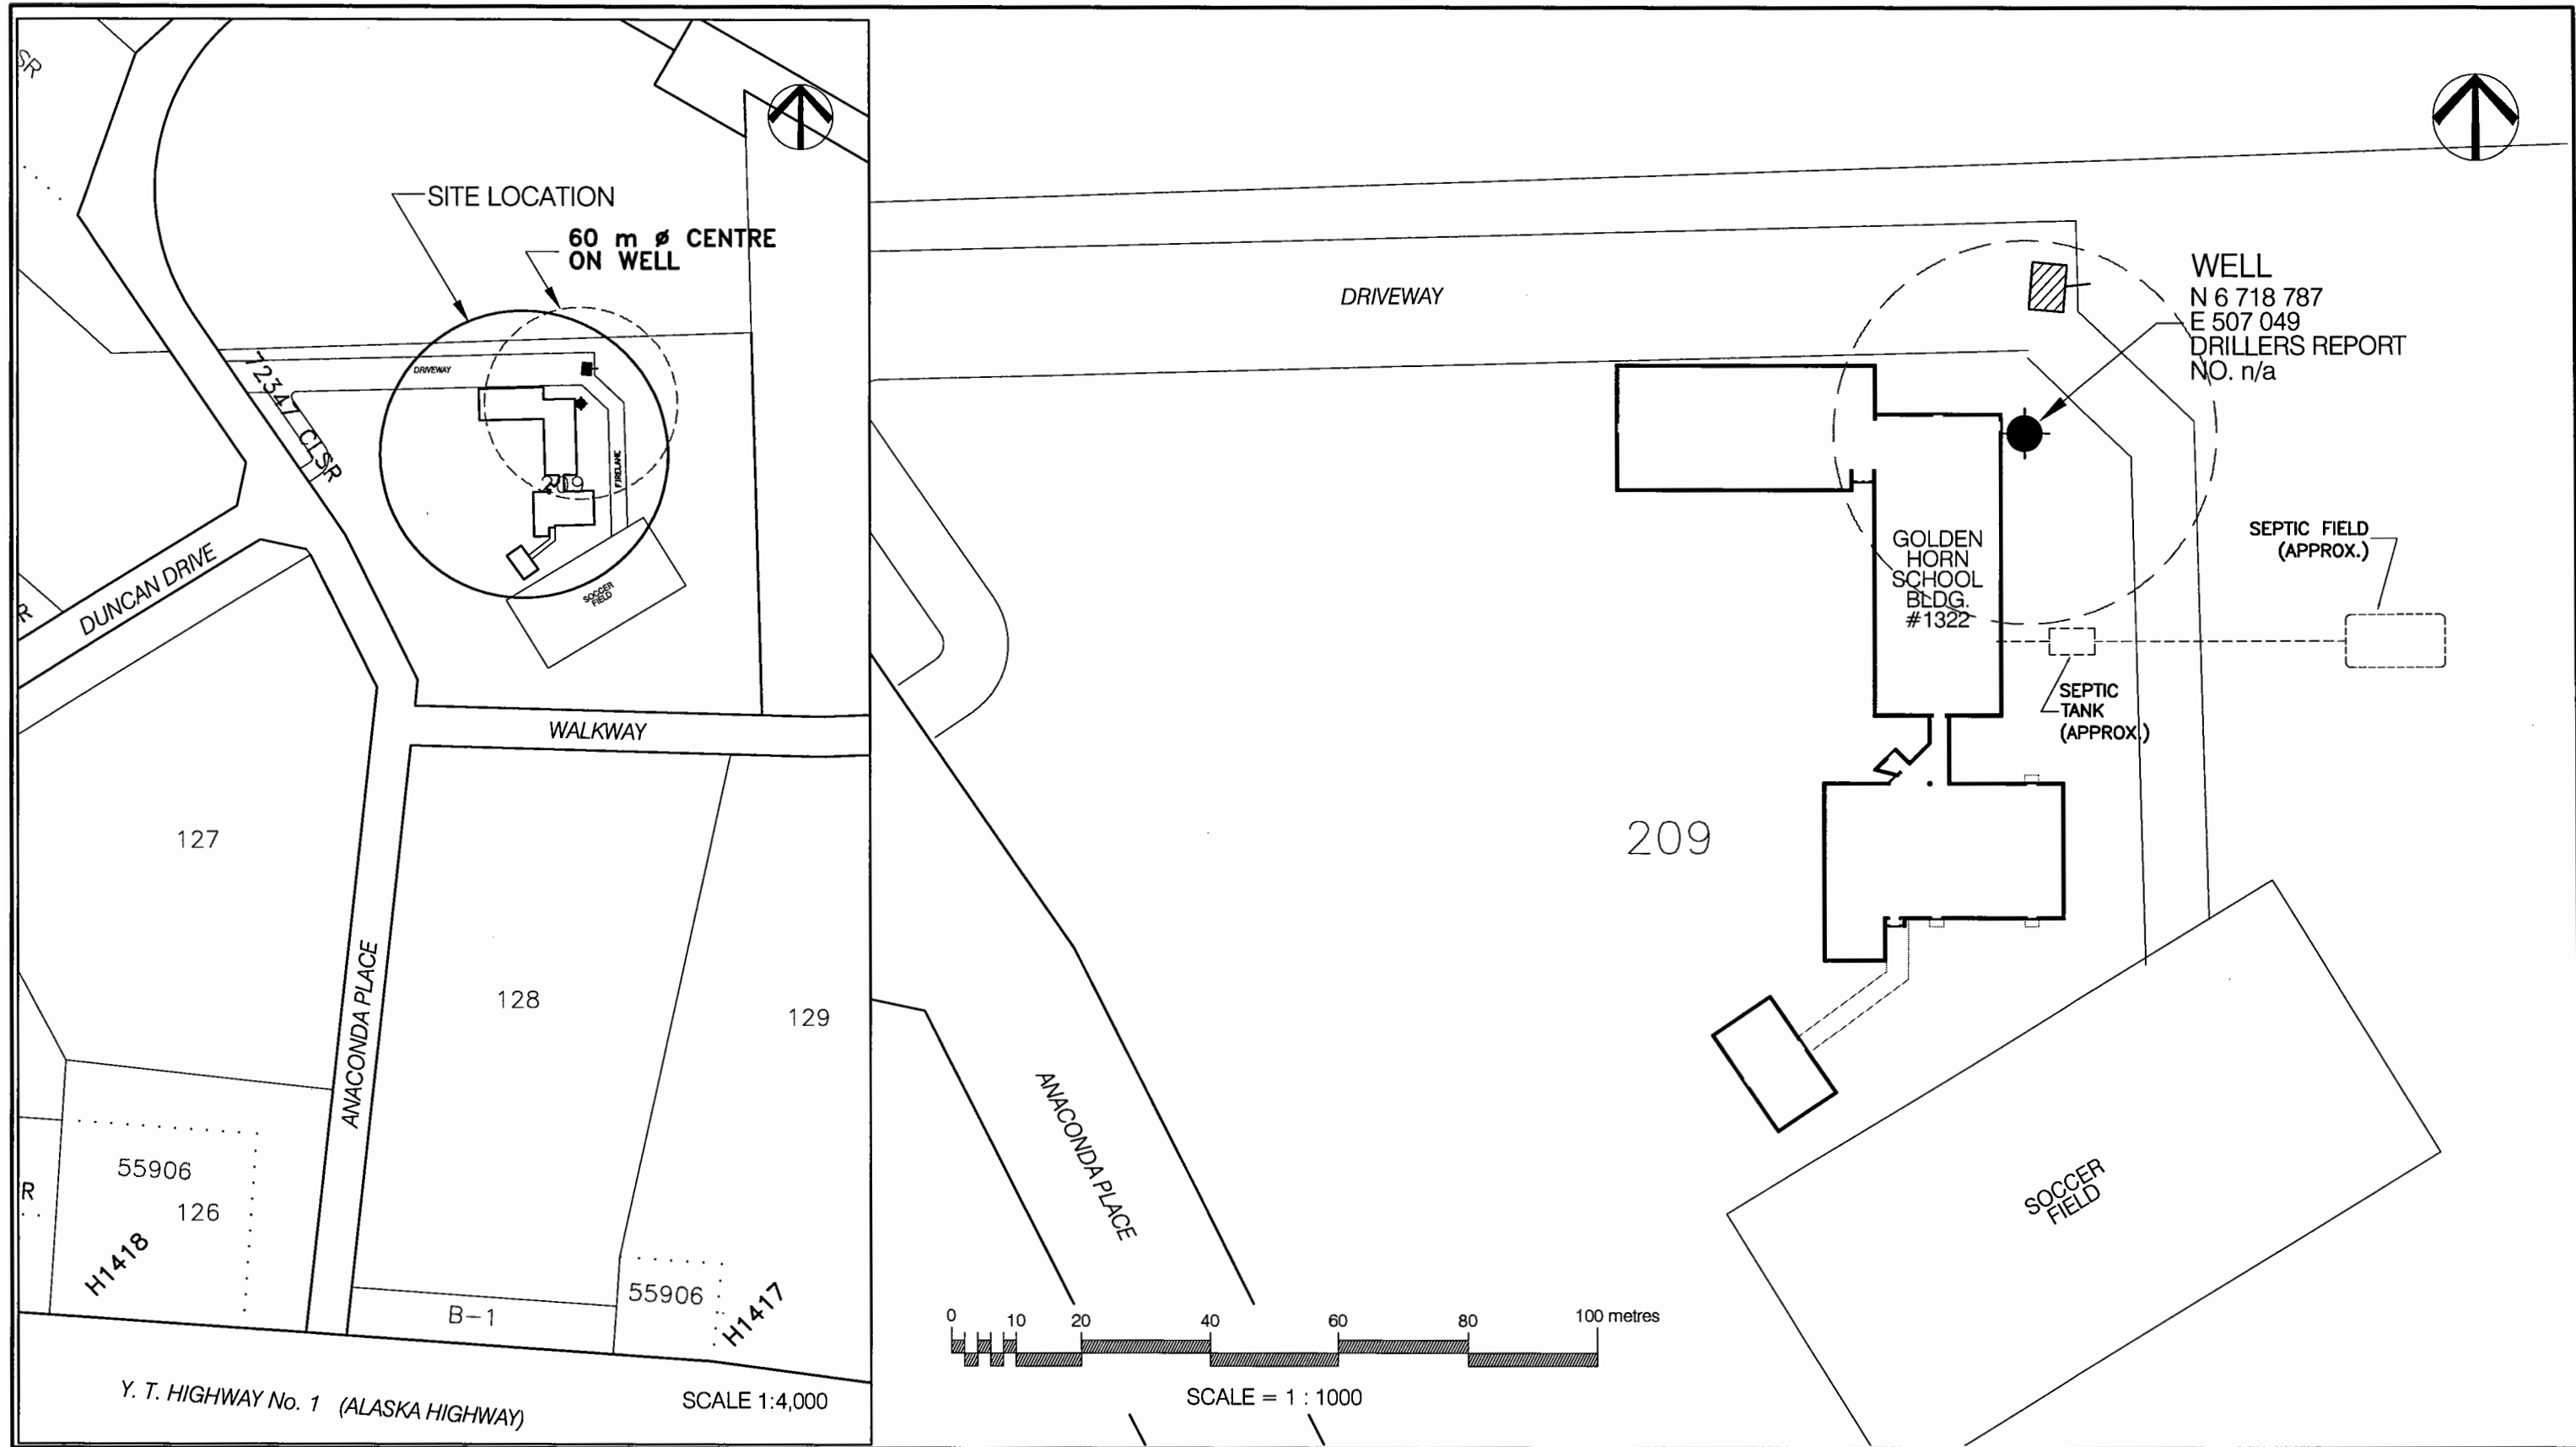
REVISION	ISSUE
0	0
DRAWING No.	FIGURE
	1322A

There is an abandoned well on the property that is no longer in use due to poor water quality. It is not a part of the existing water system. The abandoned well is shown on Figure 1322-1 in Appendix A8. The coordinates of the wellhead, as measured by a hand held GPS device, were recorded as:

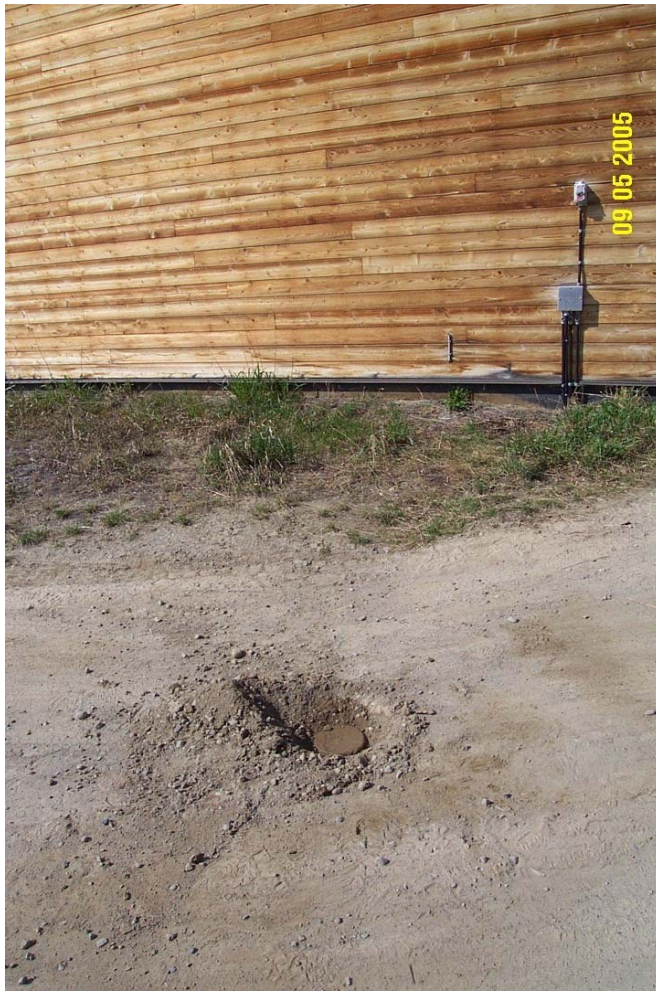
Photo 0082: 1322 Wellhead

The well is buried underneath a road, the wellhead is welded shut

l. Comments on pump installation: The well was abandoned after installation due to low flow rate and high iron content

According to the proposed Guidelines for Small Public Drinking Water Systems, an owner shall ensure that the decommissioning (abandonment) of a well is done in accordance with the criteria outlined in the *Guidelines for Water Well Construction*. A decision should be made as to whether these wells (one identified, and one not identified), may be used in the future. We understand that it is unlikely that these wells would be used in the future, due to

the fact that they were limited producers and had very high iron content. Consideration should be given to properly decommissioning these wells.

Proper decommissioning of the existing abandoned wells in accordance with the Guidelines for Water Well Construction would cost in the order of **\$1000** per well including labour and materials.

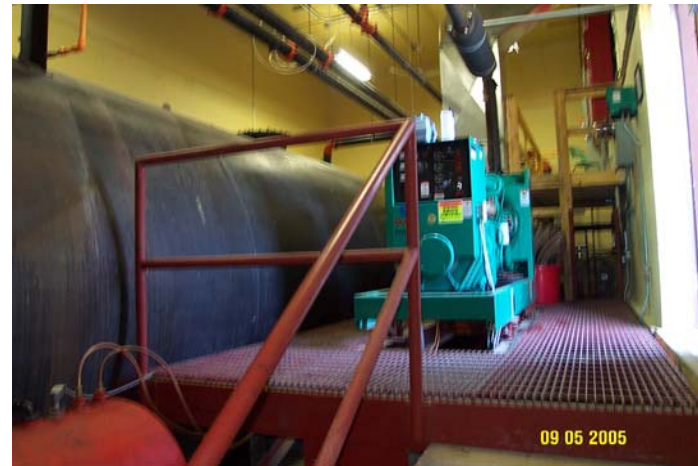
Photo 0084: 1322 Water Tank

The current water storage tank used to store the delivered water for the school water supply may require replacement or refurbishment. According to ATTS, the storage tank is made of steel with an epoxy coating and is likely unsuitable for potable water. It is suggested that the tank be inspected when it is accessible and empty during the summer months to determine its suitability. Confined space entry techniques must be used.

WATER STORAGE TANK IS NOT AN
ACCEPTABLE STORAGE TANK FOR
DRINKING WATER.
A UV SYSTEM SHOULD BE USED TO
ASSURE BAC + VIRUS FREE WATER.

The existing water storage tank may require replacement if it does not meet public health standards. As mentioned previously, it is recommended that an opinion be solicited from a qualified inspector. If required, the replacement tank should be constructed of suitable materials and be designed for use as a potable water storage tank. Removing the existing tank from the current location would be difficult.

According to Dayton and Knight, who spoke with a steel tank supplier, refurbishing tanks with an epoxy coating is possible depending on the condition of the tank. They also suggested that the tank manufacturer inspect the tank. Apparently the painting costs about \$6 per square foot. This would amount to a cost of approximately **\$1500**.
