12.0 BUILDING 1924 GOLDEN HORN FIRE HALL

SMALL PUBLIC WATER SYSTEMS ASSESSMENT
WHITEHORSE REGION

SMALL PUBLIC WATER SYSTEM ASSESSMENT

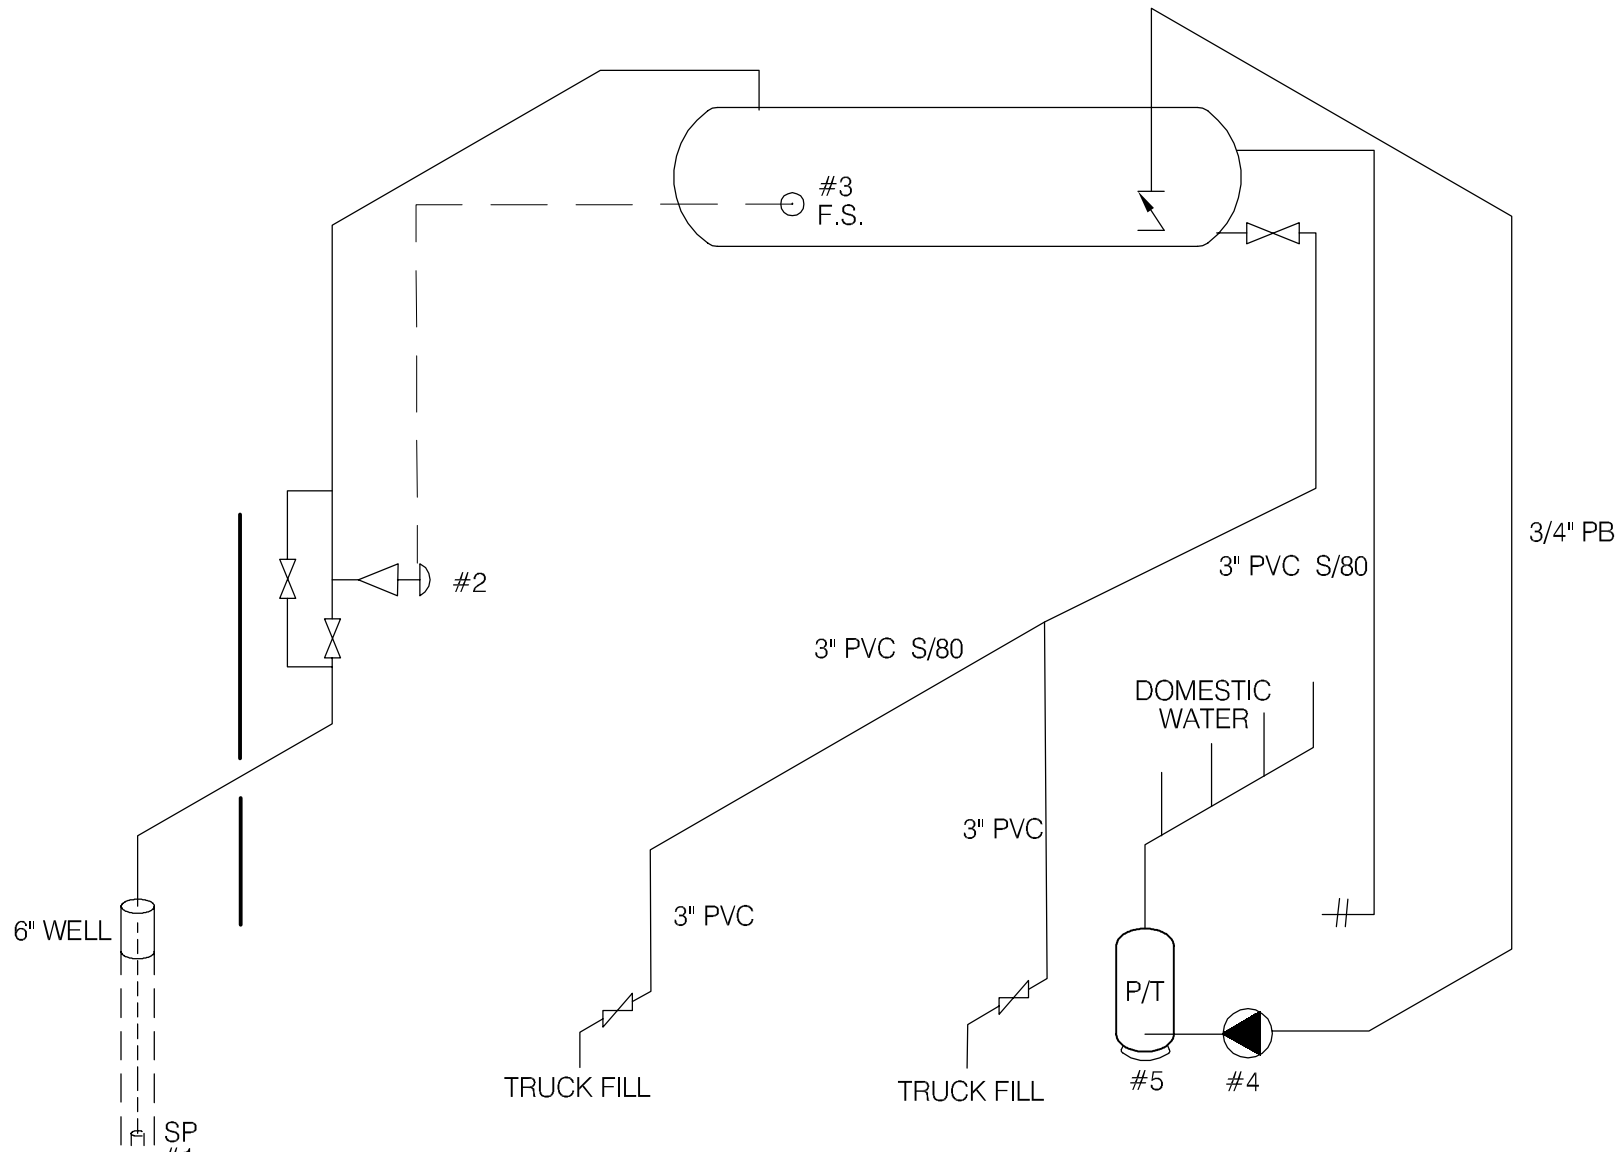
DWG.: FIGURE 1924B

WATER SYSTEM DISTRIBUTION/TREATMENT
SCHEMATIC SYSTEM ID.: 1924
GOLDEN HORN FIRE HALL

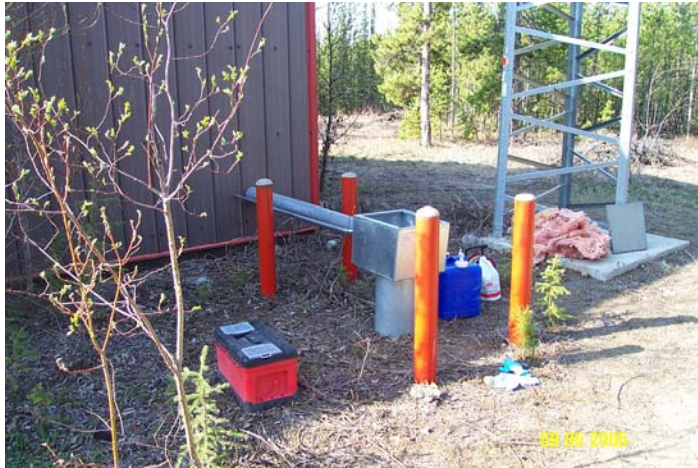
the septic system for the fire hall is located within 30 m of the well. It is unclear if the effluent field begins at a distance greater than 30 m.

Photo 0078: 1924 Wellhead (front), Golden Horn Firehall (left) and Septic Field (back)

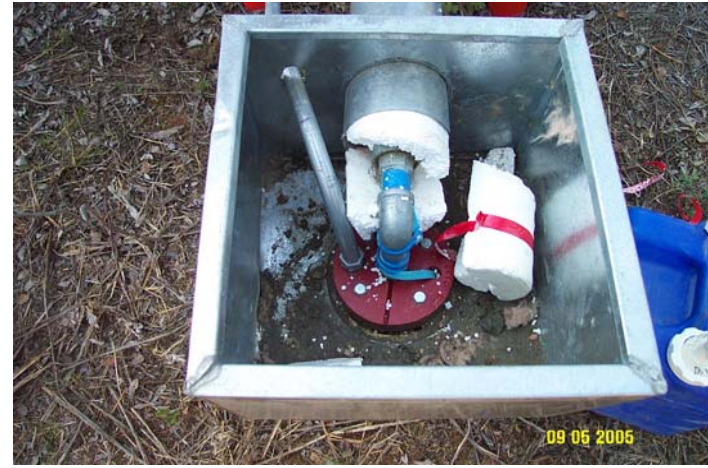
- The arsenic content of the water was above the MAC and proposed MAC for two out of three sampling events.
- There is no locking mechanism on the well enclosure and it is likely accessible to unauthorized persons.
- There is evidence of insects in the well enclosure and it is likely accessible to entrance by animals.
- There is no surface sanitary seal (grout or bentonite seal as required by the Canadian Groundwater Association's Well Construction Guidelines) and parts of

Photo 0079: 1924 Wellhead

- The well must be equipped with a surface seal to 6 m and the casing must be extended above grade and kept in a locked enclosure that is inaccessible to animals and unauthorized personnel;
- The well must be located at a distance greater than 30 m from any potential source of contamination, including the above ground storage tank;
- If the new well still has arsenic content above the current or the proposed CDWQG guidelines, then a point of entry (POE) treatment system for arsenic removal should be installed. It is recommended that a suitable POE system be designed through small scale pilot testing, and that the system be installed in advance of the potable water storage tank. Arsenic removal to below the proposed new CDWQG guideline will be necessary to utilize this water source as a drinking water supply.

- A surface seal to 3 m below ground level should be installed around the well casing;
- A point of entry (POE) treatment system for arsenic removal should be installed. It is recommended that a suitable POE system be designed through small scale pilot testing, and that the system be installed in advance of the potable water storage tank. Arsenic removal to below the proposed new CDWQG guideline will be necessary to utilize this water source as a drinking water supply;
- The wellhead enclosure should be upgraded with a lock and revamped to prevent access by animals and by unauthorized personnel.
- It is recommended that a NSF 61 certified commercial filtration system (10 micron and 1 micron absolute) followed by a chlorine disinfection system or NSF/ANSI 55 certified UV disinfection system be installed at the POE.

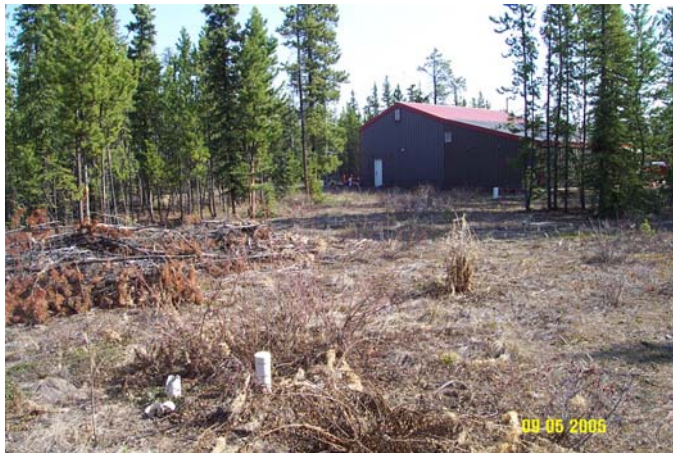
Tank @ 19 m, end of field @ ~40 m, field may start before 30 m, likely starts within 30 m

Photo 0080: 1924 Septic Field (fron), Golden Horn Firehall (back)

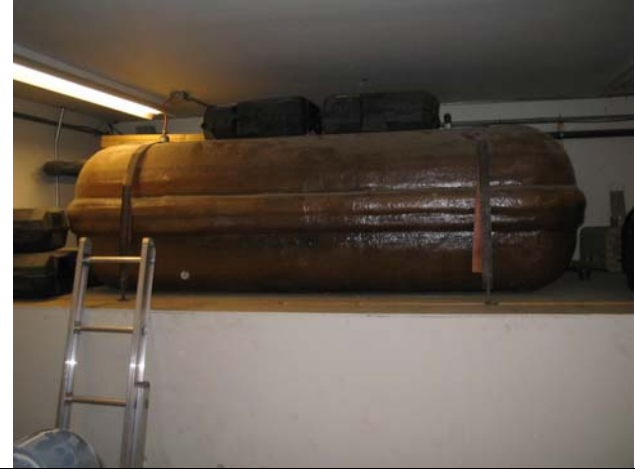
- It was noted during the system inspection that the well capacity could be inadequate to meet peak water consumption demand of the fire hall.
- The water tank has been subject to biofouling and there was reported to be sediment on the bottom of the tank. There is no routine cleaning schedule for the water storage tank that services both the domestic supply for the building and the overhead fill for fire protection.

Photo 0470: 1924 Water Storage Tank

- If a back-up well is not drilled, further investigation of the reported water quantity problems under peak demand should be evaluated. This would involve assessment of the actual demand versus the capabilities of the existing system. Modifications to the pump and/or tank sizes should be made as required, provided the well is capable of supplying water at the increased rate. The sustainable well yield may also have to be assessed.
- Fire hall personnel should also be instructed to store potential contaminants such as jerry cans a safe distance away from the well. A fence should also be placed around the well to prevent access for animals and people.
- A regular cleaning schedule for the water storage tank would effectively eliminate significant biofouling in the water storage tanks. It is recommended that the storage tanks be properly cleaned and disinfected every 6 months.
