16.0 YUKON WILDLIFE PRESERVE

16.1 Description of Existing Water Supply System

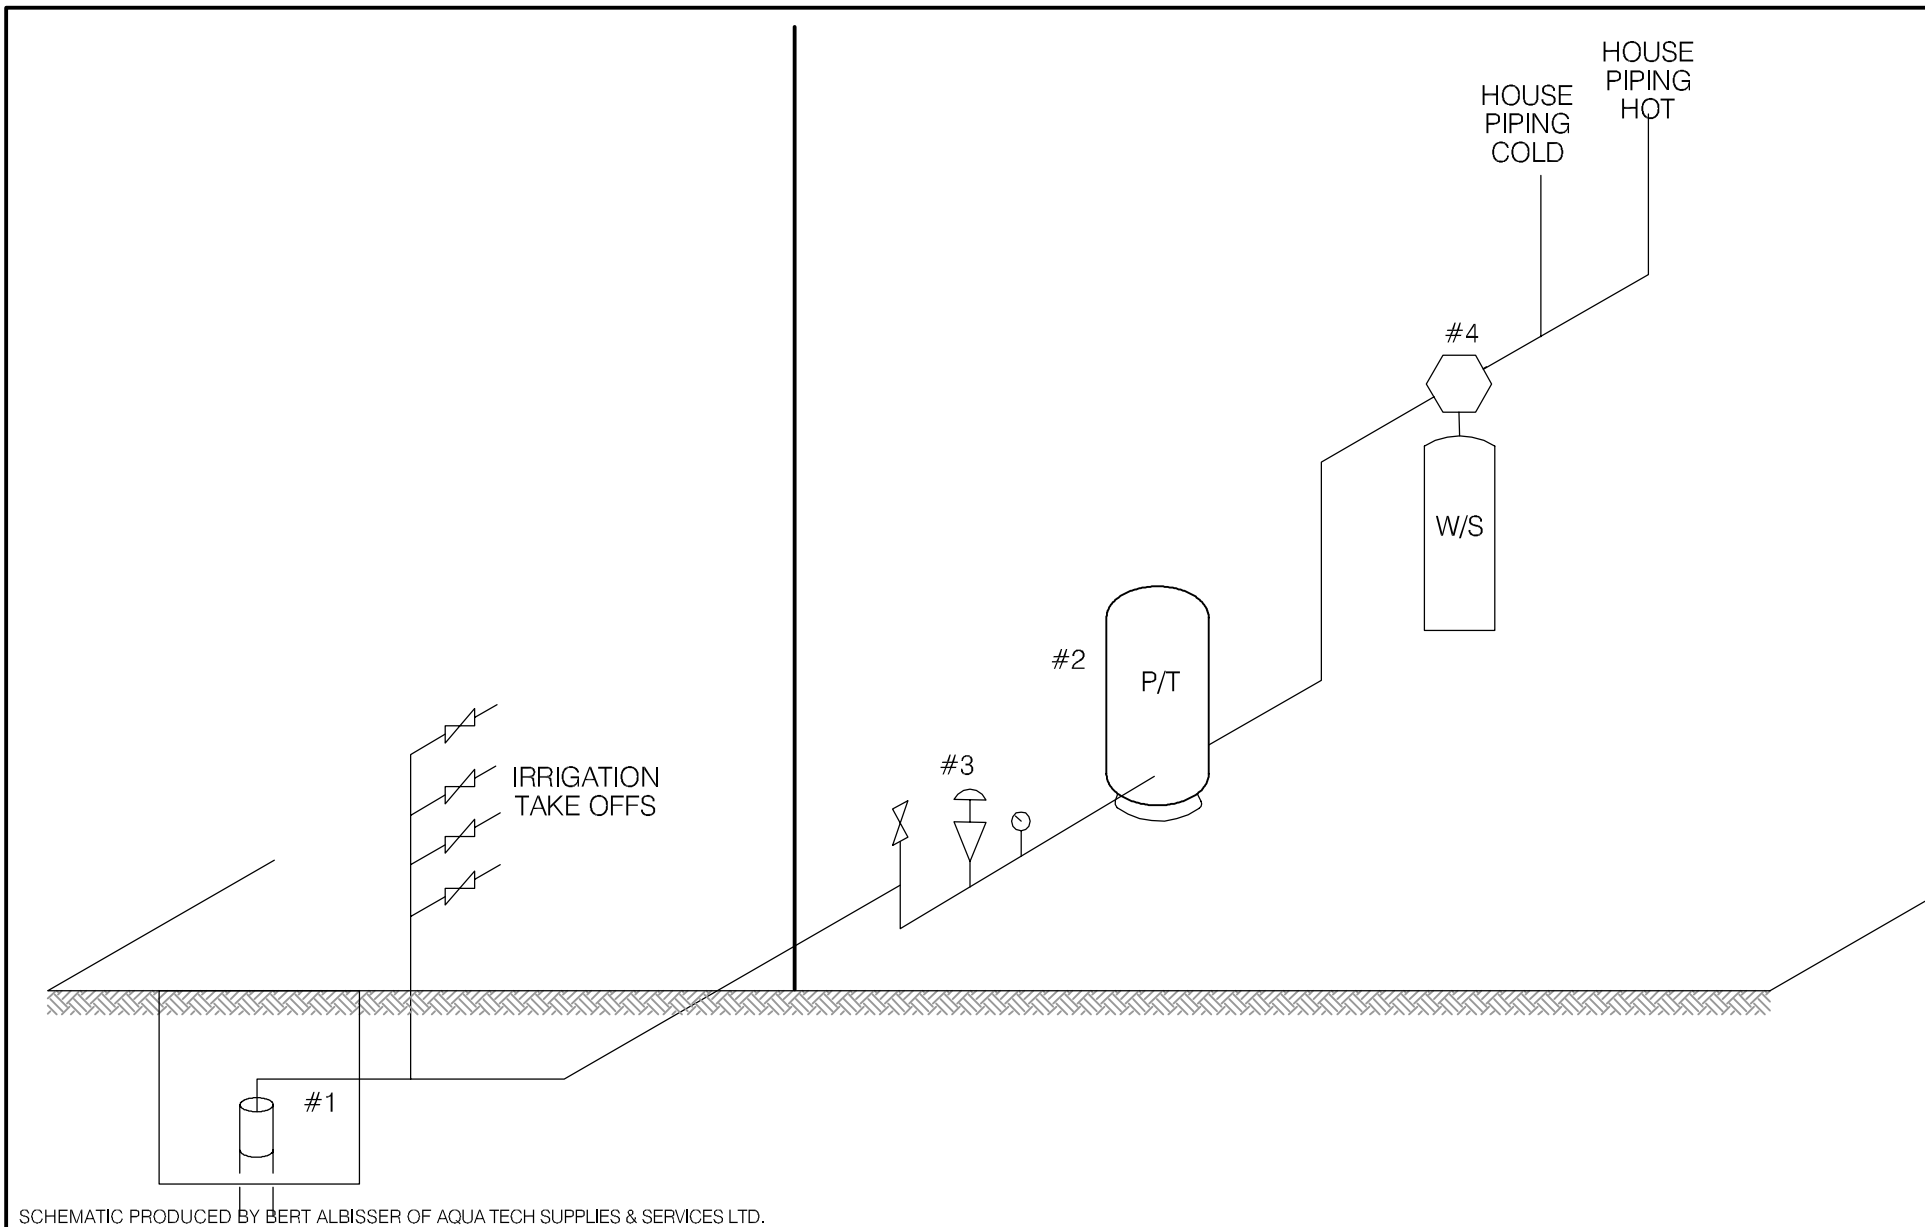
In addition to servicing the main office potable water system, there is a hydrant tree at the wellhead prior to the existing softener system that feeds irrigation and animal water tanks. The current wellhead configuration lacked proper freeze protection. The only treatment on the main office water system at the time of the assessment was an iron softener. A system schematic is provided as Figure YWP-A in Appendix A16.

- The wellhead completion should be improved. This would involve raising the well casing to a minimum of 500 mm above ground level and retrofitting a proper surface-seal to bedrock around the well casing. If possible, the casing should be extended to at least 6 m below grade by hanging a smaller diameter casing with a packer, and grouting the casing between the casing and the packer. We understand that Aqua Tech Supplies and Services have been retained by PMA to complete this work and it is in progress at the time of this final report.

- The ground surface around the wellhead should be graded to promote surface drainage away from the well;
- It was recommended that a NSF 61 certified commercial duplex filtration system (10 micron and 1 micron absolute) followed by a chlorine disinfection system be installed at the point of entry. The system should be equipped with a proportional feed digital dosing chlorine injection pump. Sodium hypochlorite dosing rates should be adjusted as necessary to maintain a residual chlorine concentration above 0.4 mg/L. We understand that a filtration and digital dosing chlorine injection pump with necessary appurtenances were installed in July 2005 shortly after the positive *E. coli* result and the publication of the draft report that preceded this report. The project team has not inspected the current system.

- A backflow preventer should be installed on the irrigation piping. This work should be completed by Aqua Tech in conjunction with the wellhead upgrades that are in progress.

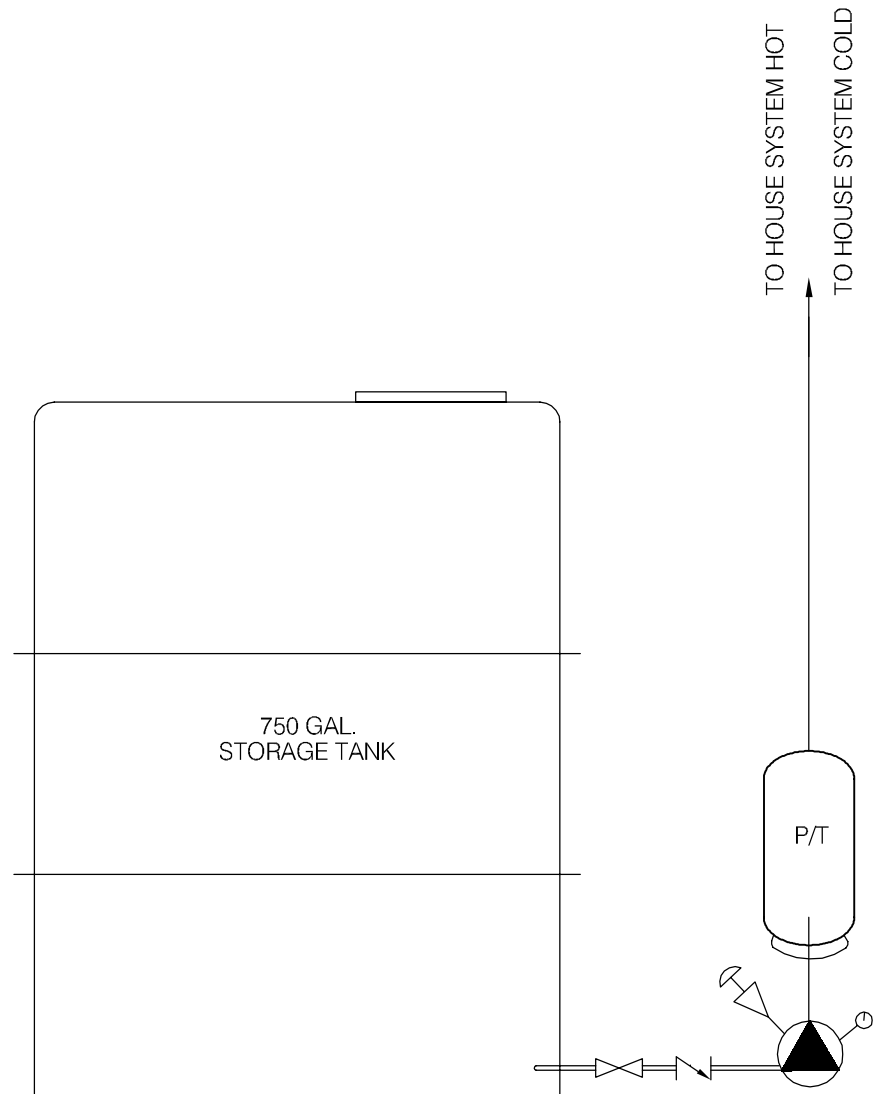
DWG.: FIGURE YWP-B

The Yukon Wildlife Preserve Kestrel Cottage (YWP-B) is currently serviced by a water delivery system. Water from a 3000 L water storage tank supplies potable water to the building. A system schematic is provided as Figure YWP-B in Appendix A16. There is no treatment or disinfection system, but the delivered water is chlorinated at the source. Field chemistry with a Hach Colorimeter at the site taken at the time of water sampling indicated that the residual chlorine was at 0.38 mg/L, which is considered adequate according to the proposed regulations.

- There is no floor in the crawl space that leads to the water storage tank and there is evidence of biofouling in the tank.
- The tank was not sanitary and appeared that it had not been cleaned recently if ever.
- Due to the lack of flooring in the crawl space leading to the tank, any attempt to clean the tank would likely track in dirt and make the cleaning process particularly difficult.

The water storage tank at the Yukon Wildlife Preserve Kestrel Cottage can not be properly accessed for cleaning. To mitigate this, it is recommended that a concrete floor be installed in the building crawl space to properly house a water storage tank. The tank should be dismantled, and a section removed, so that the height of the tank would render it accessible for cleaning. Re-plumbing with PVC should be completed at this time.

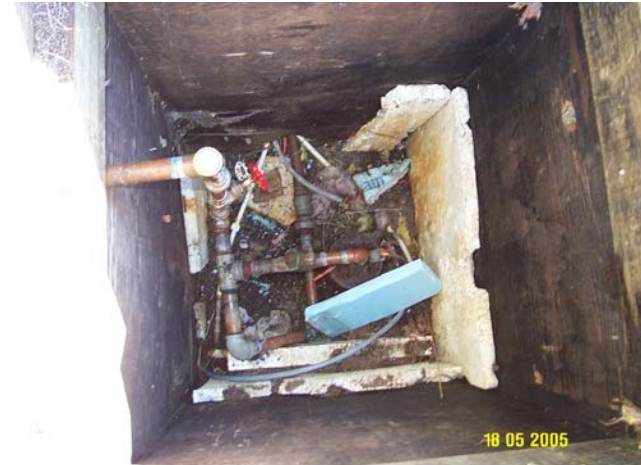
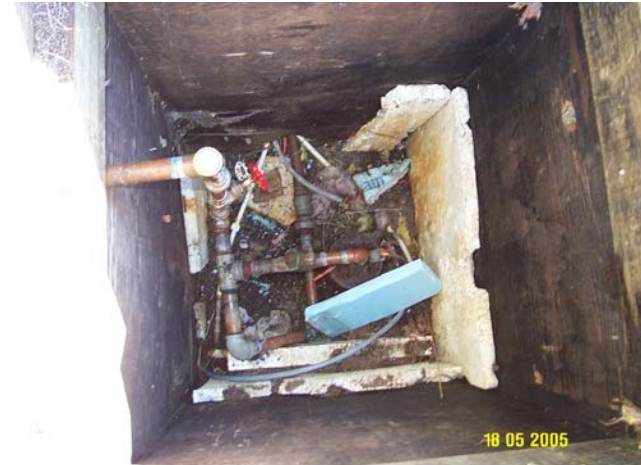
Photo 0173: YWP-A Well Head

- Positive coliform and *E. coli* results.
- The well is located in a pit below grade, without a surface seal, and there was evidence of vermin presence inside the pit enclosure;

- By definition of the Draft Yukon GUDI Assessment Guideline, the well is potentially under the direct influence of surface water because it does not meet the requirements of the Guidelines for Water Well Construction;

- The well is located in an enclosure that is not locked and may be accessible to animals and unauthorized personnel;
- The well it is located within 30 m of the office septic system, as well as within 30 m of muskox pens;

- There is an above ground fuel storage tank located 6 m away from the wellhead;
- There is no disinfection system;
- Nitrate and chloride levels may be higher than expected background concentrations for the Whitehorse area; and,

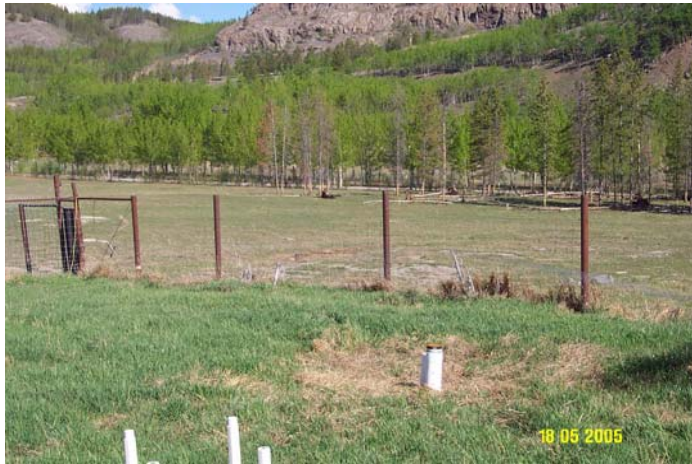
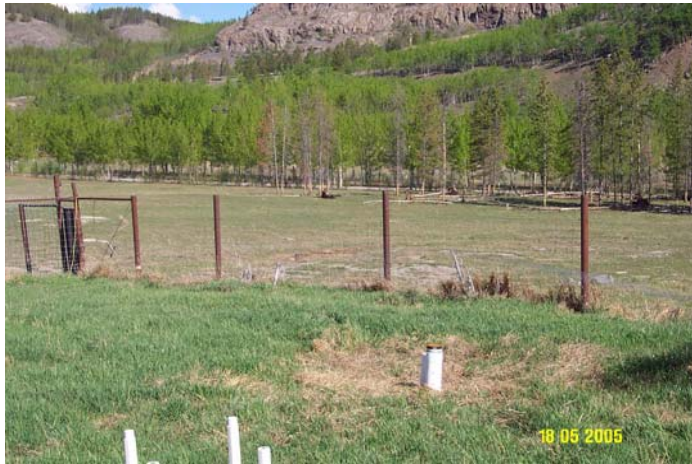
Photo 0175: YWP-A Septic Field (front) and Muskox Pen (Back)

The septic tank for the Yukon Wildlife Preserve Main Office is located north of the main office building and approximately 20 m northwest from the wellhead. The septic tank discharges effluent to a field located greater than 40 m northwest of the tank. The septic tank and effluent field are located down slope from the well. A site plan showing the septic system is provided as Figure YWP-A in Appendix A16.

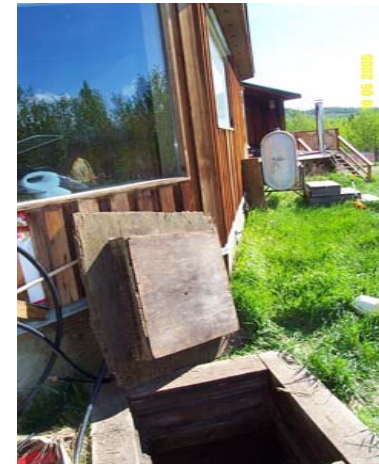
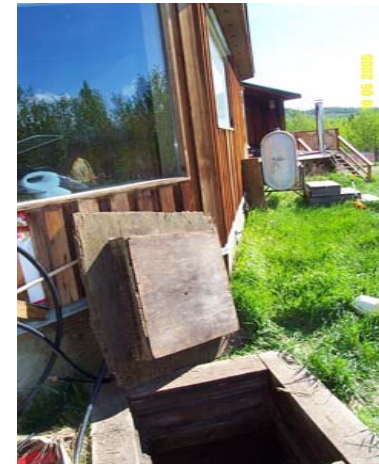
Photo 0178: YWP-A Well Head Enclosure (front), Main Office (left) and Above ground Fuel Storage Tank (right)

- Muskox pens and other game enclosures are at 12 m and 25 m respectively, and
- Above ground fuel storage tank is 6 m from the well.

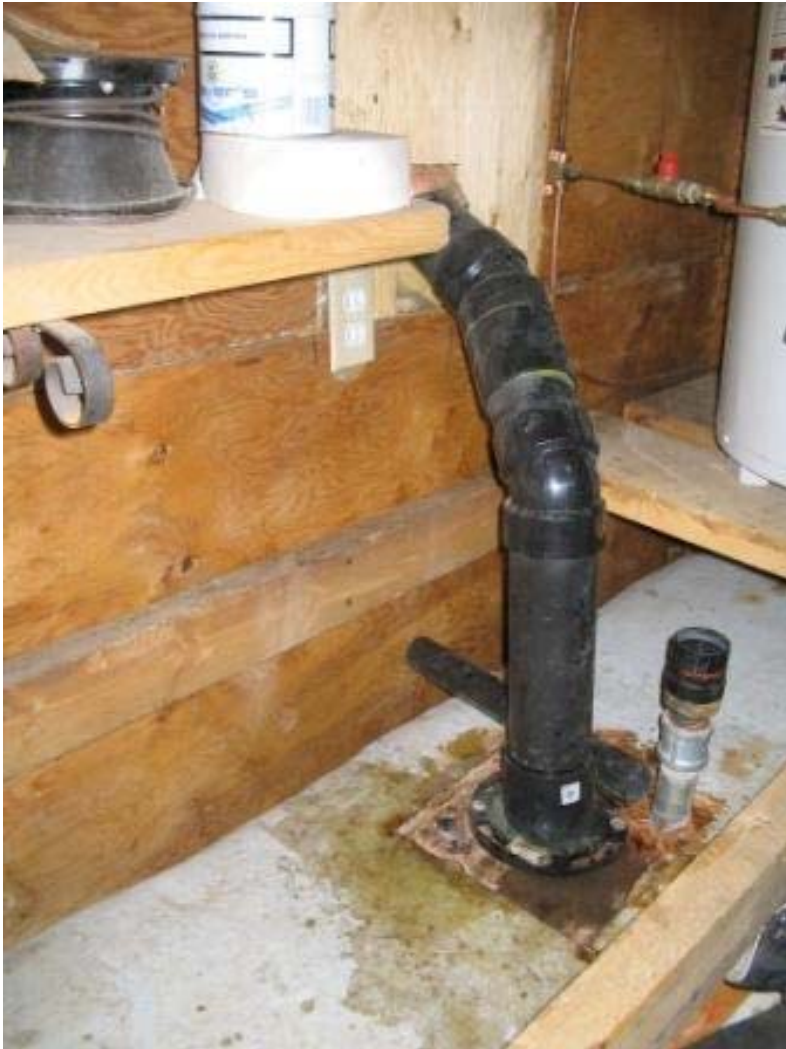
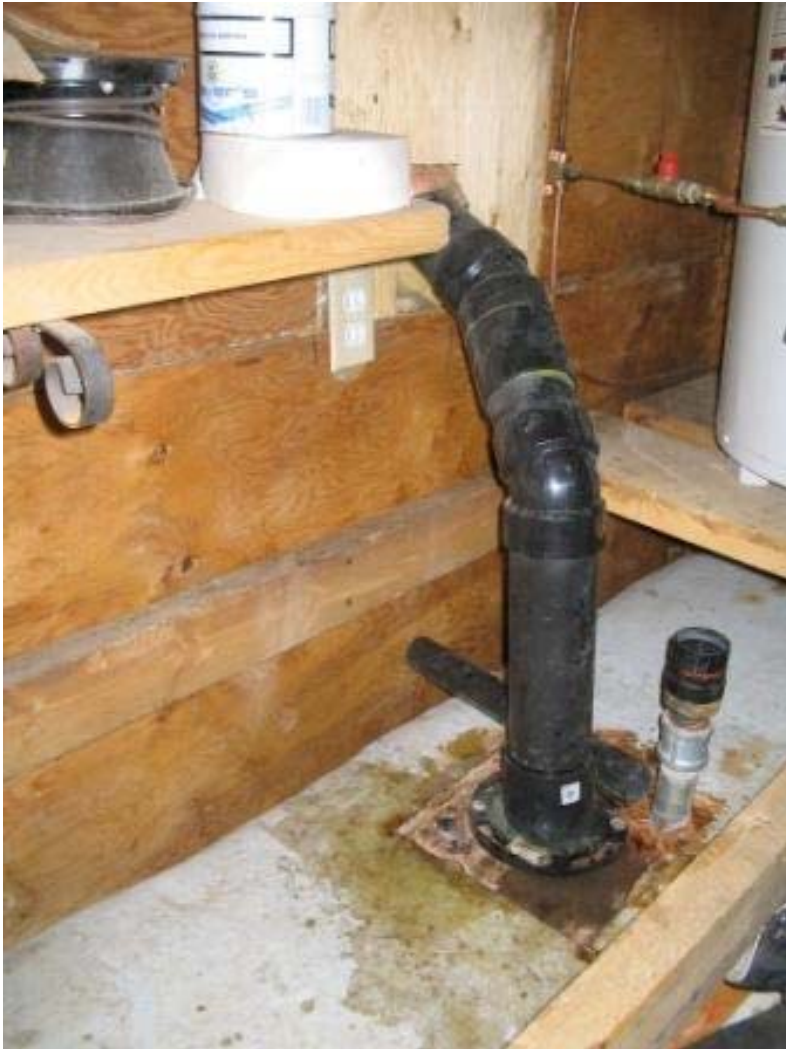
Photo 0182: YWP-D Piping

The piping for the Ptarmigan Tower fill pipe and overflow was also of ABS construction, which is not suitable for potable use.

ABS piping at the Yukon Wildlife Preserve Ptarmigan Tower should be replaced with PVC piping. Additionally, the cap for the water fill pipe should be replaced with one that will offer a proper watertight seal.

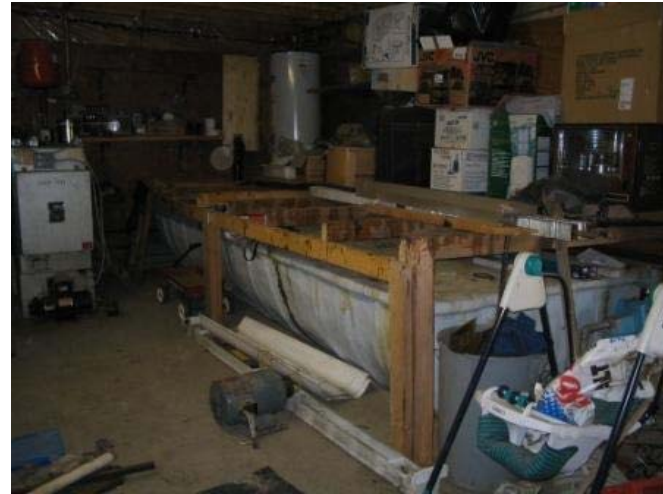
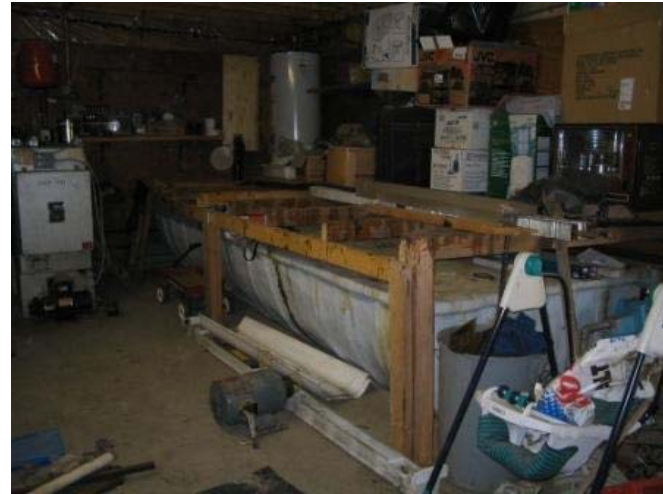
Photo 0006: YWP-D Water Storage Tank

The water storage tank installation for the Yukon Wildlife Preserve Ptarmigan Tower is sub-standard and likely not acceptable for potable water storage. The fill cap had holes in it. Fill caps should be properly sealed to prevent insect/vermin entry to the water system.

- The current water tank is inaccessible for cleaning. The storage tank should be replaced with a smaller 5000 L storage tank and be installed in a location that is accessible for cleaning. The new tank should be properly cleaned annually;
