11.0 BUILDING 5629: MAYO GRADER STATION

SMALL PUBLIC WATER SYSTEMS ASSESSMENT
NORTHERN REGION

MAYO GRADER STATION
BUILDING # 5629
SITE LOCATION DIAGRAM
WELL ID: 5629

SMALL PUBLIC WATER SYSTEM ASSESSMENT

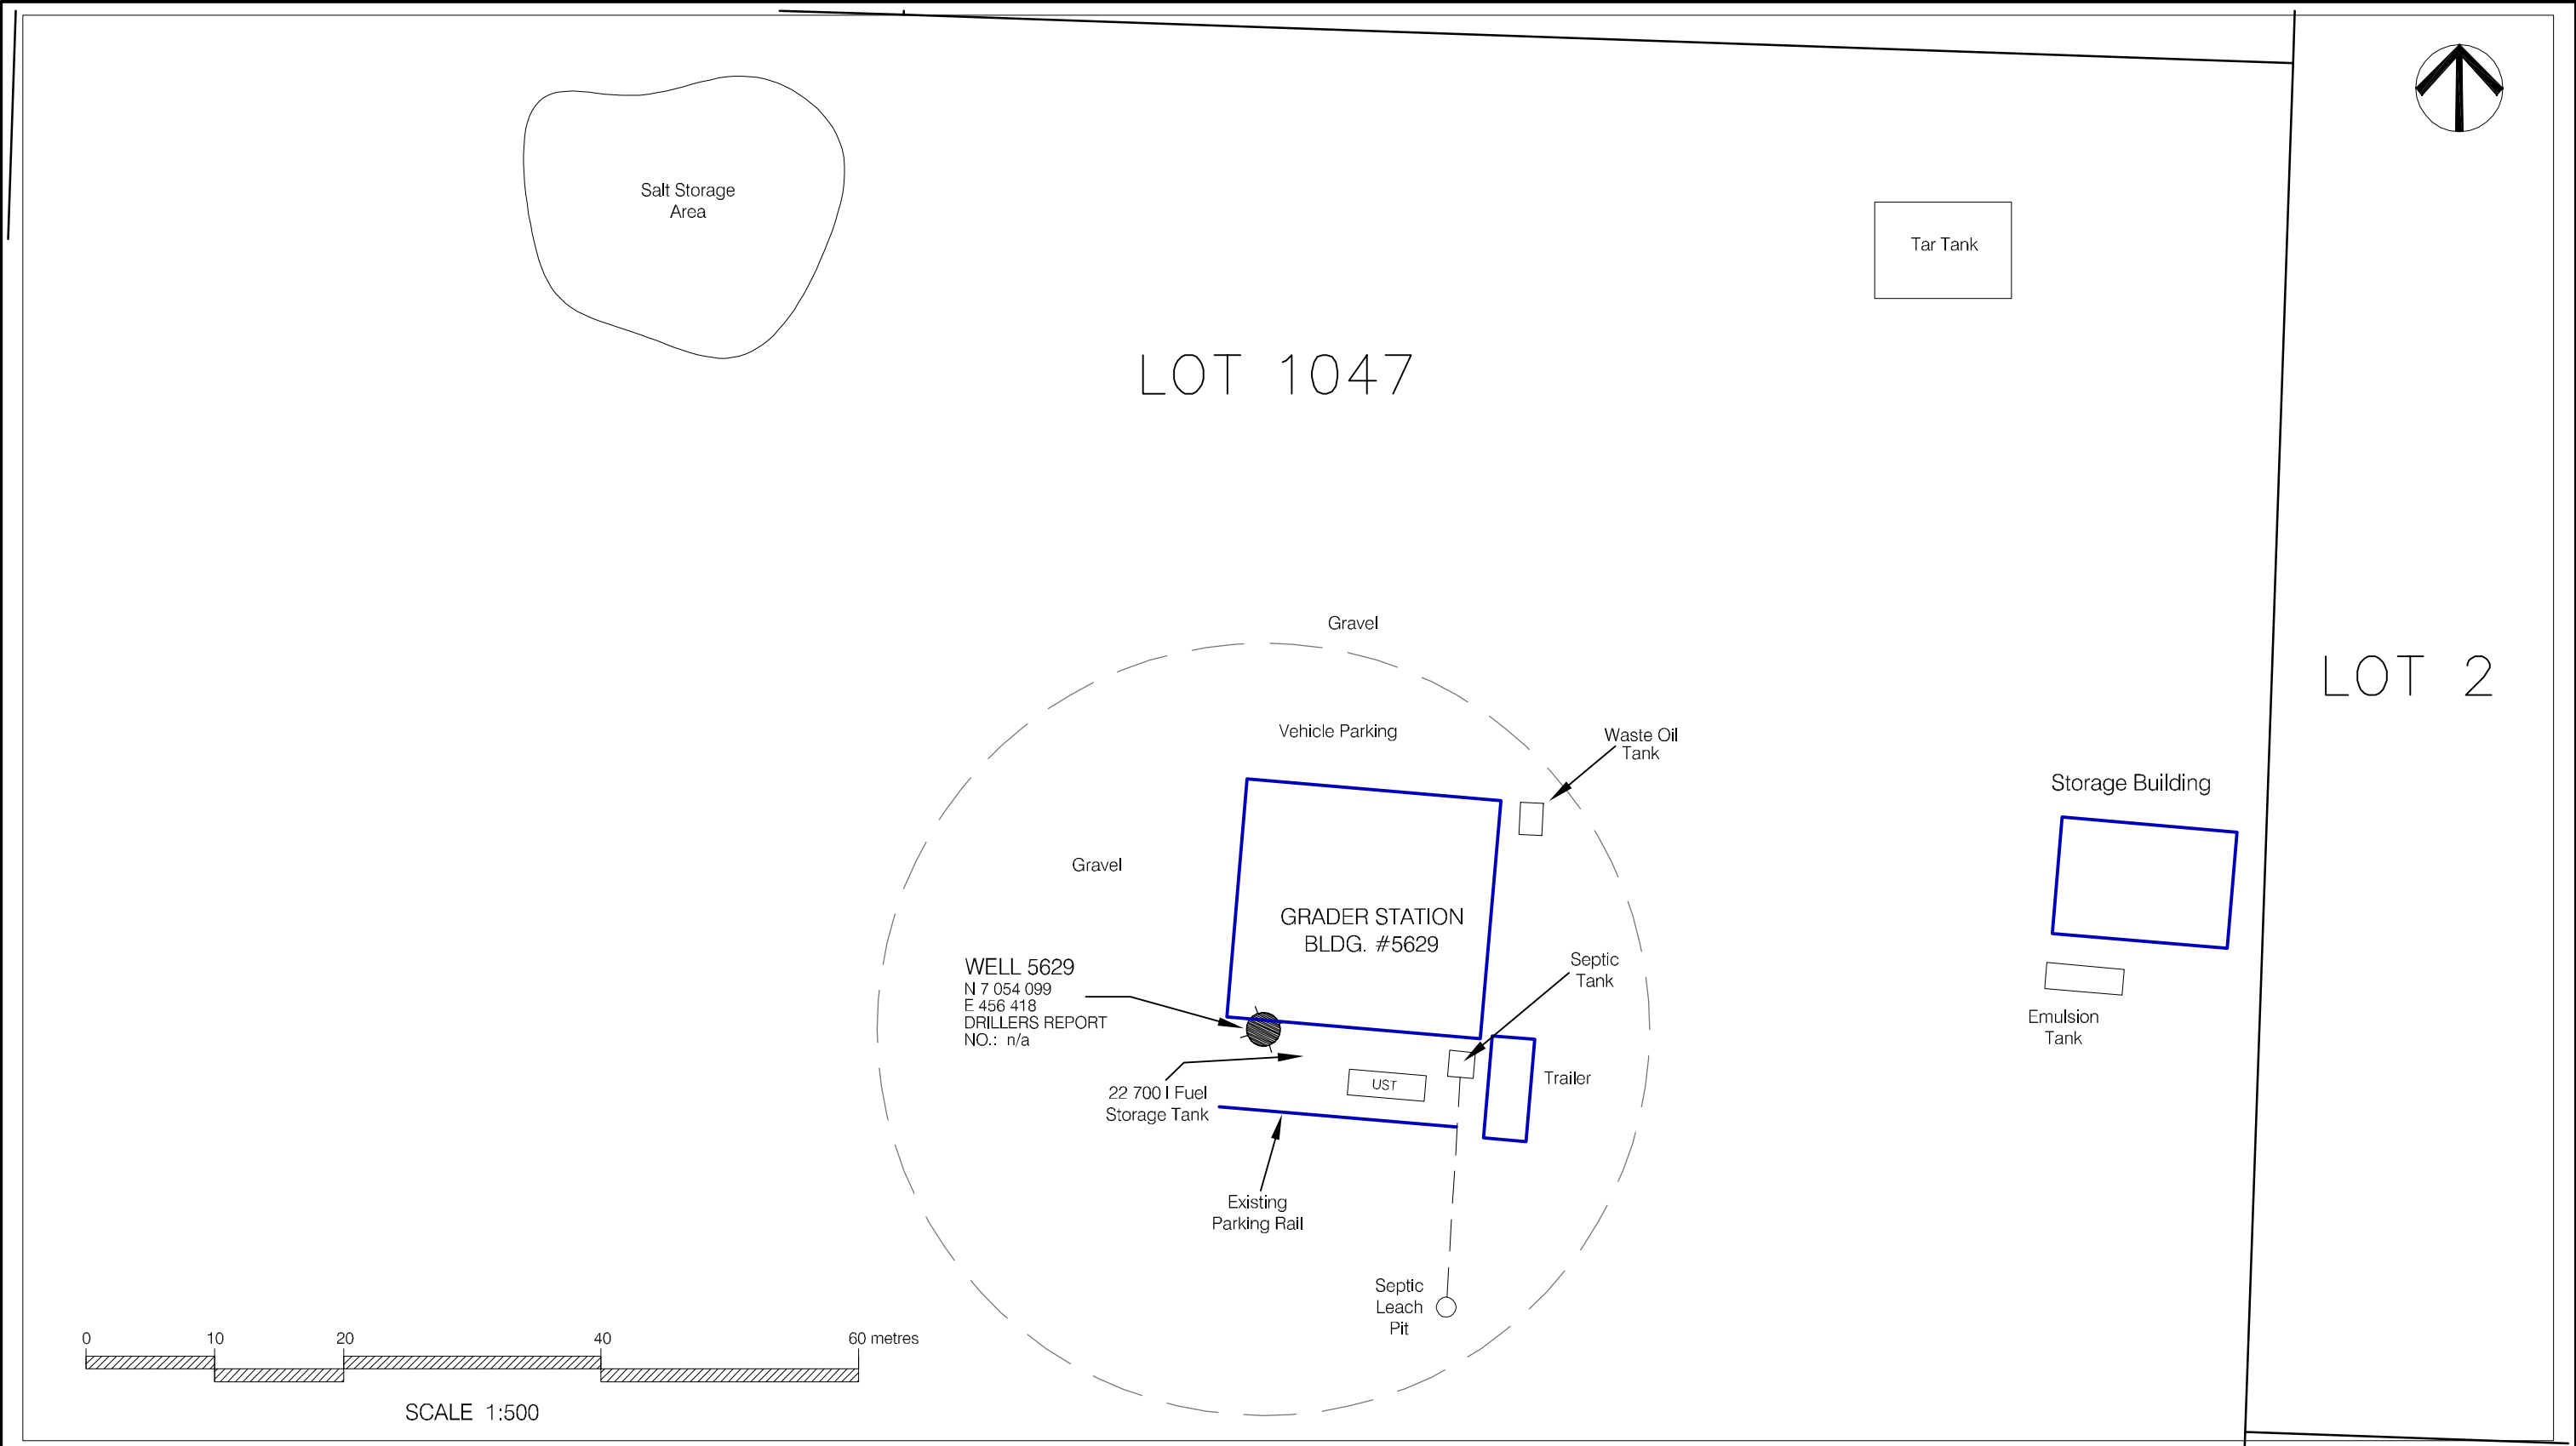
REVISION ISSUE
0
FIGURE No.
FIGURE 5629-A

Wastewater from the Grader Station building is discharged to an in-ground septic disposal system located south of the maintenance garage. The septic tank is located approximately 14 m east of the well. The effluent field may begin as close as 15 m from the well; however, it appears that there is leach pit style culvert for sewage disposal that is approximately 26 m from the well. A site plan showing the location of the septic system is given by Figure 5629-A in Appendix A11.

Potential contaminant sources within 30 m of the wellhead include:

- A septic leach pit is located within 26 m;
- A septic tank is located 14 m from the well (this is in contravention of the SPDWSR);
- An above ground waste oil storage tank at 22 m;
- An underground fuel storage tank at 7 m; and
- Industrial activities within 30 m.

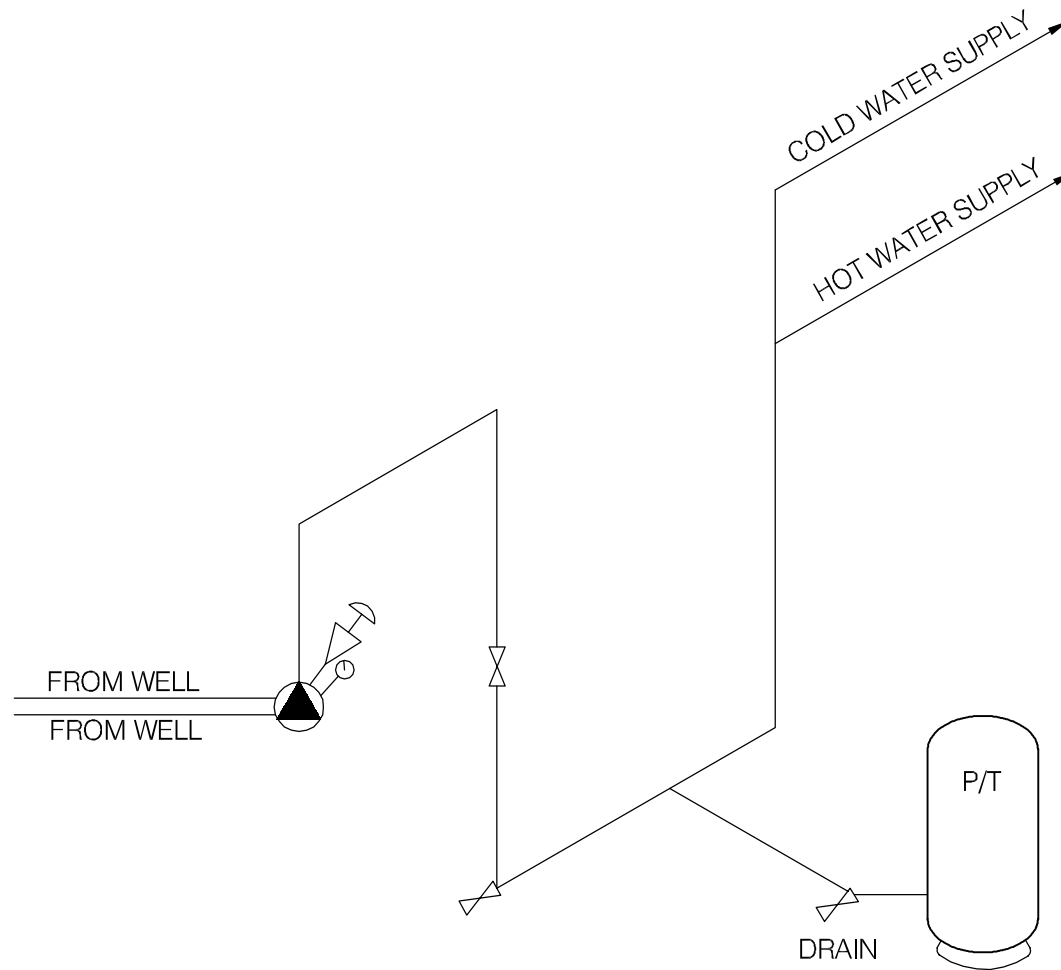
<div>Yukon Highways and Public Works Property Management Branch</div>			TITLE WATER SYSTEM DISTRIBUTION/TREATMENT SCHEMATIC SYSTEM ID.: 5629 GRADER STATION - MAYO, YT.						
DATE	SEPT. 2005	DWN.	JSB	CHKD.	RMM	FILE NO.	1260002.004	DWG.:	FIGURE 5629-B

THIS IS A OLD STYLE JET PUMP SYSTEM THAT HAS
A BAD PIPING CONFIGURATION THAT WILL DRIVE
YOU MAD SHOULD IT EVER LOOSE SUCTION

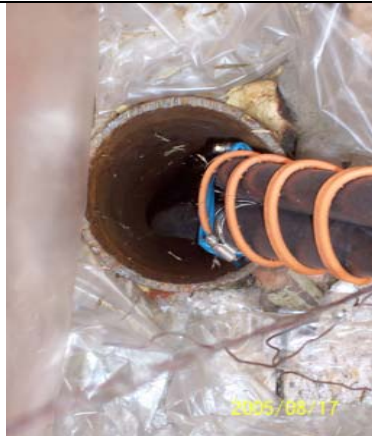
- Poor surface completion of the well (there was no well cap on the casing at the time of the assessment and the casing does not extend the required 500 mm above grade). We understand that a well cap has been installed since the assessment;

- There is no surface sanitary seal (grout or bentonite seal as required by the Canadian Groundwater Association's Guidelines for Water Well Construction);

Photo 042: 5629 Wellhead – note that there was no well cap at the time of assessment.

- The well should be equipped with a surface seal to at least 6 m and a pitless unit should be installed with the casing raised above grade (500 mm);
- The well must be located at a distance greater than 30 m and upgradient from any potential source of contamination;
- The well should be at least 15 m in depth; and,
- The water from the new well must meet all CDWQG health based guidelines. If there are any exceedences in the CDWQG health-based guidelines then a treatment system must be designed and installed as necessary. A treatment/disinfection system would likely consist of a

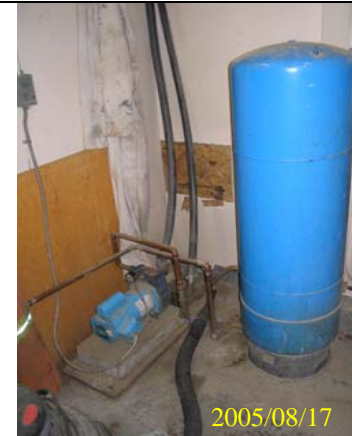
Photo 192: 5629 Grader station pressure tank and jet pump.
